BUILDING SURVEY REPORT

The format of this BUILDING SURVEY REPORT is consistent with the guidance defined by the
RPSA Survey Inspection & Reporting Standards Edition 1v5.2 November 2020

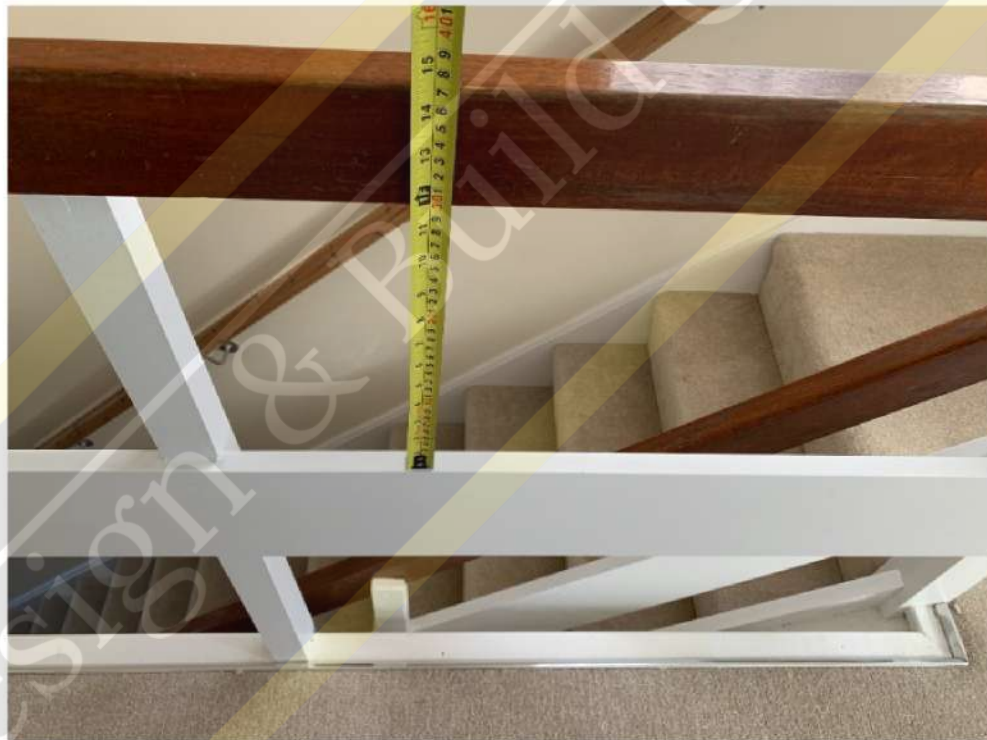
Gap is wider than required

The guarding should not be readily climbable, it is therefore recommended to replace the handrail and balustrade horizontal bars with vertical balusters.

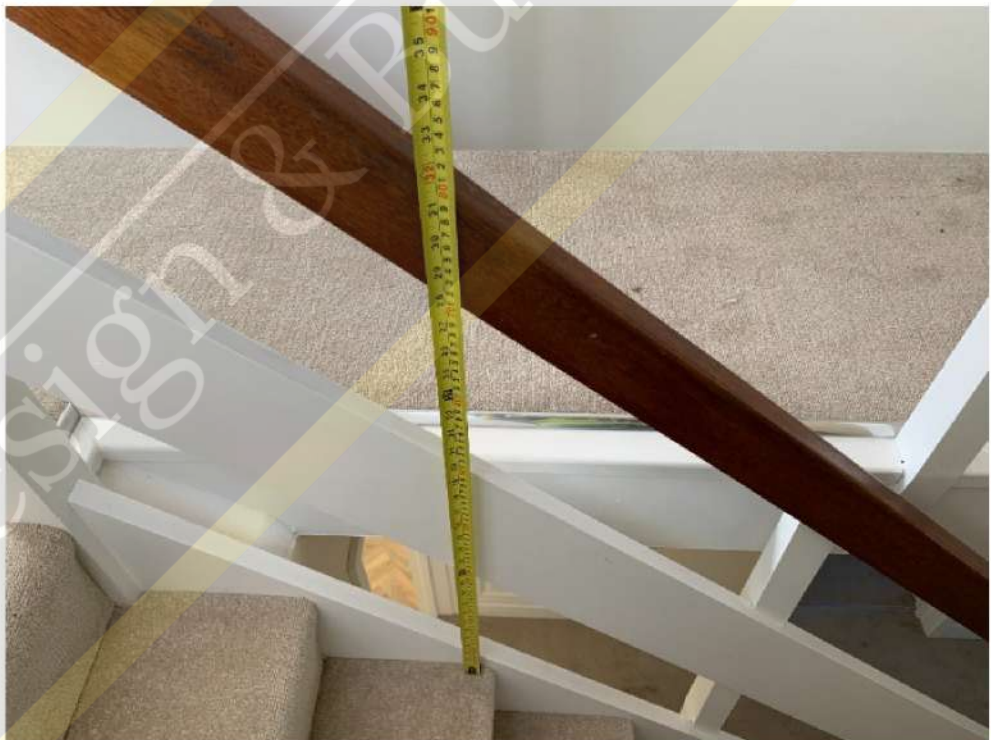
Handrail is lower than required

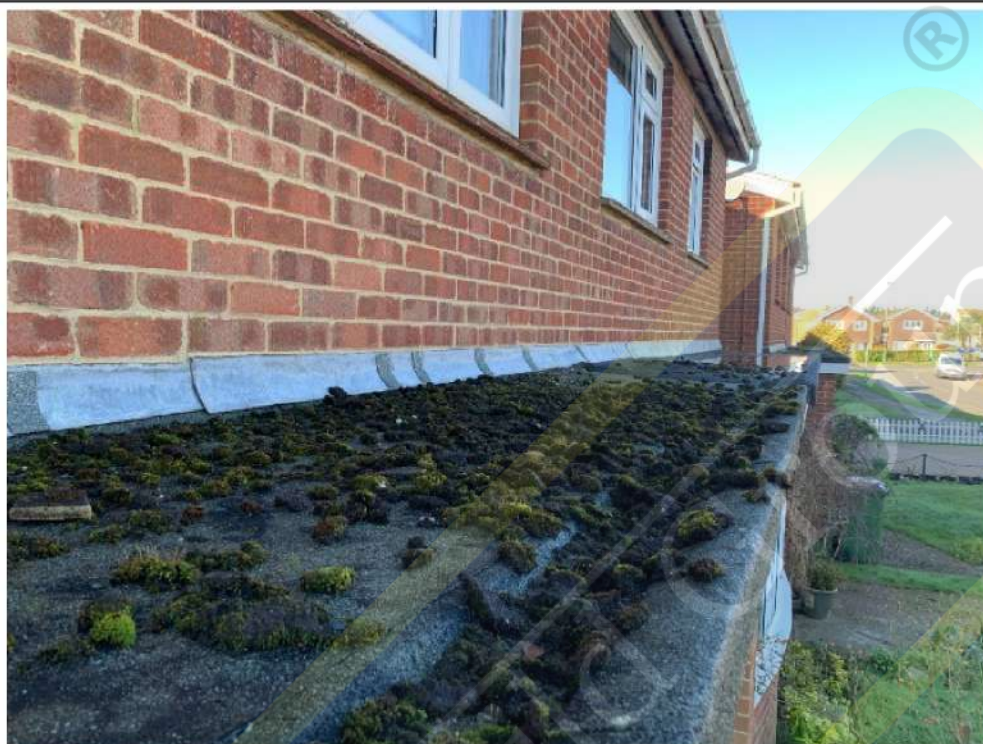
Moss growing on flat roof (front flat roof)

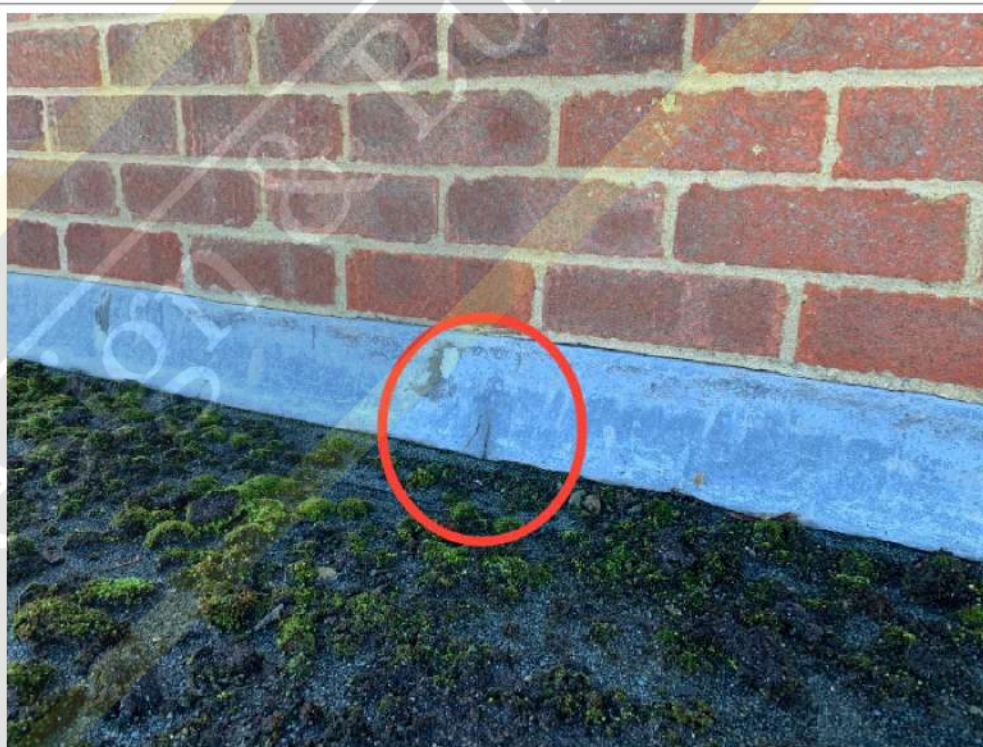
Cracked flashing (front flat roof)

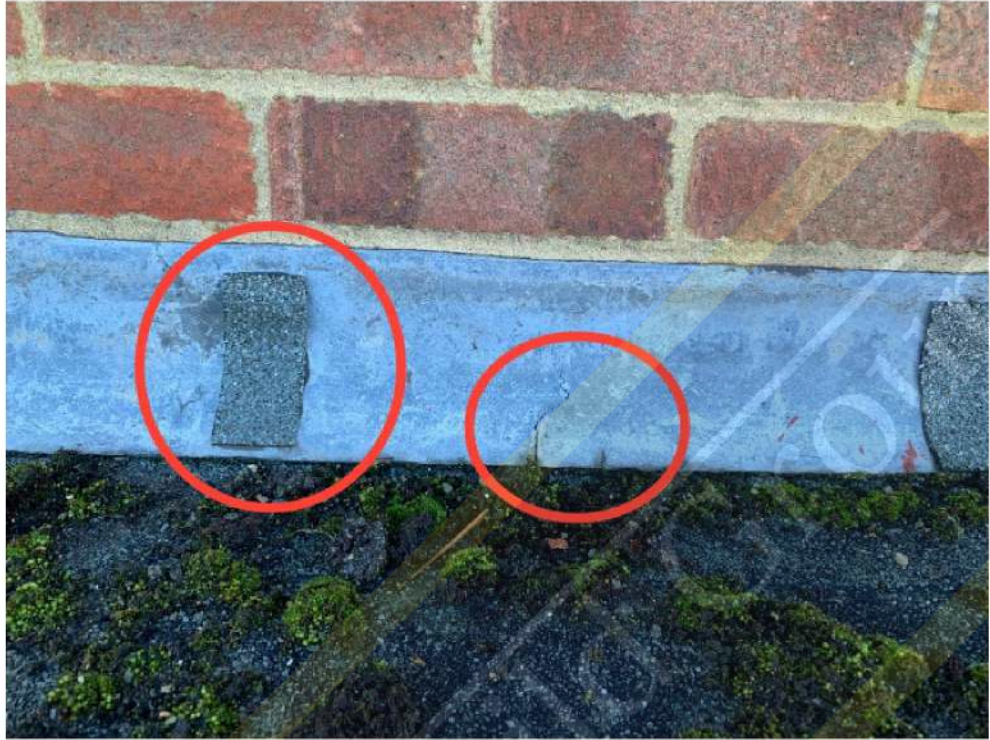
Cracked and poorly repaired flashing (front flat roof)

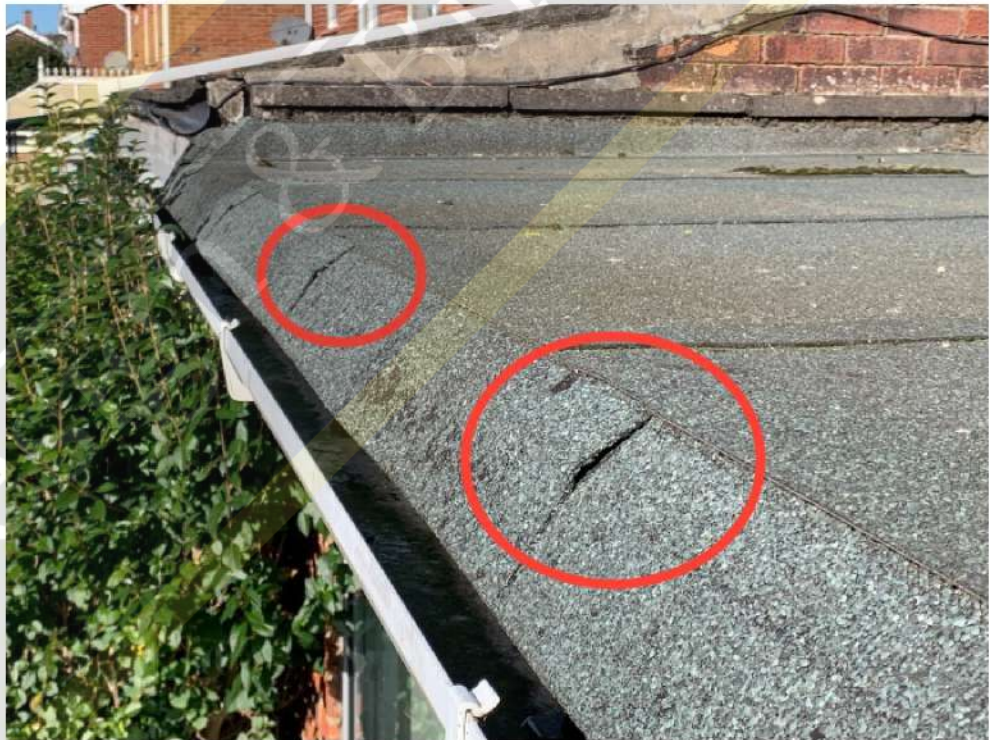
Deteriorated felt (extension roof)

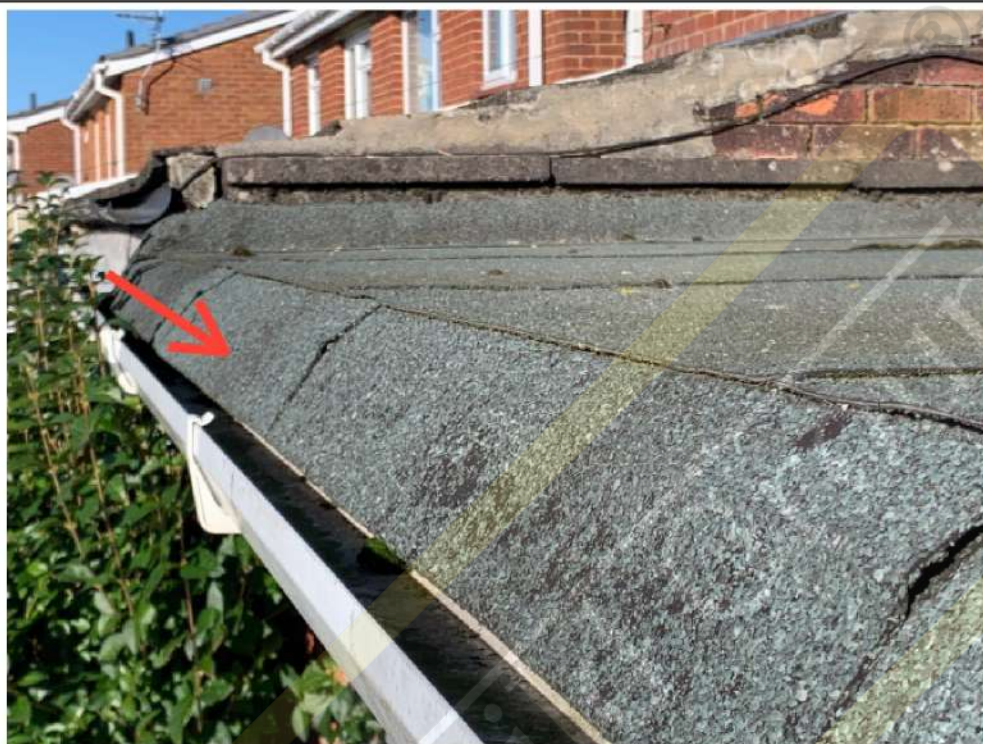
Poorly installed felt

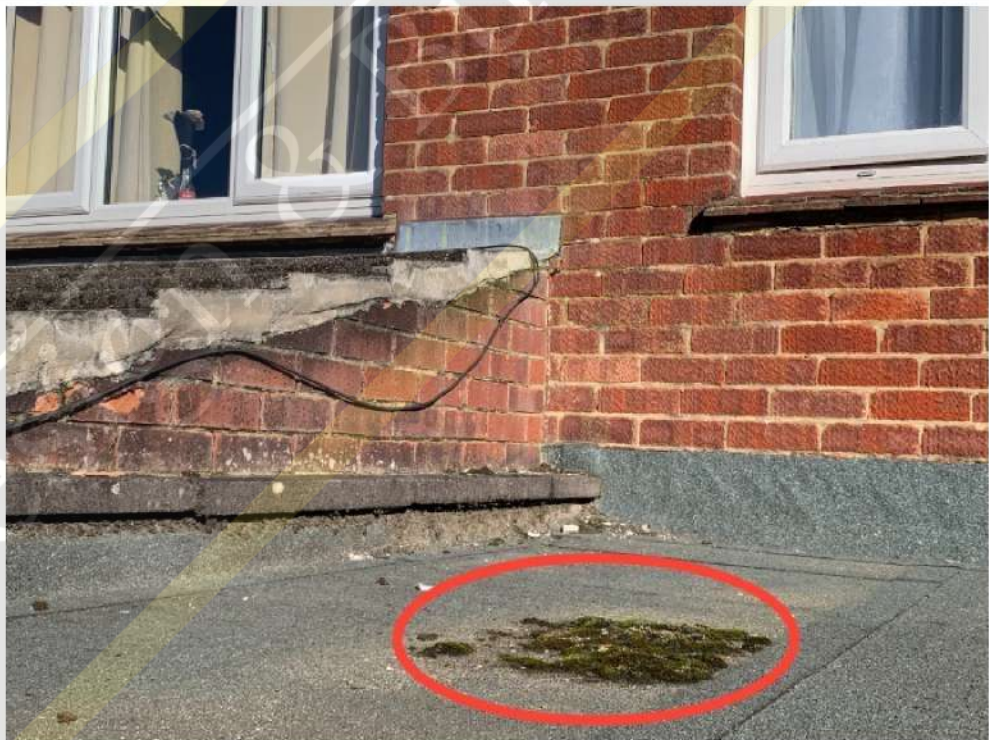
Moss (extension roof)

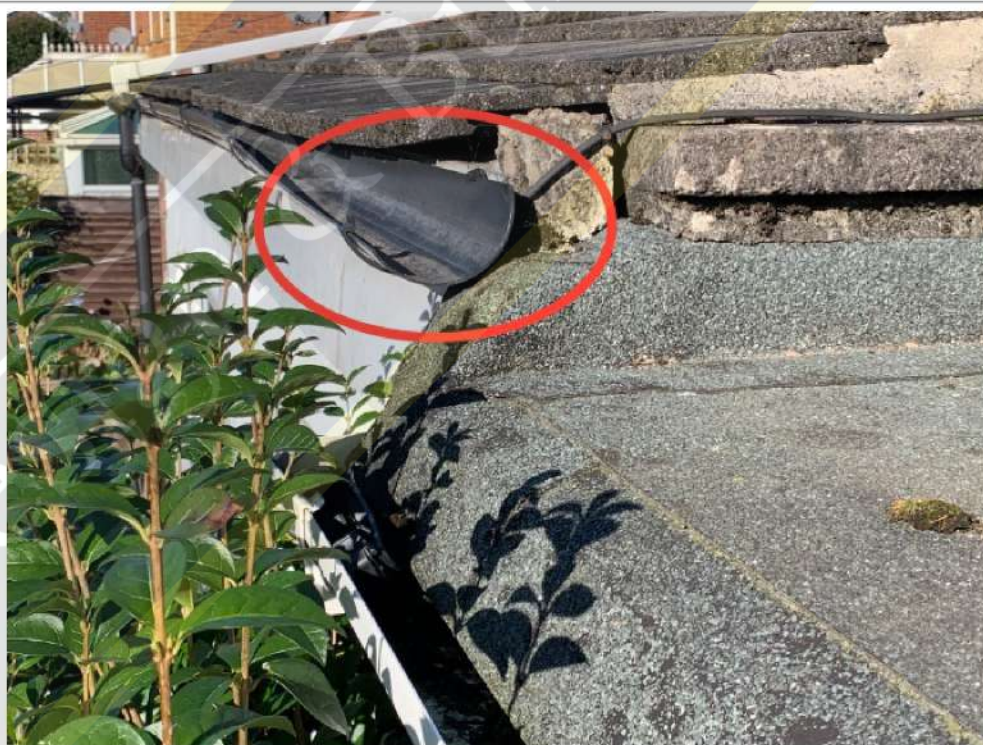
Neighbour's gutter stop end is missing

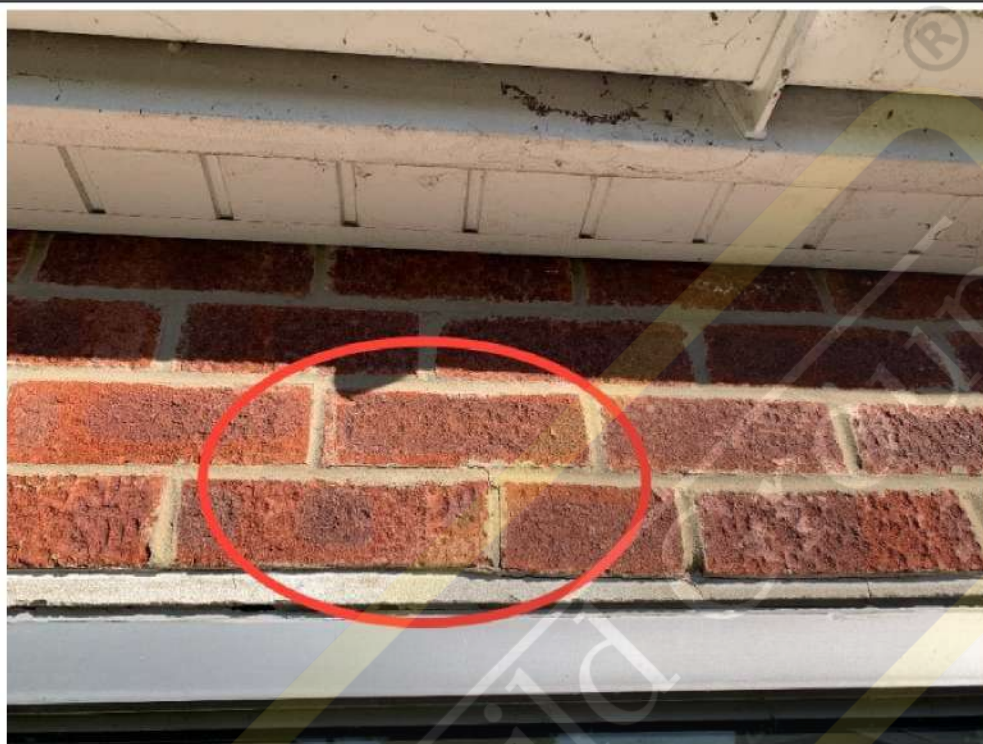
Hairline crack above the rear door (extension rear wall)

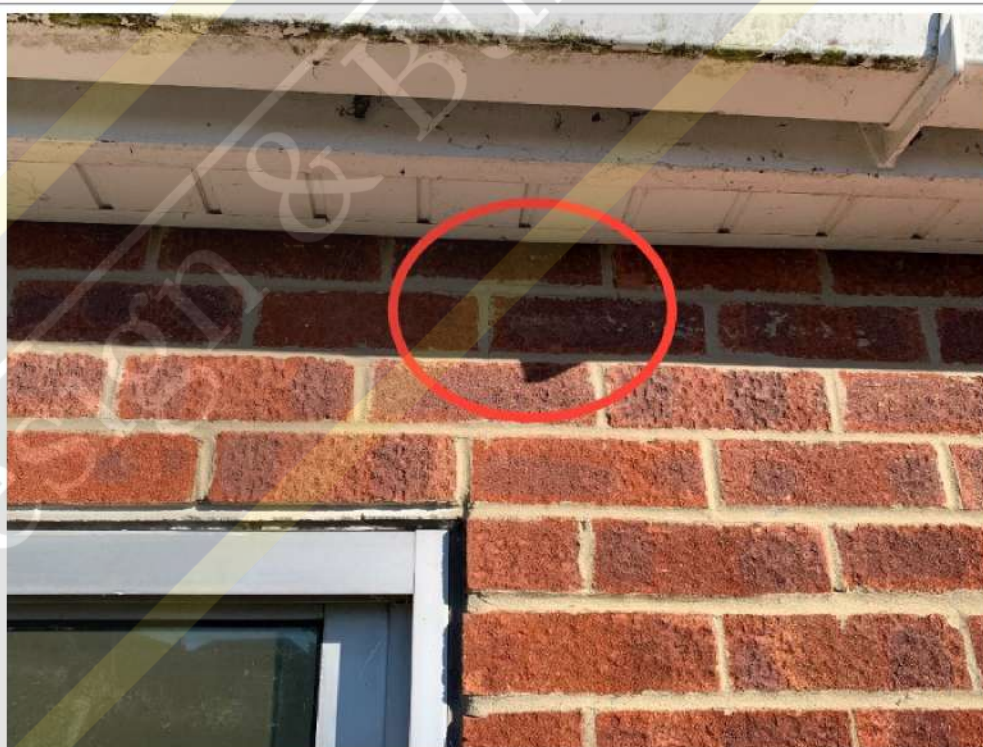
Hairline crack (extension rear wall)

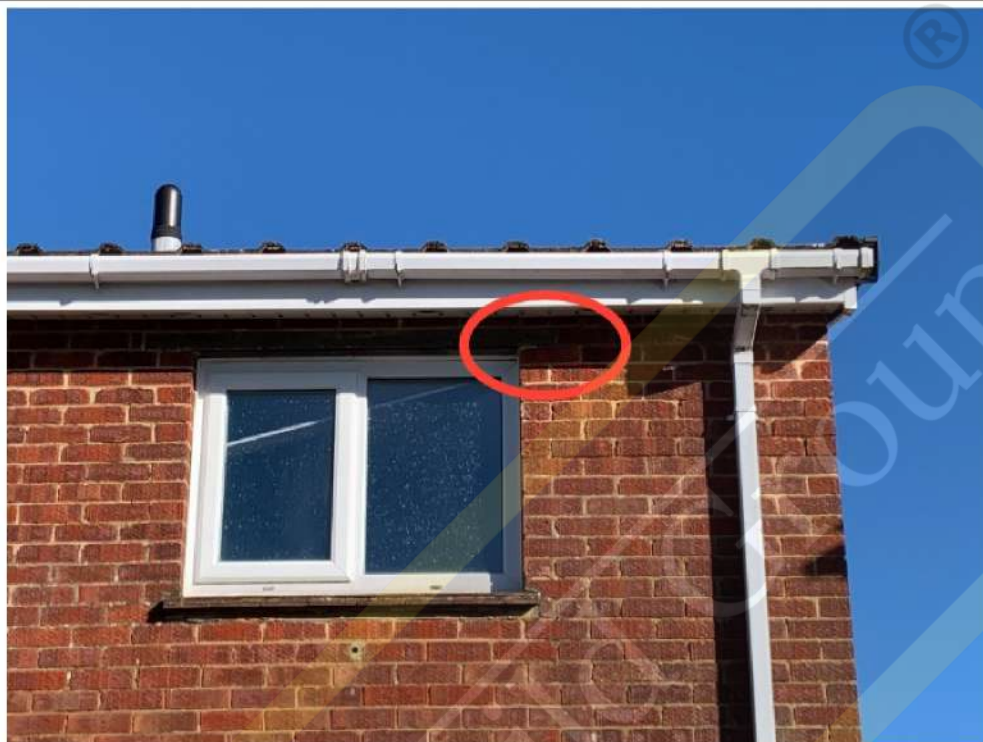
Crack above window (rear wall)

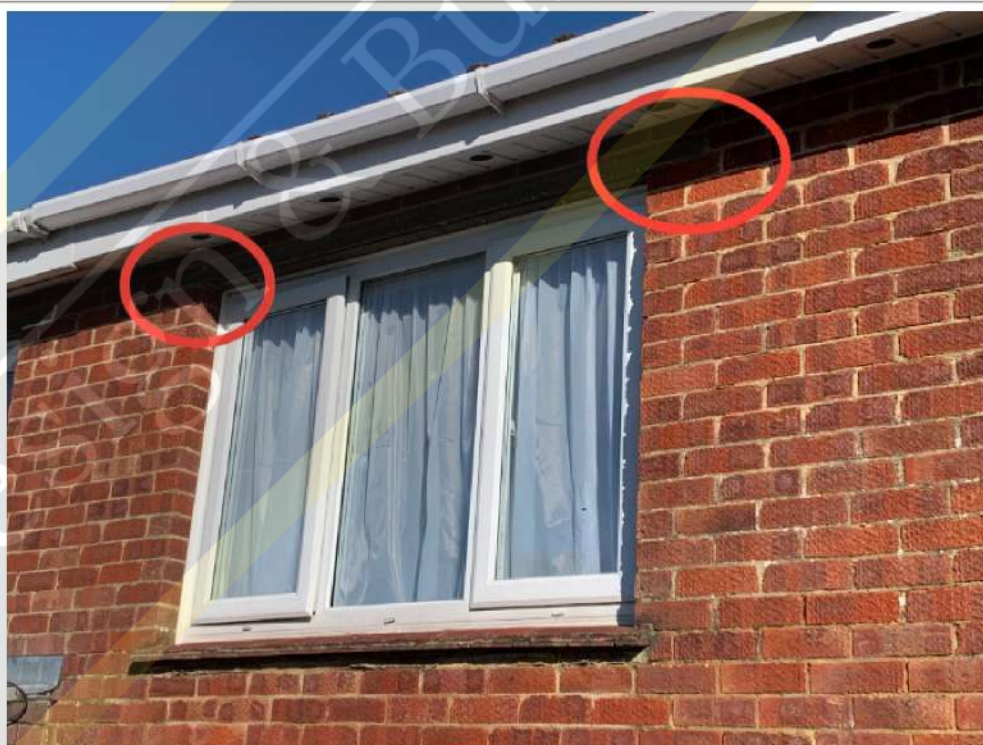
Cracks above window (rear wall)

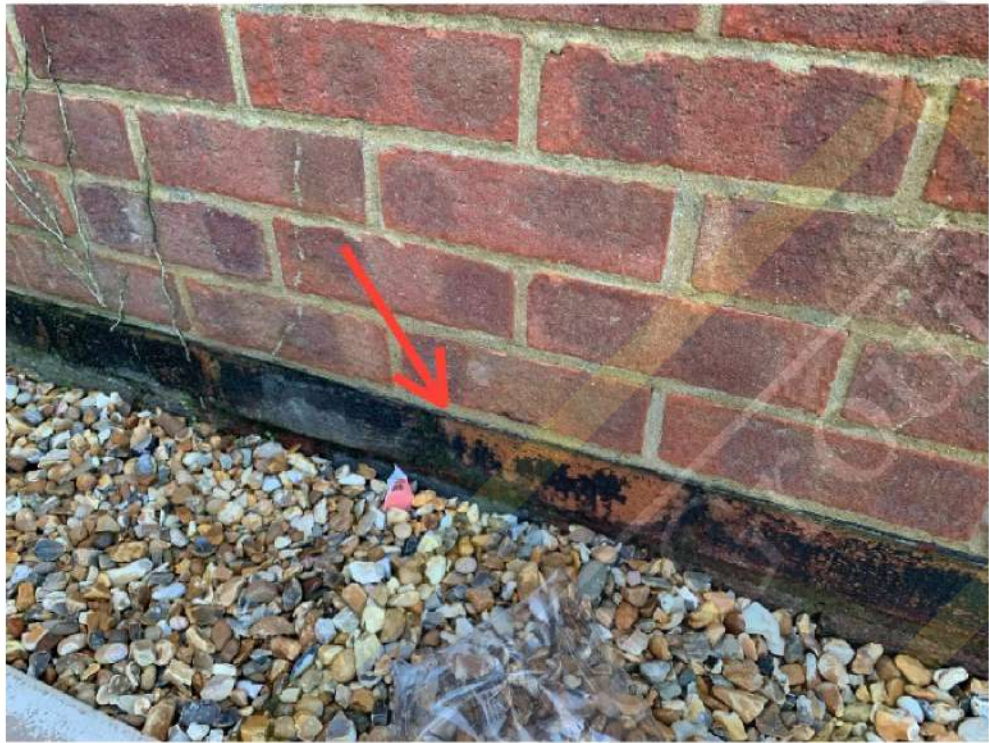
DPC is lower than 150mm

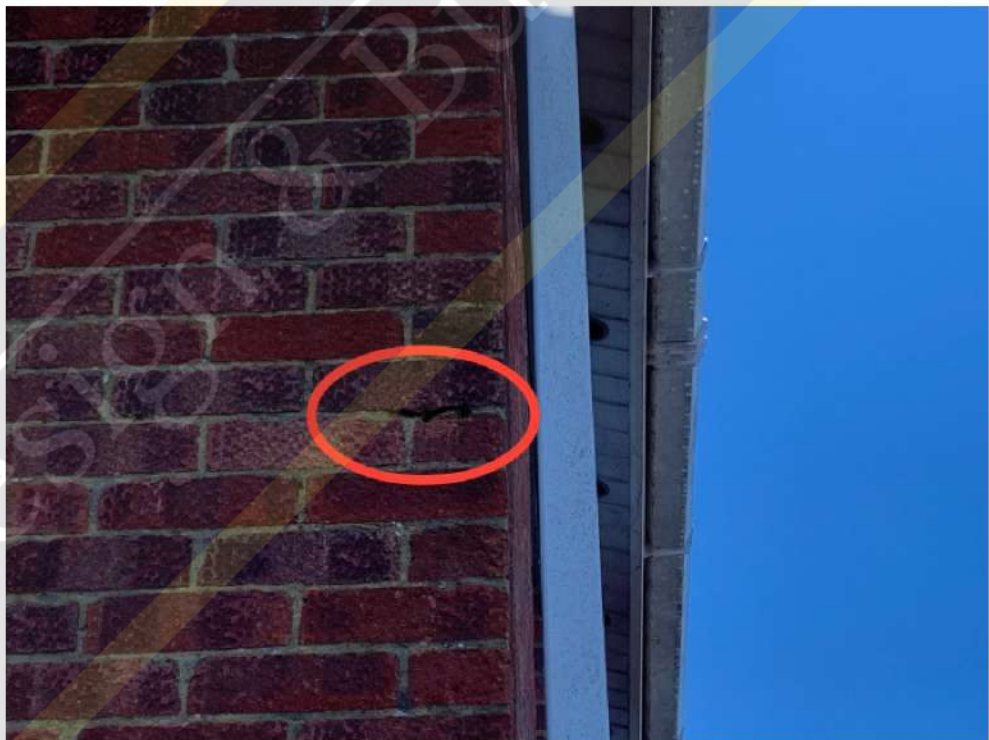
Deteriorated pointing (side wall)

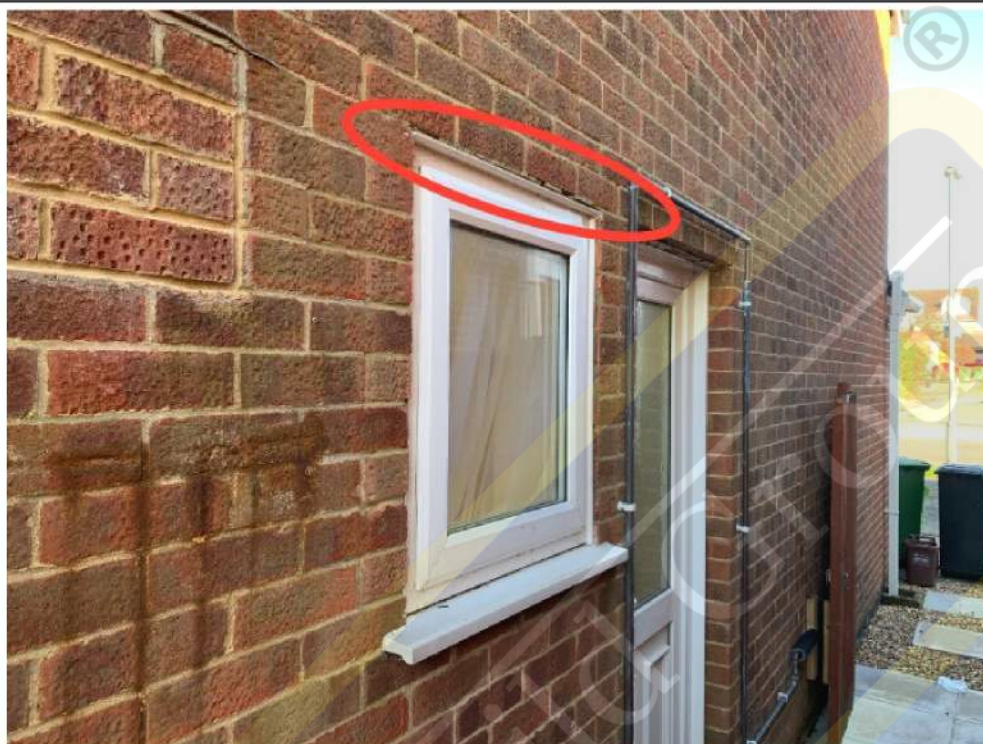
Deteriorated pointing (side wall)

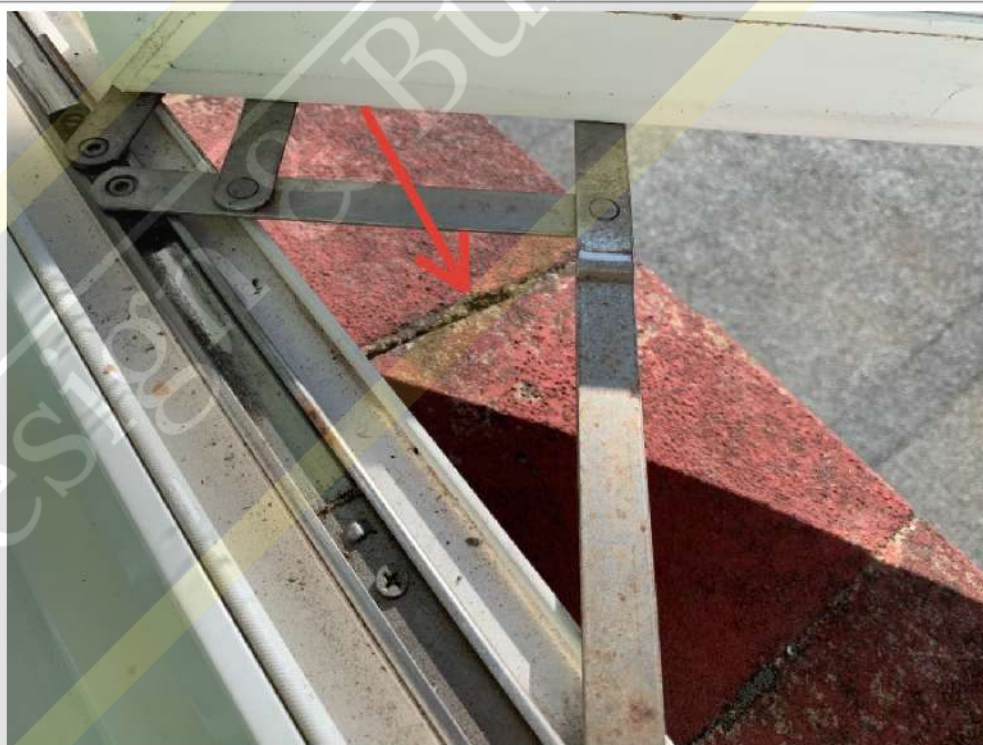
Window sill deteriorated pointing (rear bedroom window)

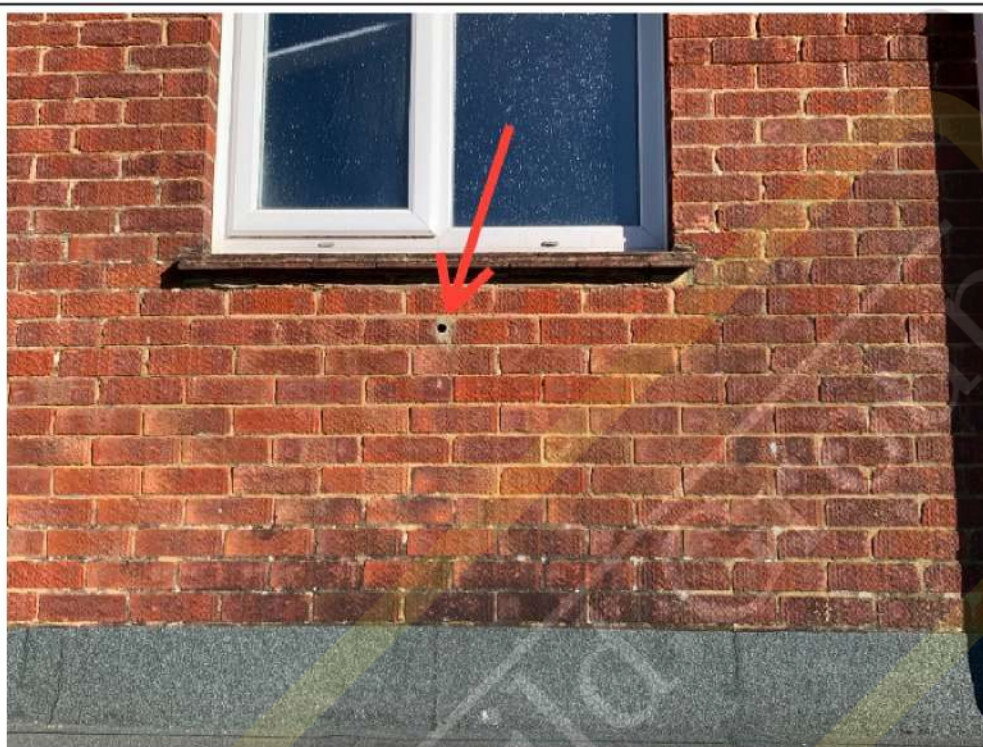
Unused service hole (rear wall)

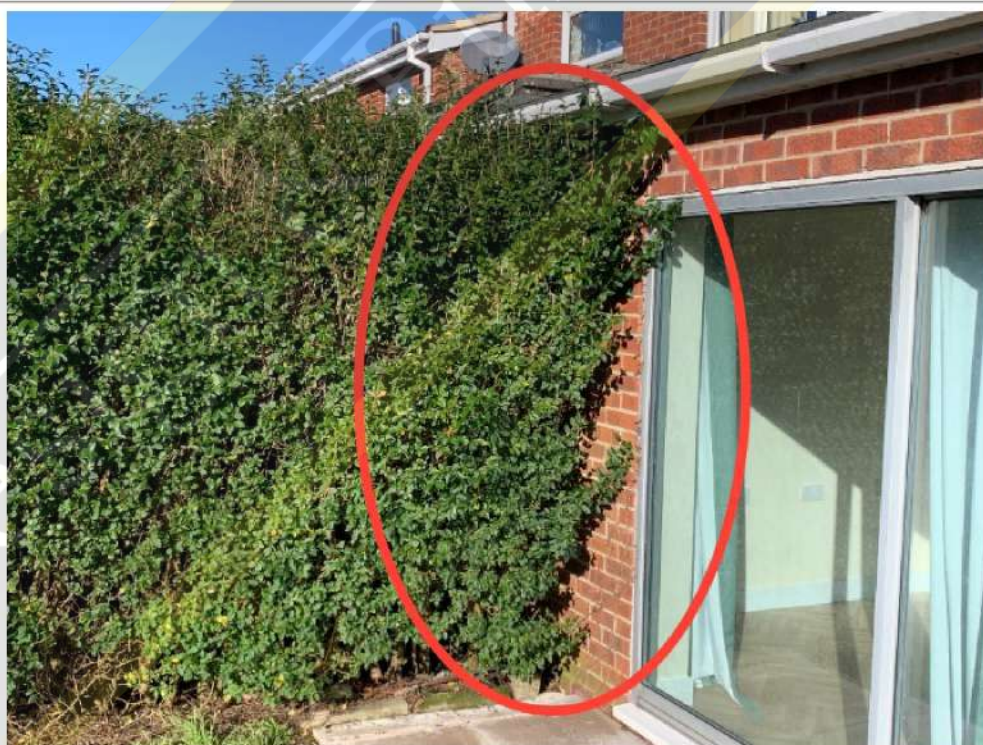
Vegetation close to the wall

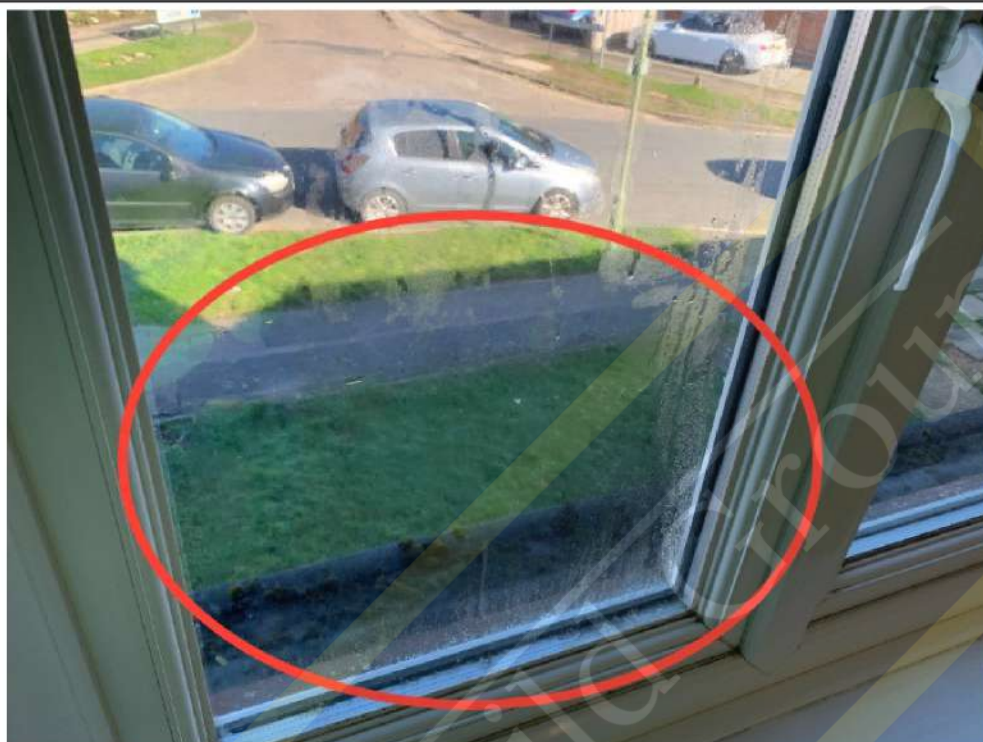
Condensation inside double-glazed unit (bedroom 1)

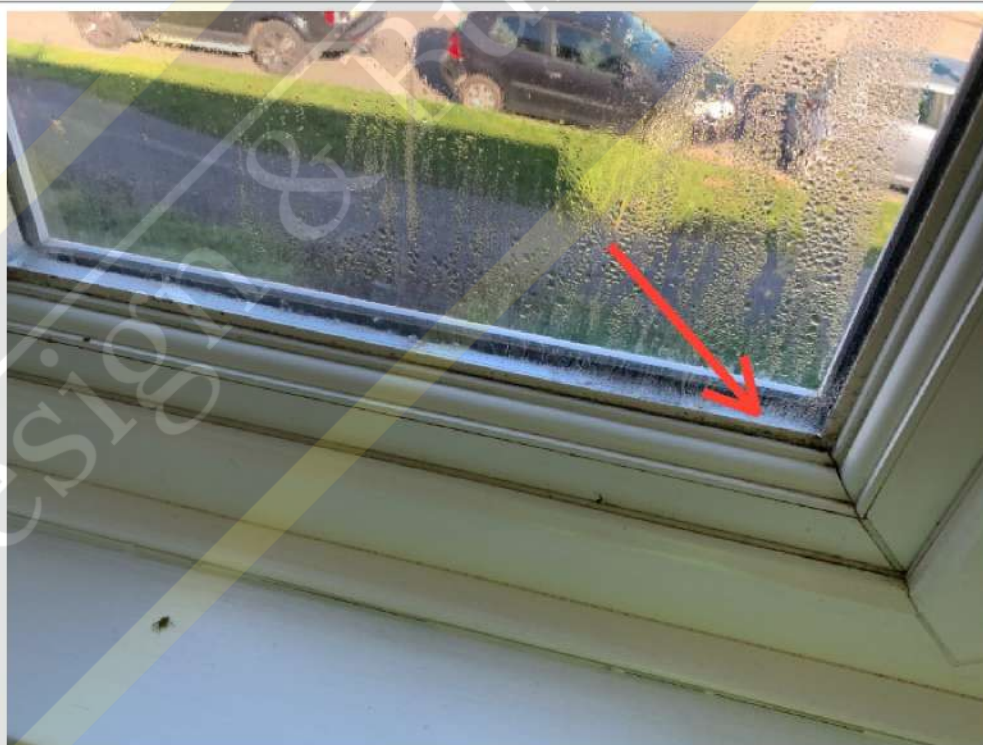
Mouldy and deteriorated gaskets (bedroom 1)

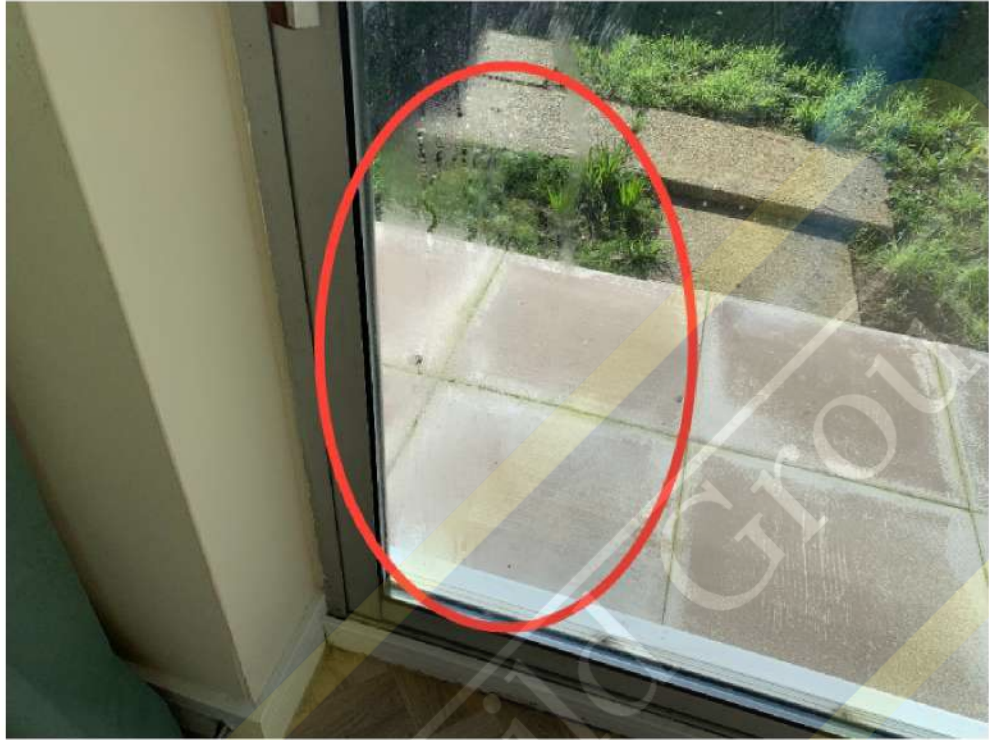
Condensation inside large double glazed unit (rear door)

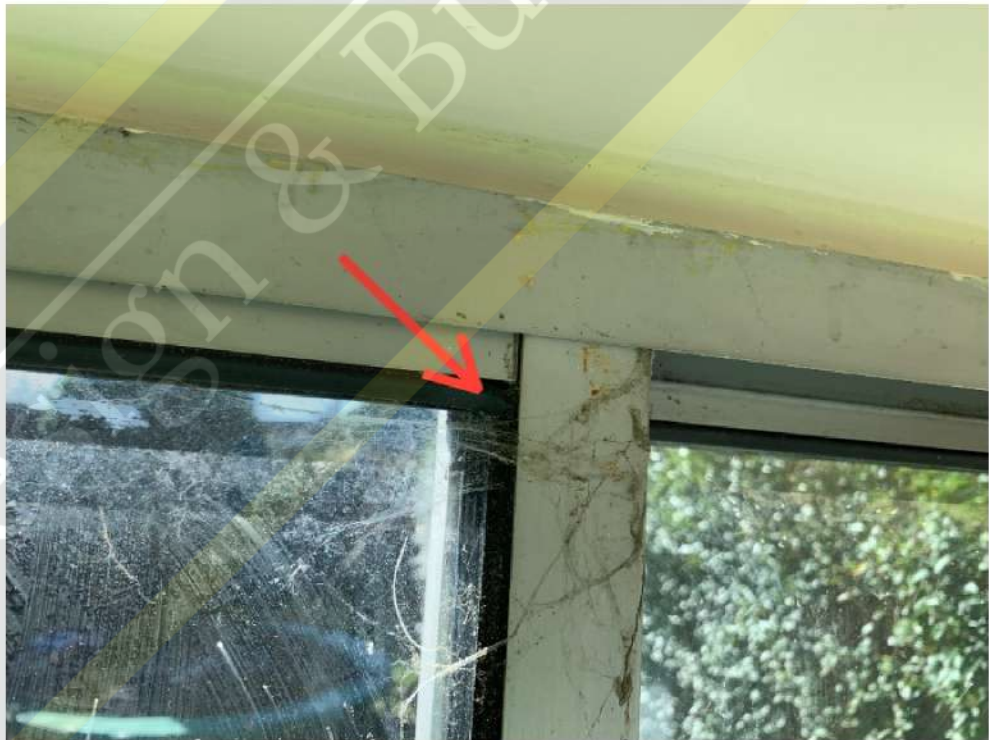
Deteriorated gaskets (rear door)

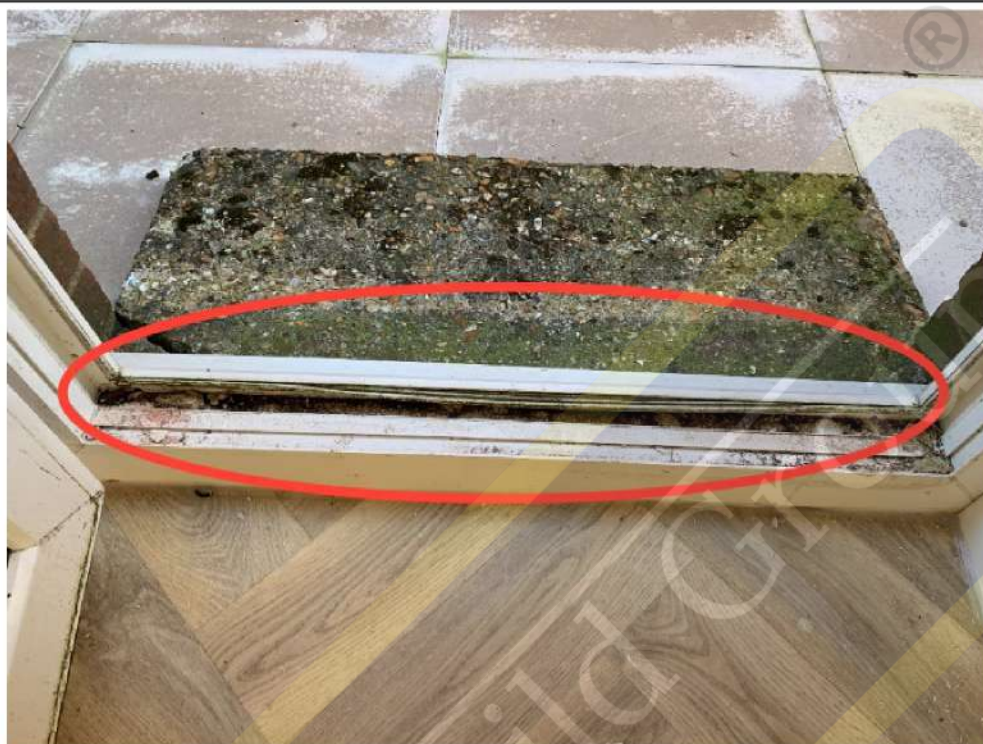
Deteriorated gaskets (side door)

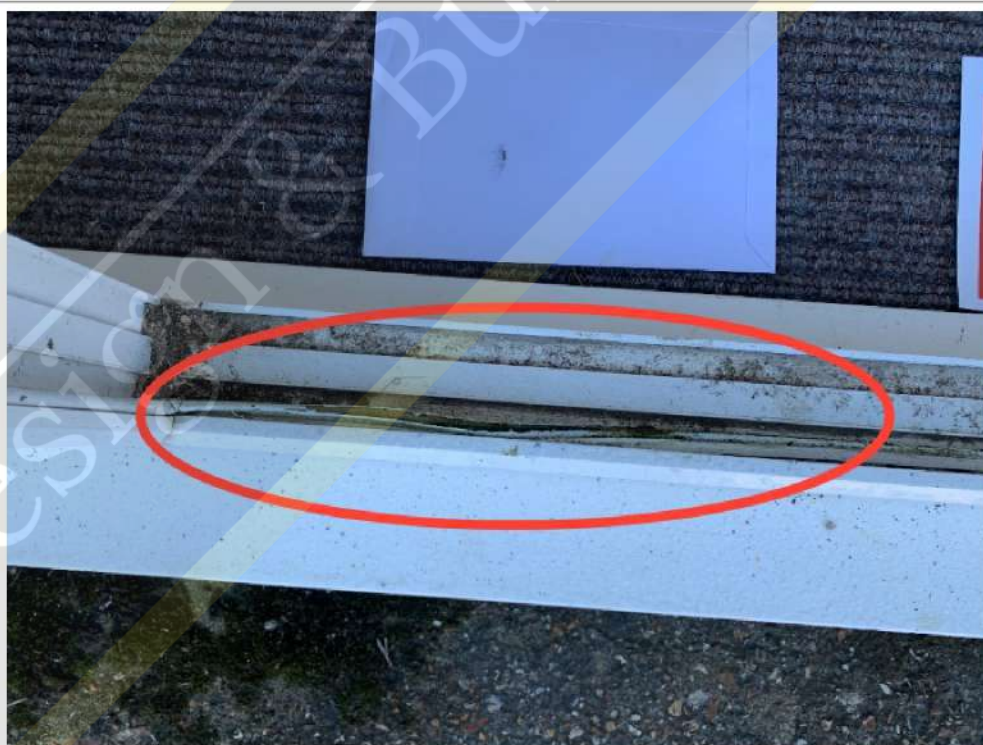
Deteriorated gaskets (front door)

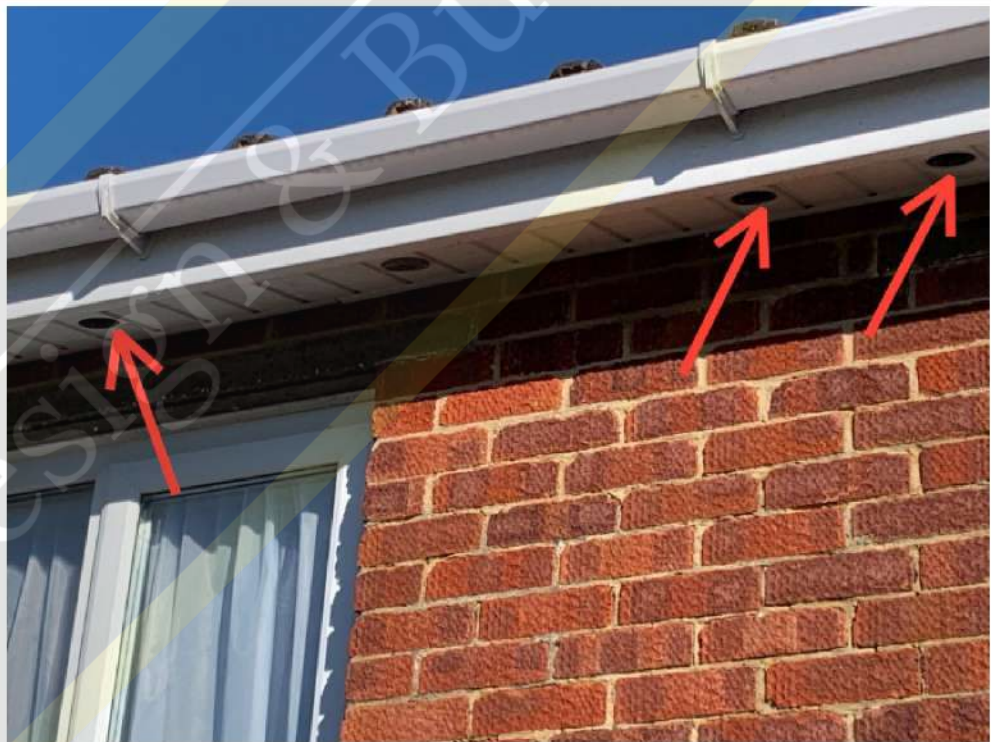
Missing soffit vent grills

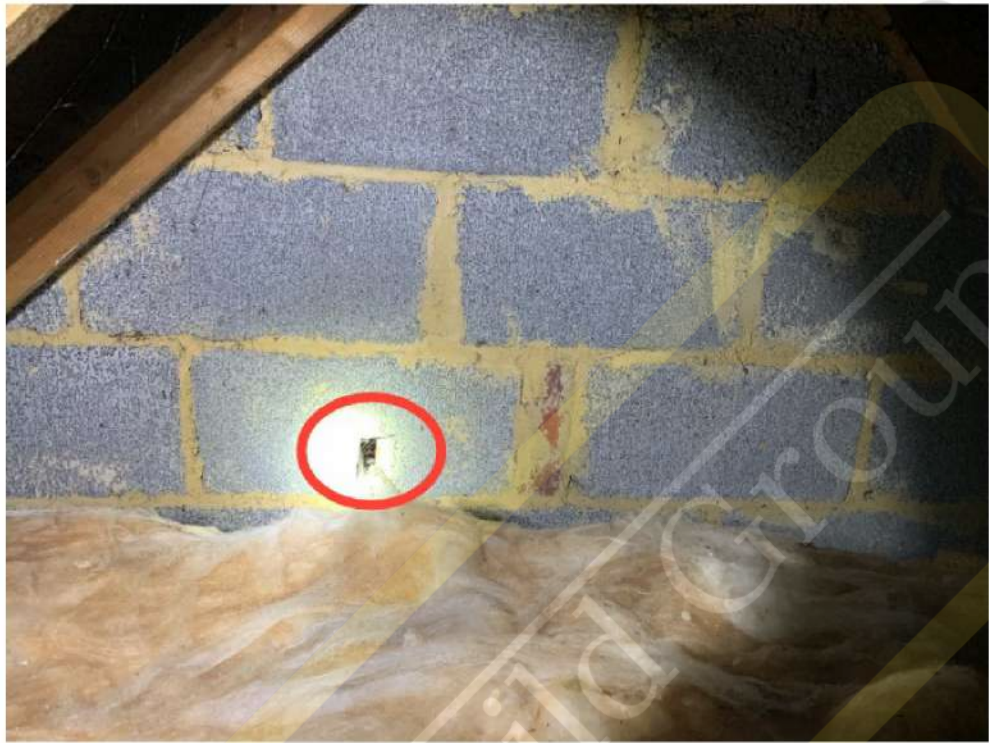
Minor opening in a gable wall

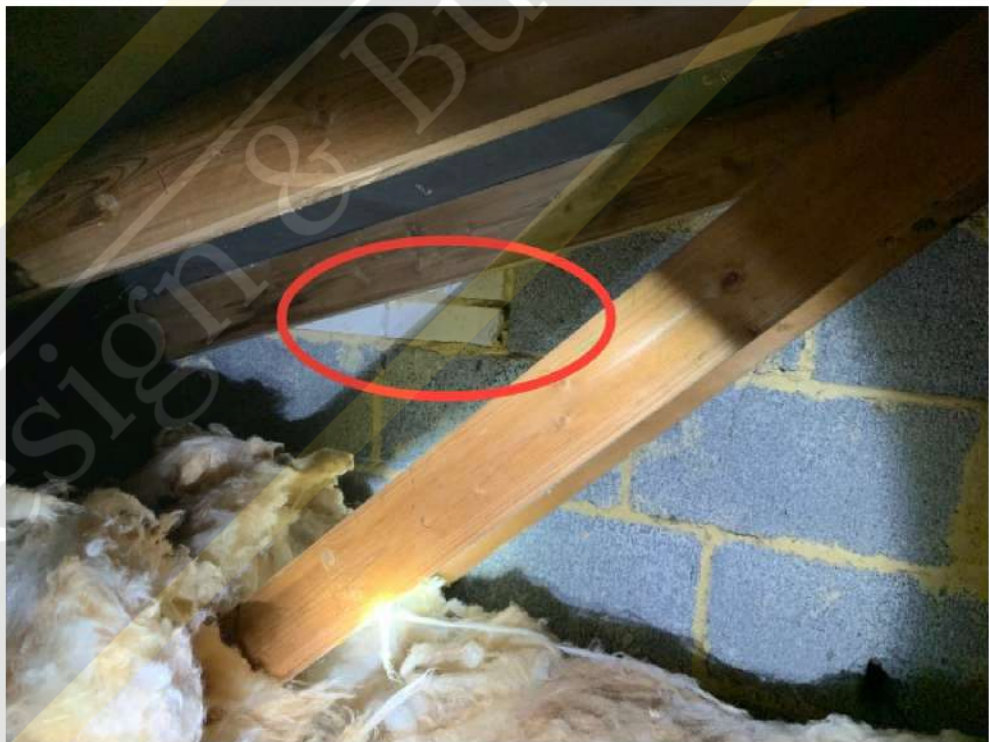
Deteriorated pointing

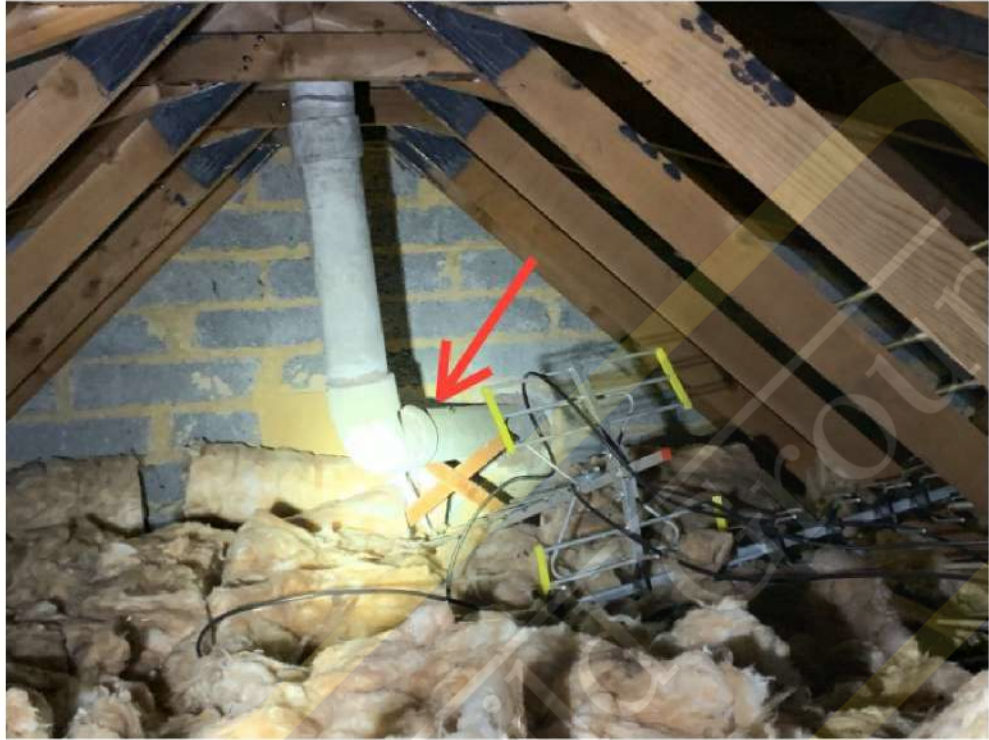
Asbestos cement flue supported by two timber planks

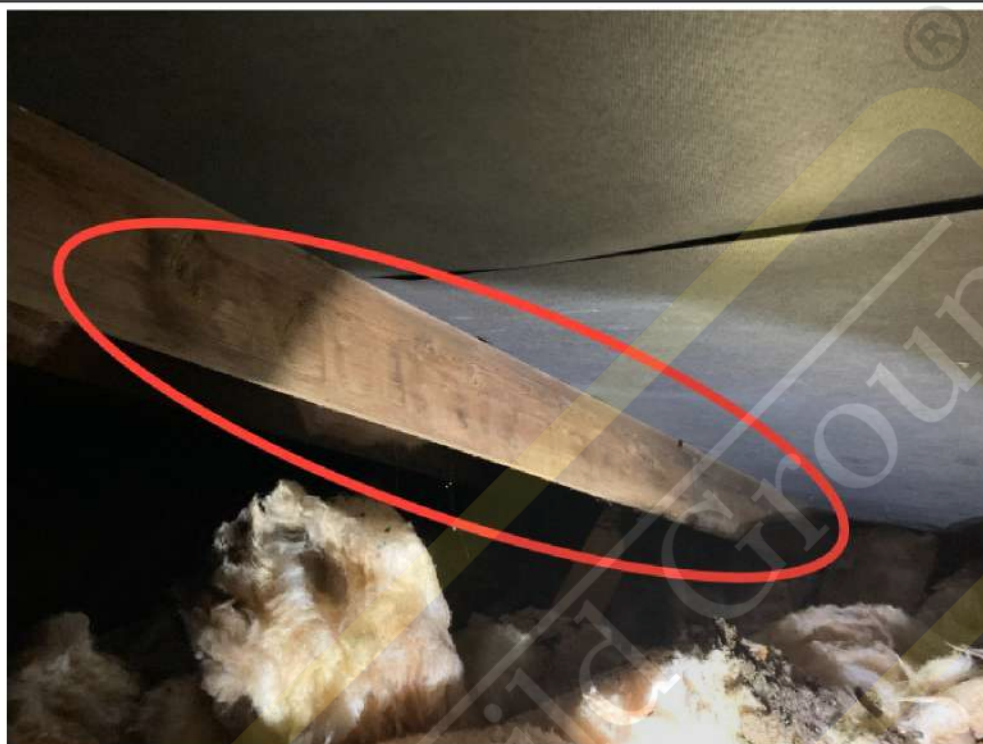
Mouldy rafter

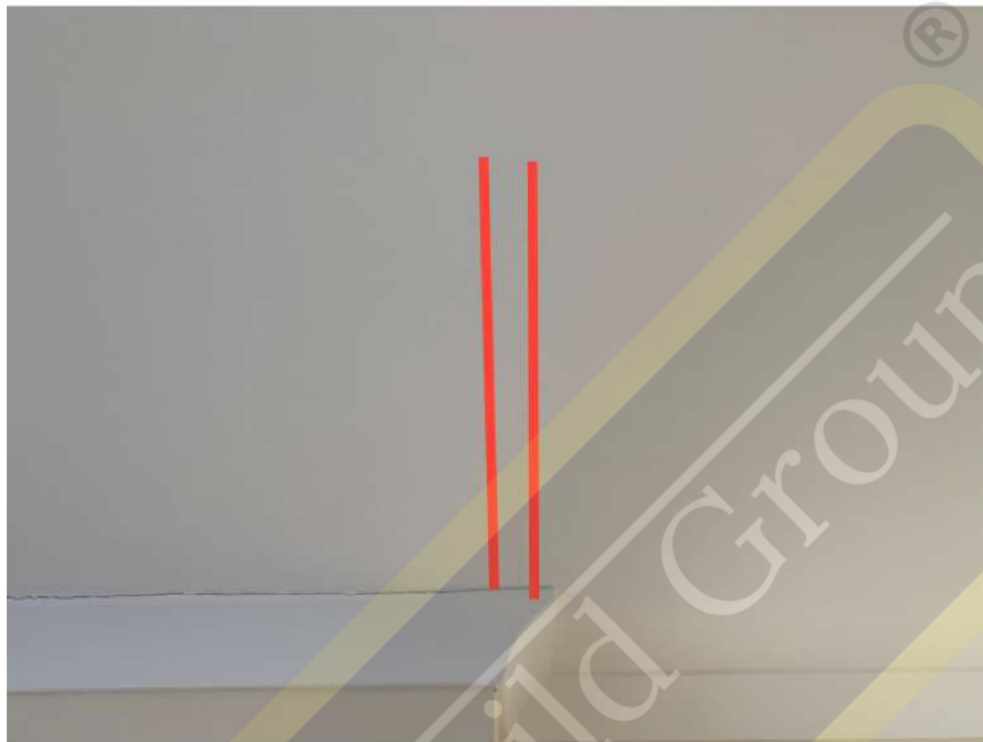
Hairline crack in plasterboard ceiling (bedroom 1)
