BUILDING SURVEY REPORT

The format of this BUILDING SURVEY REPORT is consistent with the guidance defined by the
RPSA Survey Inspection & Reporting Standards Edition 1v5.2 November 2020

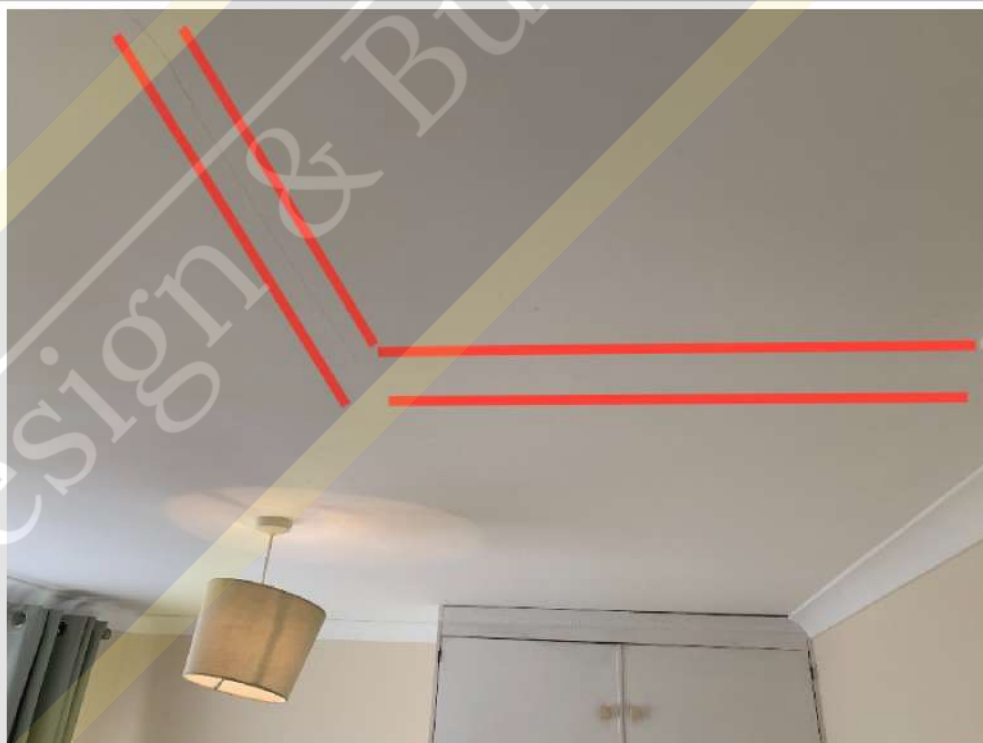
Hairline cracks in plasterboard ceiling (bedroom 2)

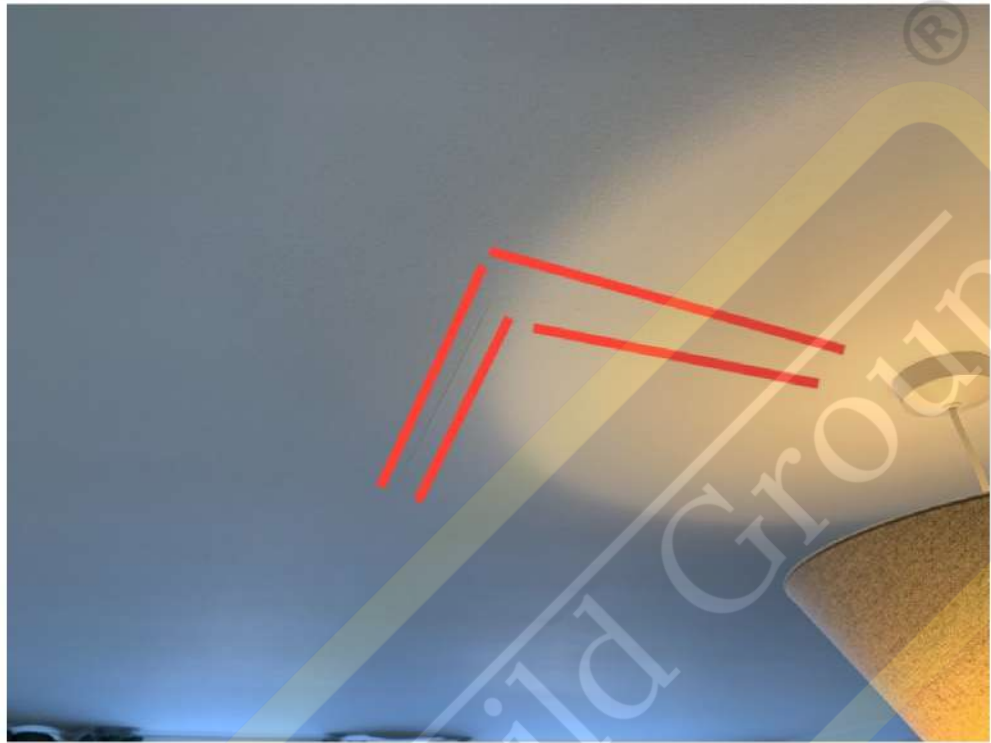
Hairline crack in plasterboard ceiling (living room)

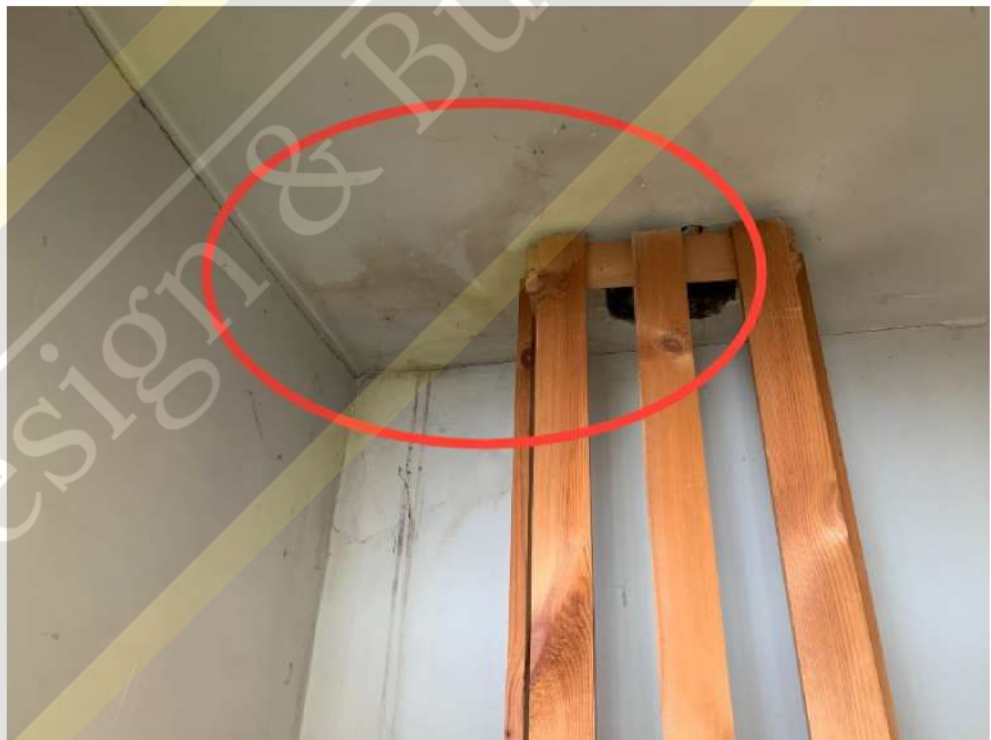
Leak stains (landing cupboard)

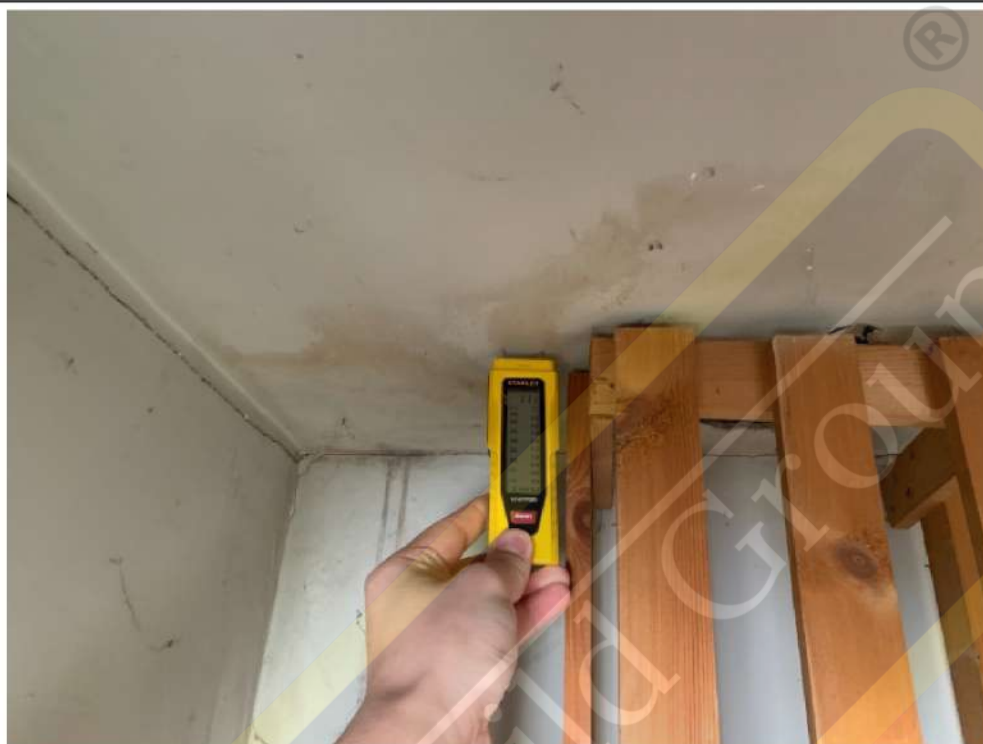
Leak stains - no excessive moisture (landing cupboard)

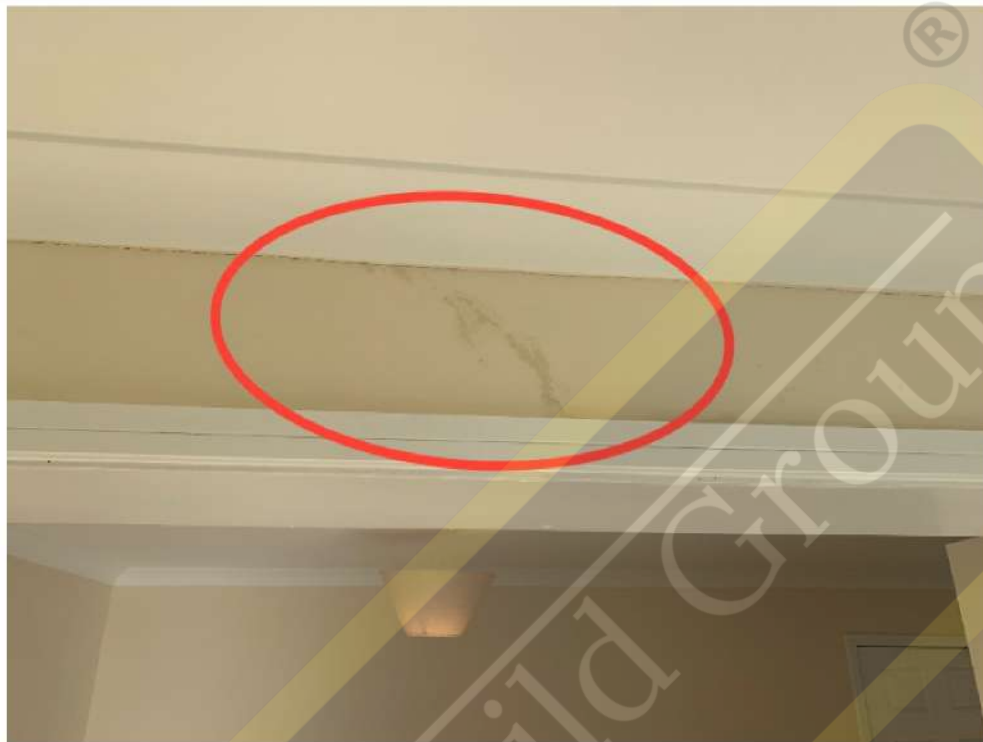
Dampness Summary	There is a hairline crack above a doorway in the wall between the dining room and kitchen. The wall next to the crack had high moisture content which indicates a leak. Please refer to section 5.3 for more details.
Structural Summary	<p>There is a hairline crack above a doorway in the wall between the dining room and kitchen. The wall next to the crack had high moisture content which indicates a leak. Please refer to section 5.3 for more details.</p> <p>The concrete lintel above the garage door has cracked and the rebar is rusty. Please refer to section 7.1 for more details.</p>

Hairline crack with high moisture content (wall between dining room and kitchen)

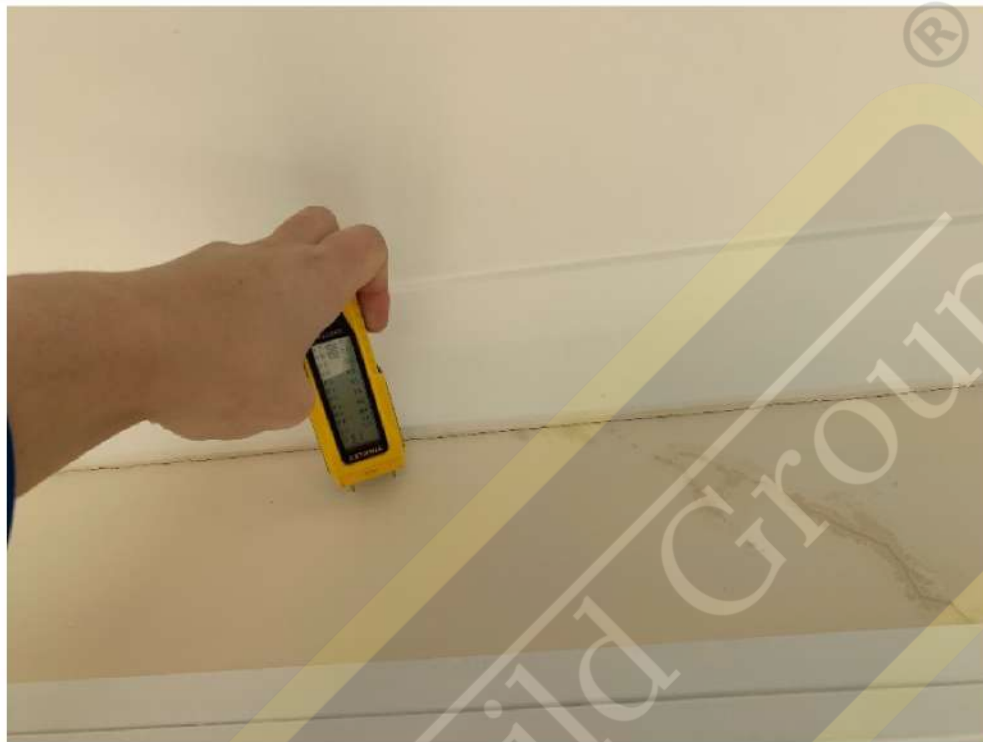
No excessive moisture further away from the crack (wall between dining room and kitchen)

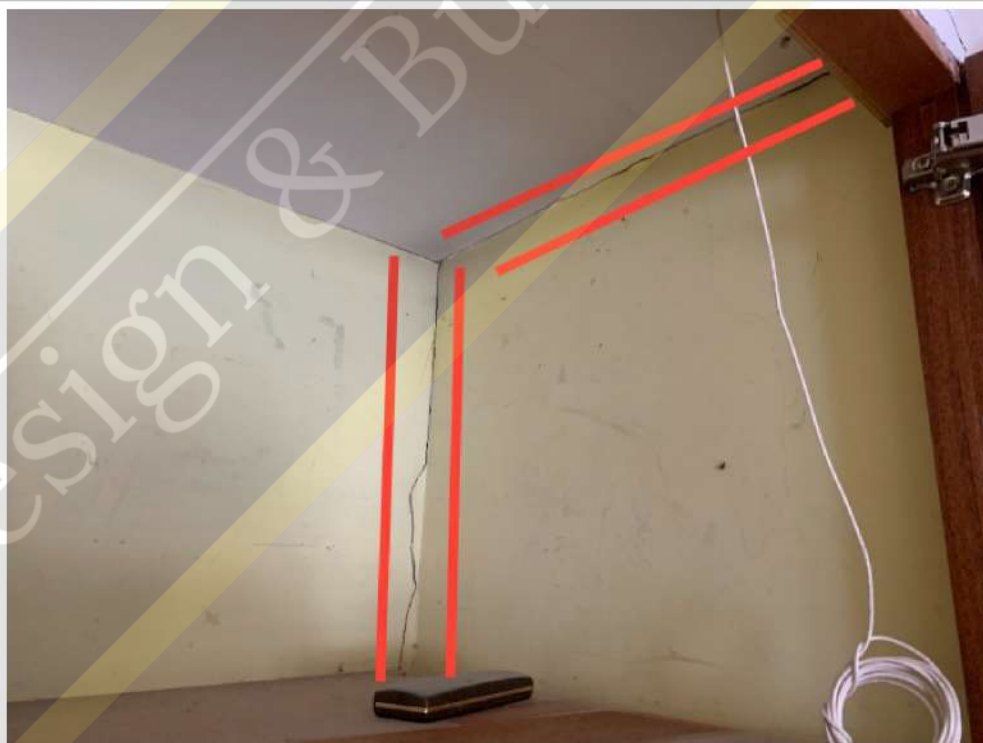
Slight and hairline cracks (bedroom 1 wardrobe)

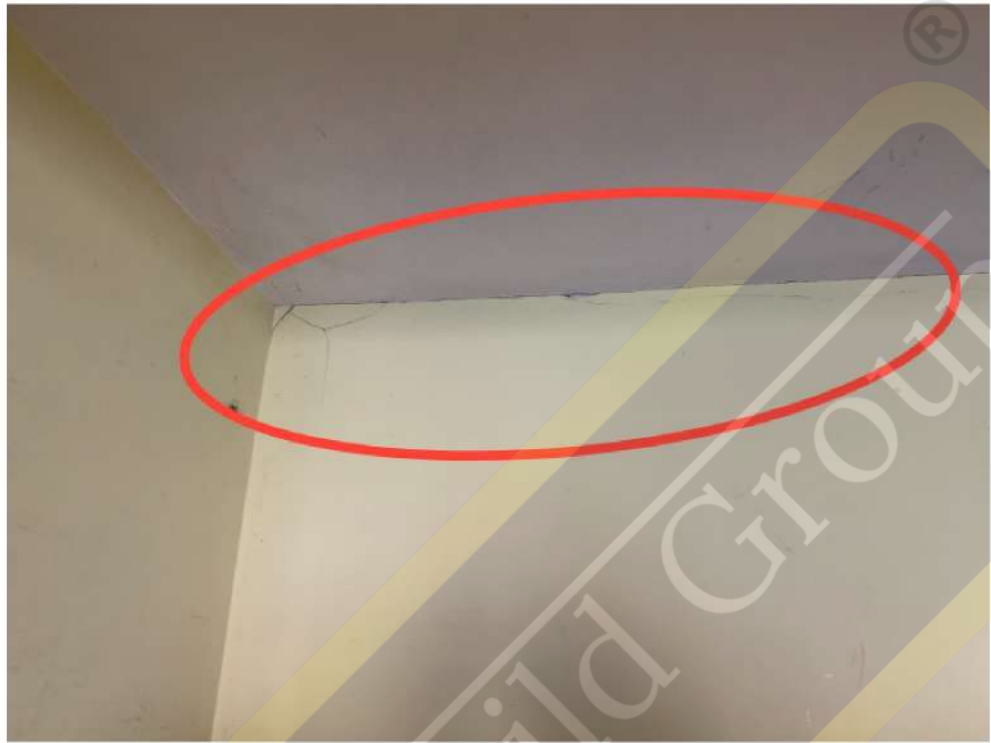
Hairline cracks (bedroom 1 wardrobe)

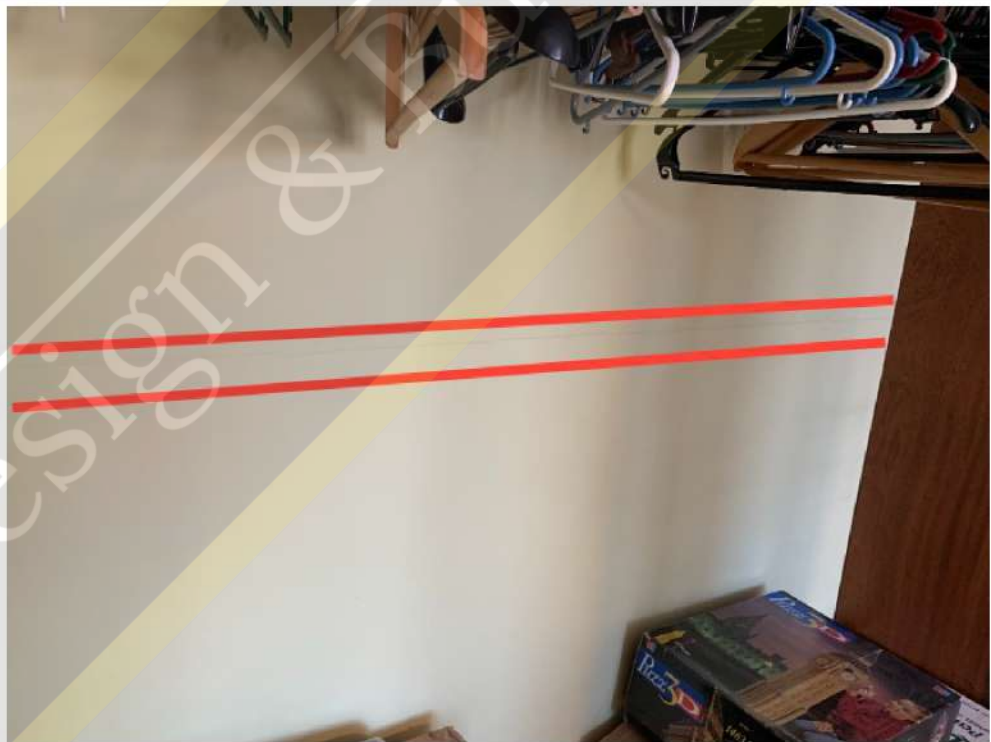
Hairline crack (bedroom 1 wardrobe)

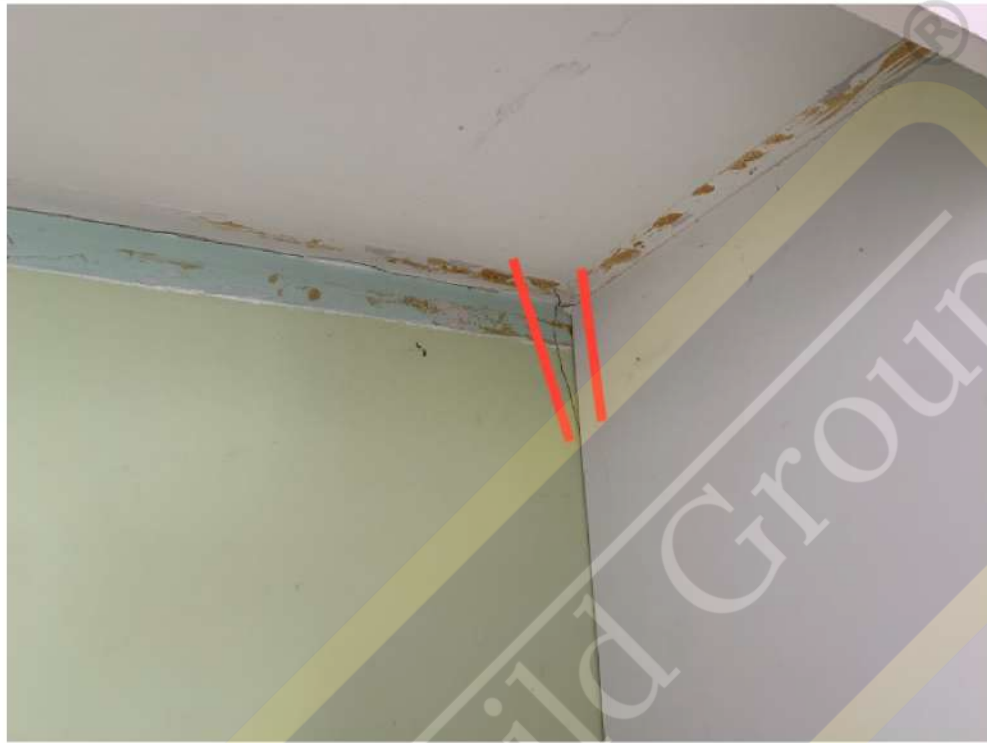
Hairline crack (bedroom 2 wardrobe)

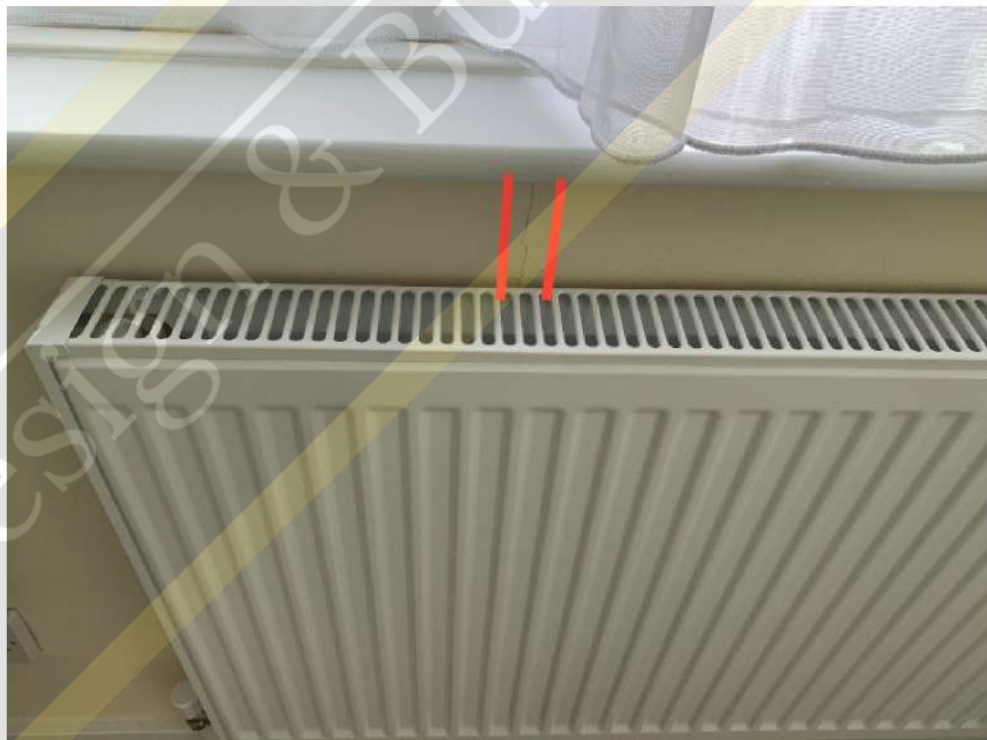
Hairline crack (bedroom 2)

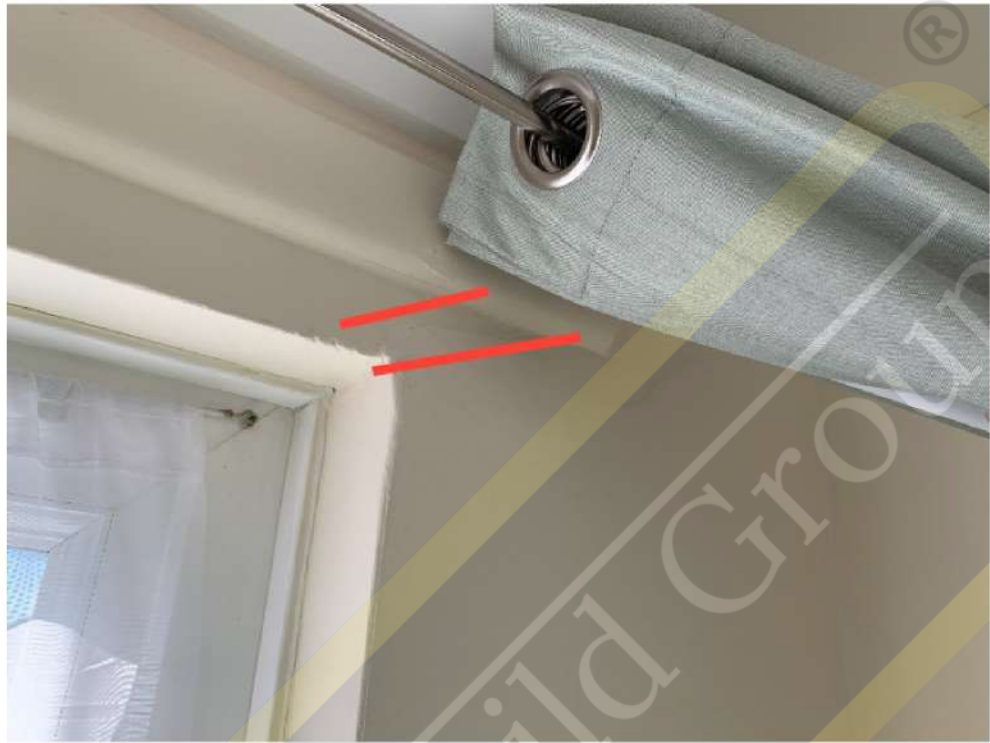
Hairline crack (bedroom 2)

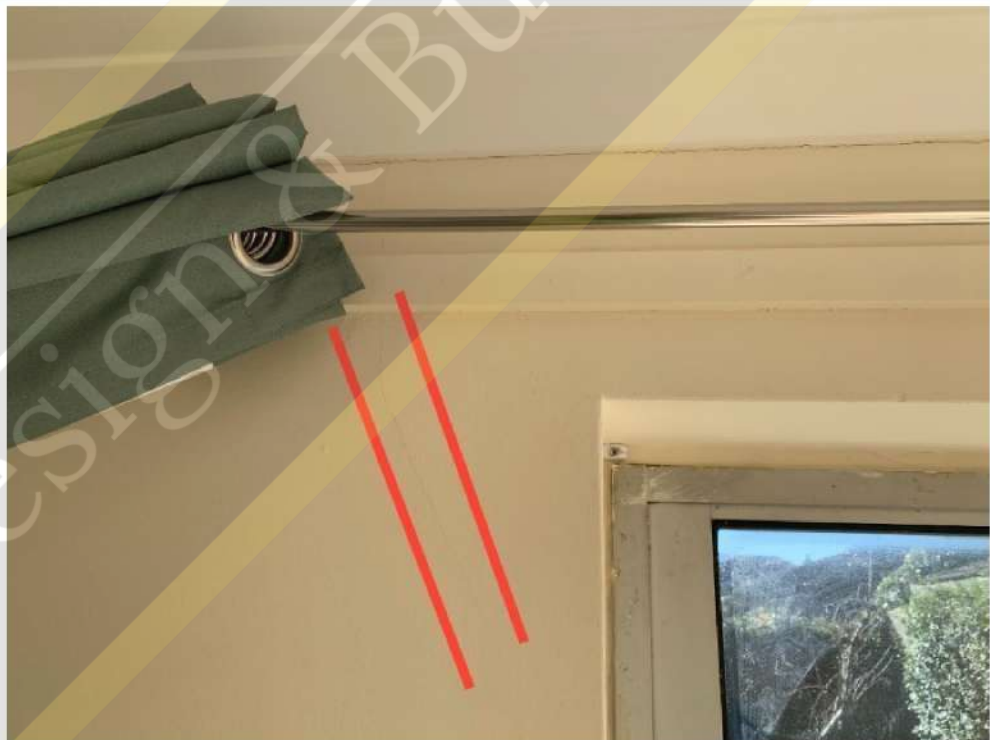
Hairline crack (dining room)

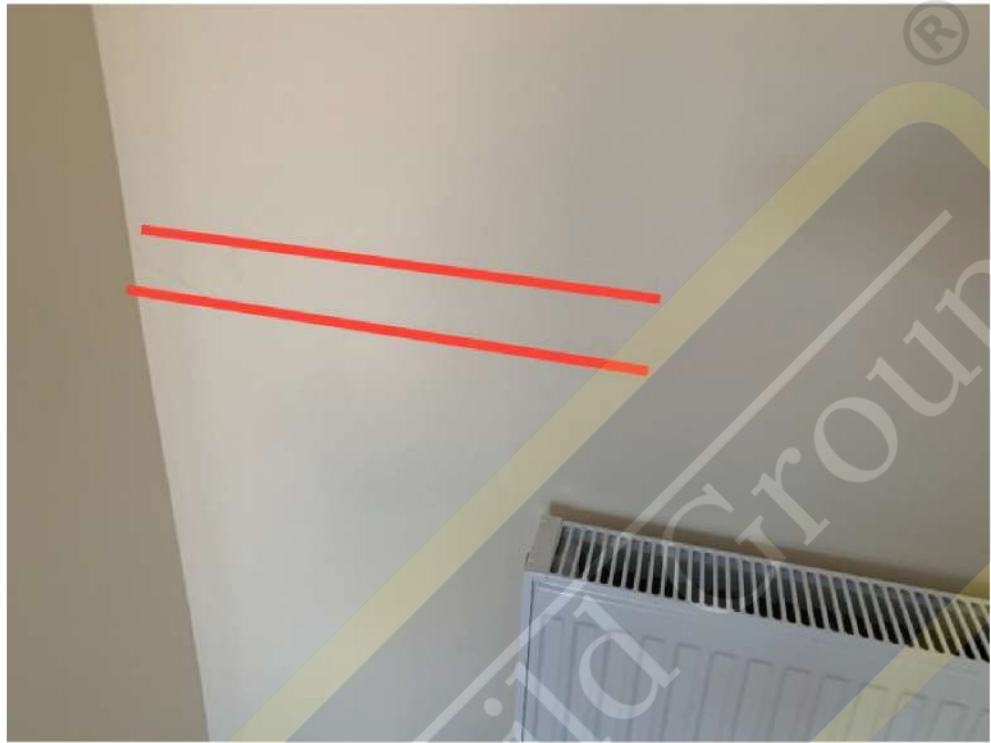
Hairline crack (living room)

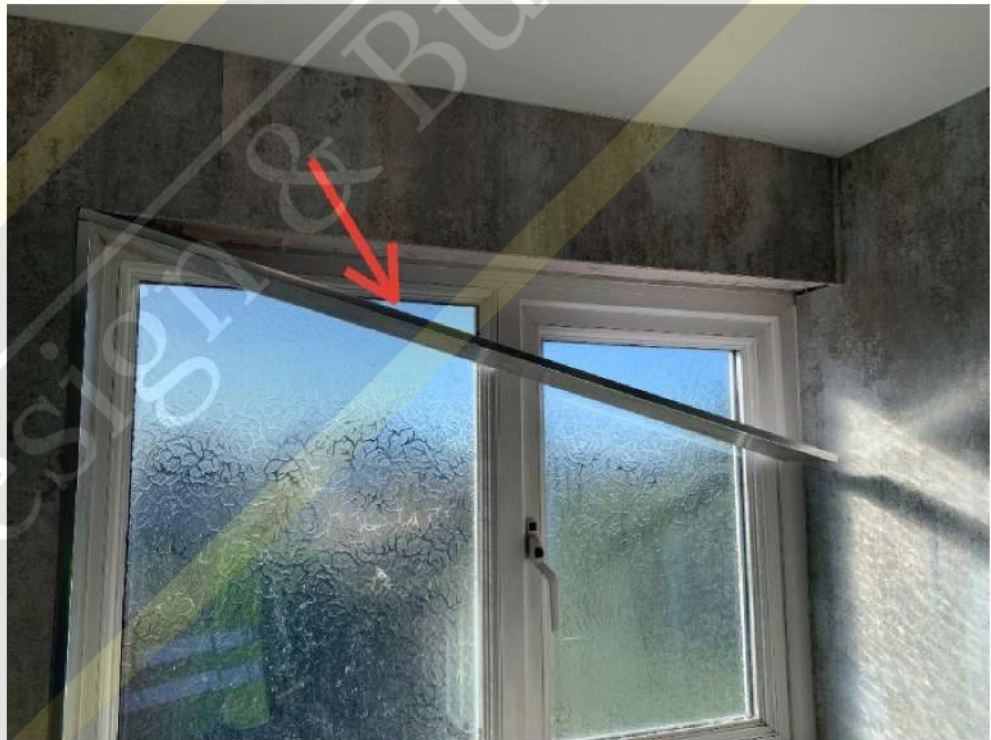
Detached plastic wall panel (bathroom)

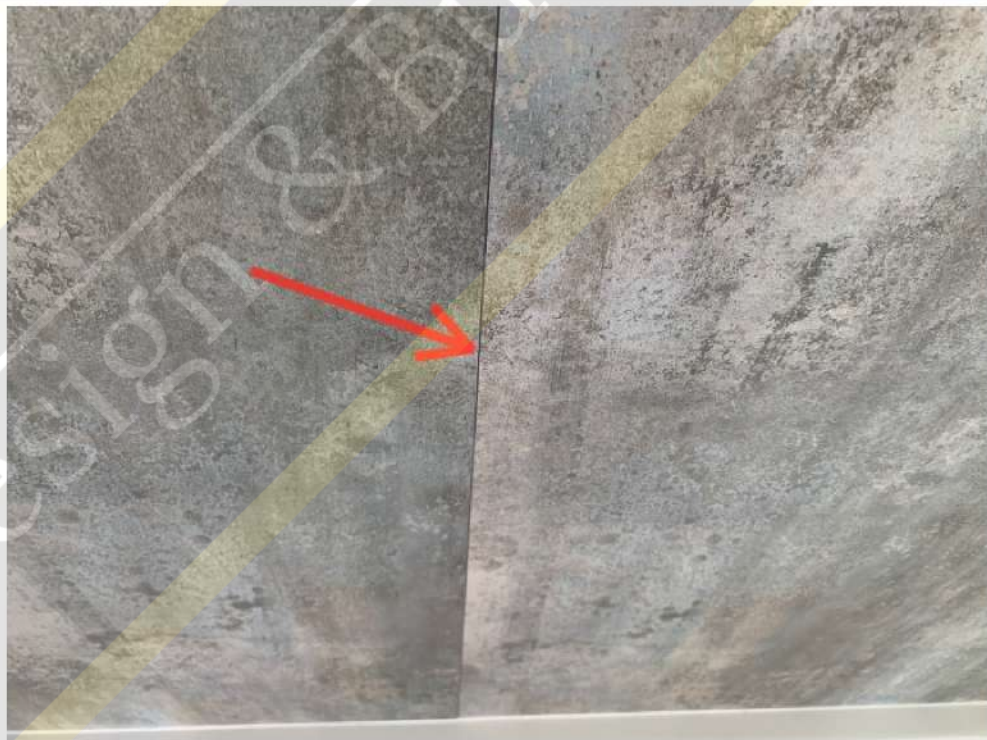
Joint between plastic panels is not sealed (bathroom)

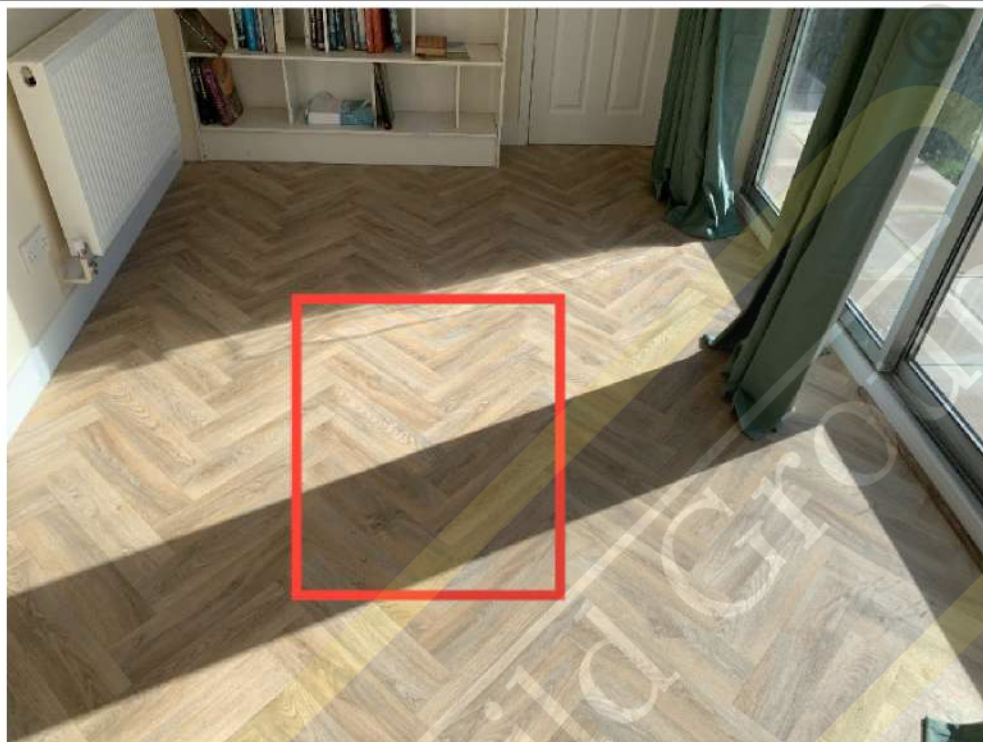
Part of the floor appears to be timber (dining room)

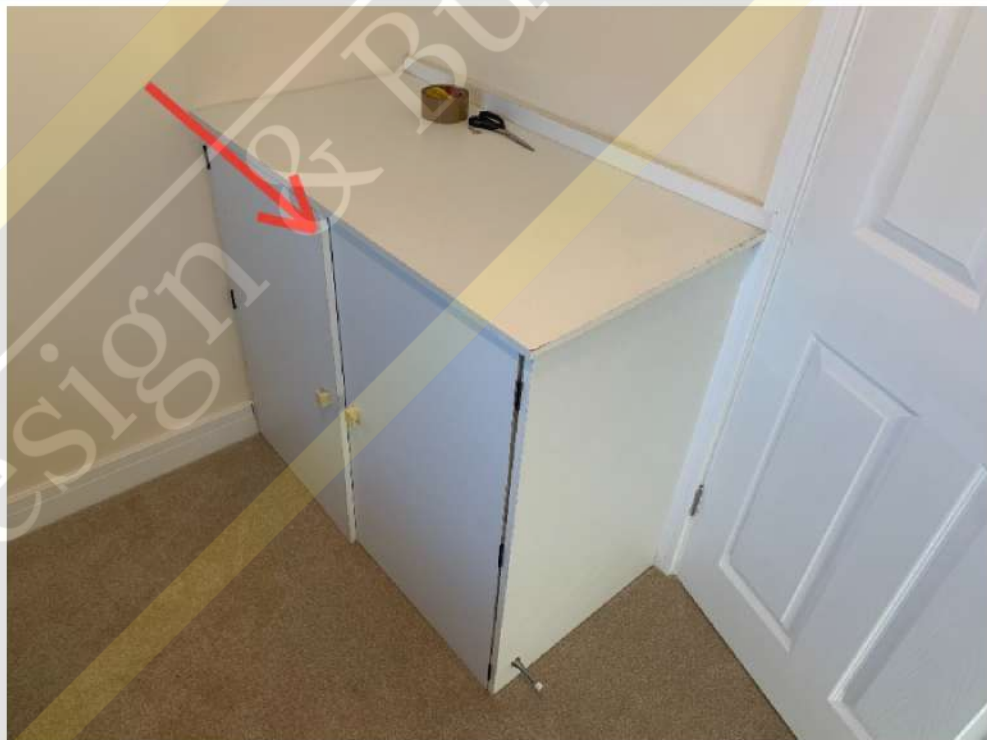
Doors do not close properly and drag on carpet (bedroom 3)

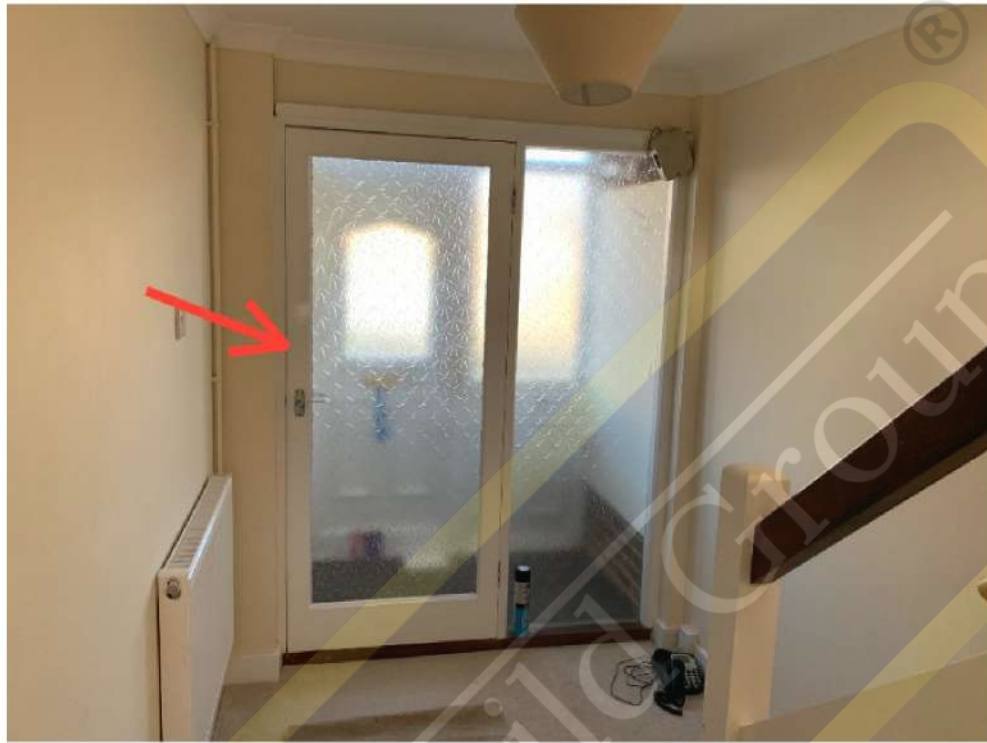
Door does not close properly (hallway)

Action Required	<p>The small bedroom door and the door between the porch and hallway should be adjusted.</p> <p>Rectification of minor and cosmetic defects and door adjustments are considered to be part of normal maintenance.</p>

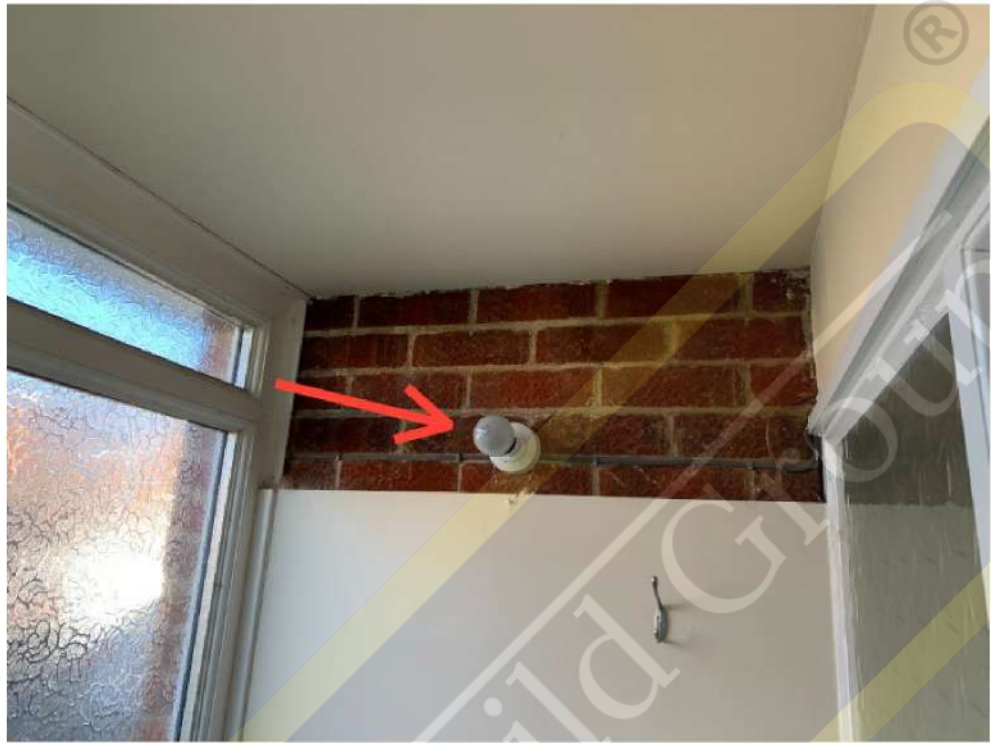
Light does not work (porch)

<p>Action Required</p>	<p>It is recommended to replace the light bulb in the porch and fit a bulb to the hallway fitting and then test the lights prior to the exchange of contacts. If the lights still do not work, the light fittings may need to be replaced.</p> <p>It is recommended that domestic electrical installations be tested at least once every 10 years and on change of occupation. If there is no record of a test certificate within this period, then we would recommend that the system be tested.</p> <p>At the time of the survey, no documentation was seen to verify that an inspection has been carried out within the last 10 years and the installation must therefore be considered to be in a potentially dangerous and unsatisfactory condition. Unless you are provided with verifiable evidence that such an inspection has recently been carried out by a competent person, the electrical installation should be inspected by a suitably competent person (registered with the Electrical Contractors Association, ECA, or the National Inspection Council for Electrical Installation Contracting, NICEIC) prior to the exchange of contracts.</p> <p>In the bathroom, the area above the bathtub requires a minimum lighting rating of IP45. In the area stretching 0.6m outside the bathtub and wash basin perimeter, the minimum rating is IP44. This should be checked by a suitably qualified person.</p> <p>Your legal adviser should obtain Building Regulations certificates for any electrical installations undertaken.</p>

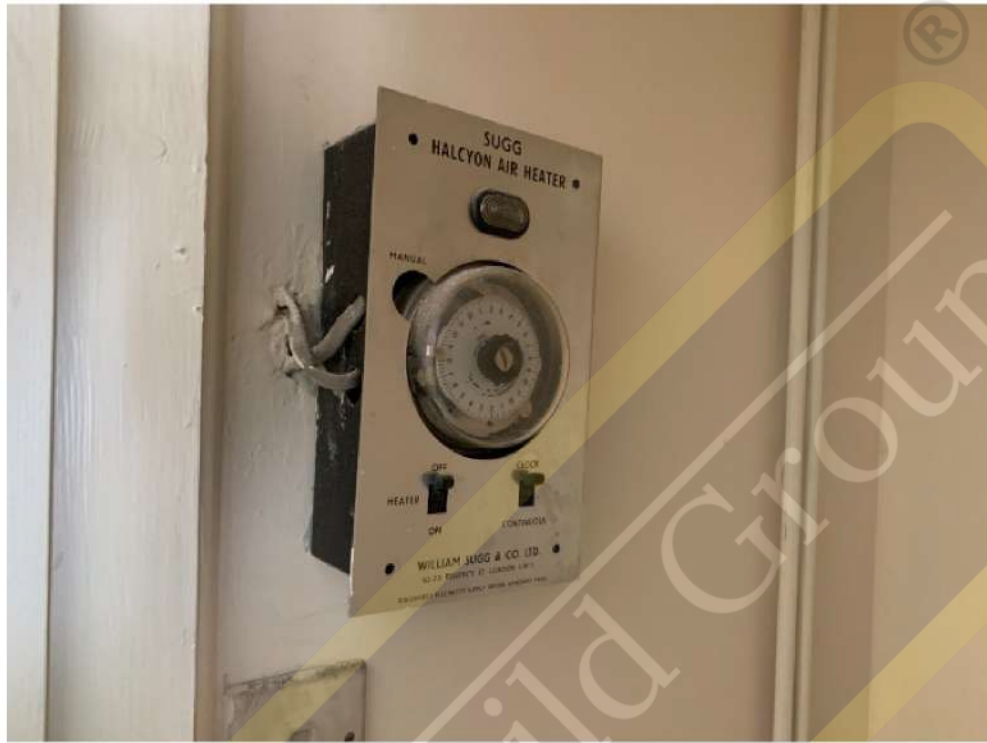
Old air heater control panel

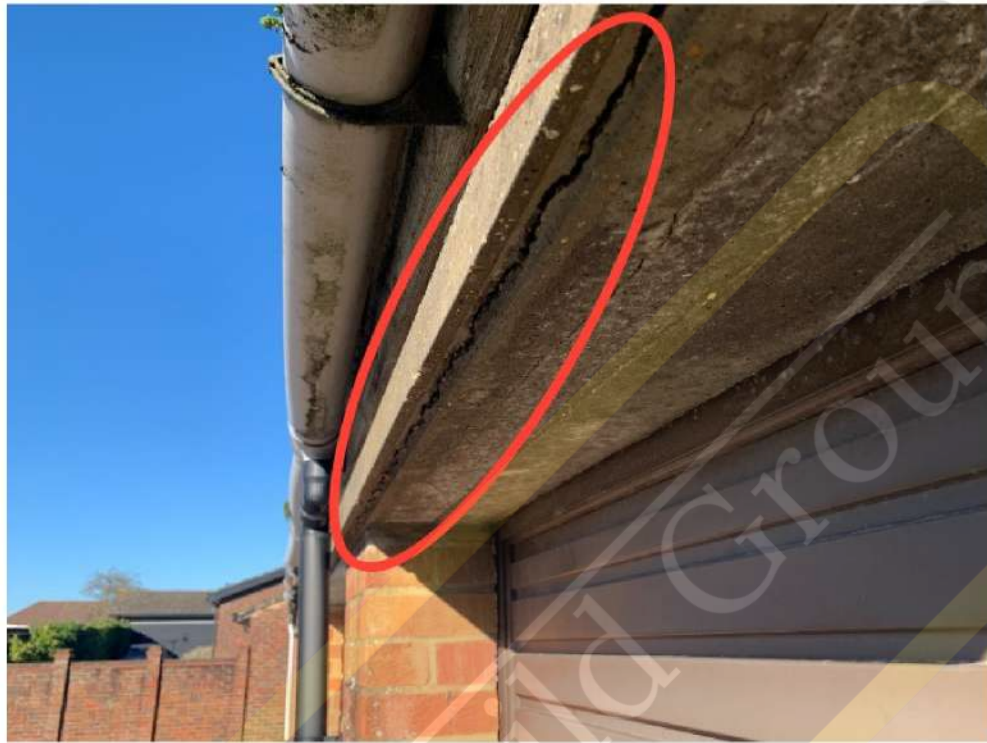
Cracked lintel

<p>Action Required</p>	<p>It is recommended to treat the rusty rebar and repair the lintel soon after taking over the property.</p> <p>It is recommended to remove vegetation growing on and near the garage. Once vegetation is removed the felt covering should be checked and repaired if necessary.</p> <p>The gutter should be replaced. It is also important to clean the gutter regularly.</p> <p>The fascia board should be treated.</p> <p>It would be prudent to ask the vendors about the purpose of the metal posts.</p> <p>The damp-proof course should be improved which could be done by injecting a silicone-based damp-proof cream into the brickwork above the low DPC</p> <p>Rectification of any minor or cosmetic defects is considered to be part of normal maintenance.</p>
	  <p style="text-align: center;">Garage</p>

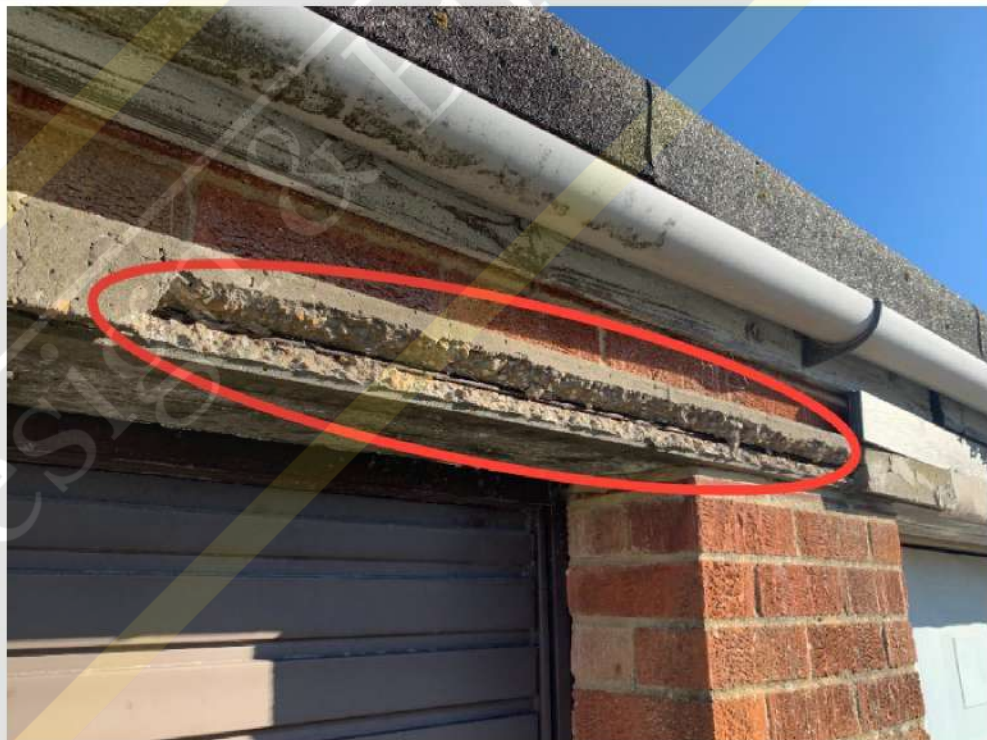
Deteriorated lintel and rusty rebar

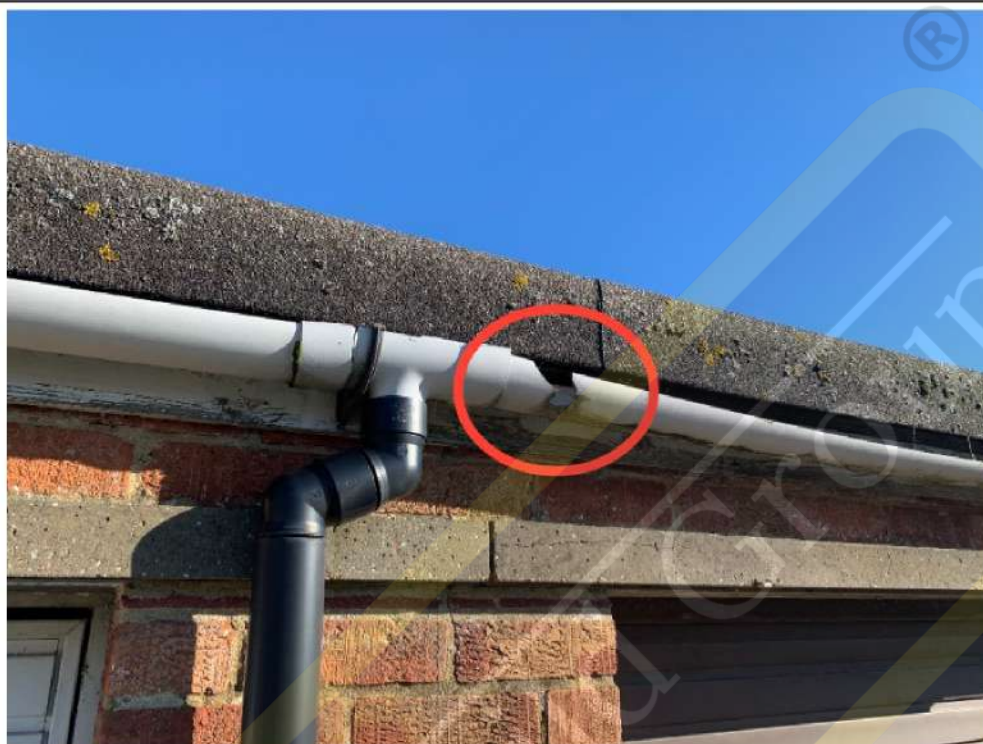
Broken gutter

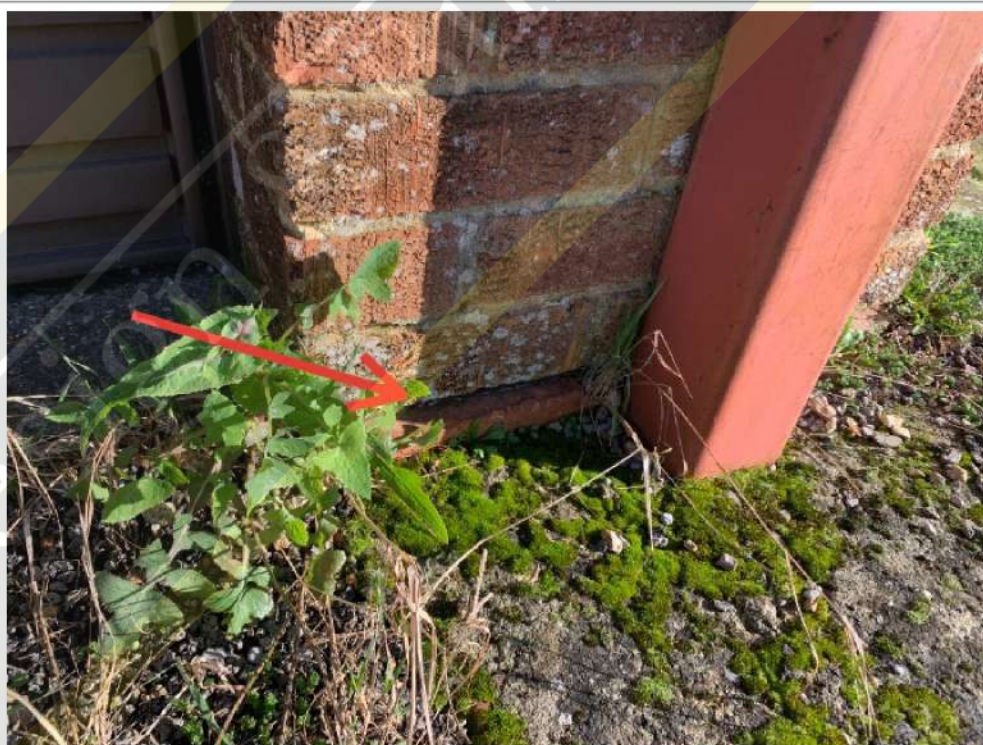
DPC is lower than 150 mm from the ground

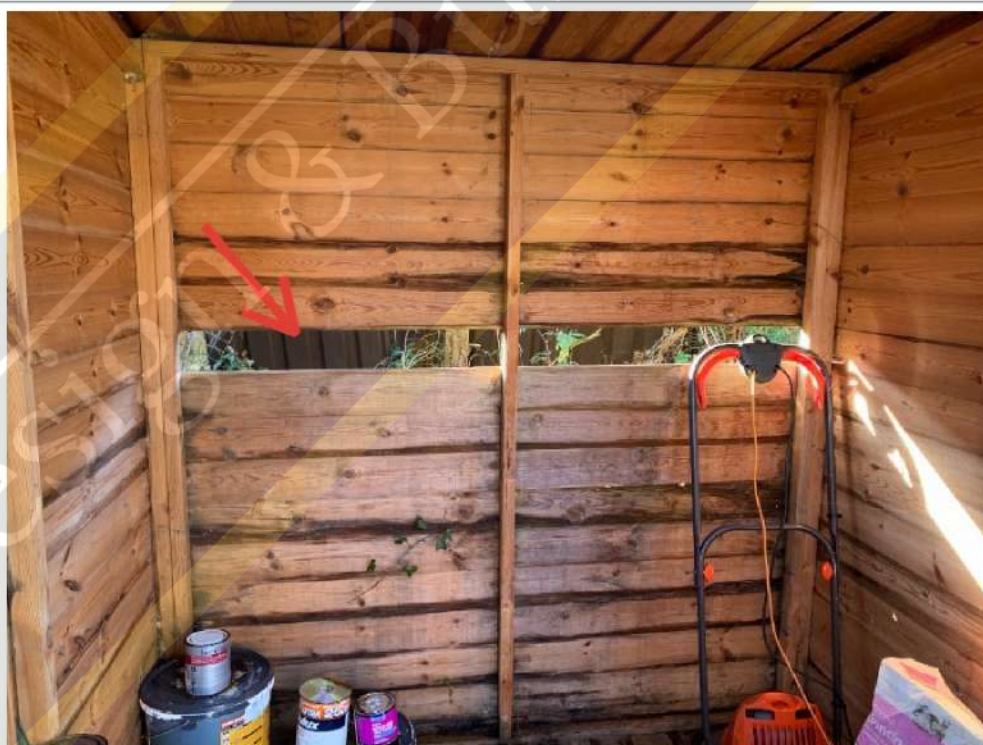
Missing wall panel

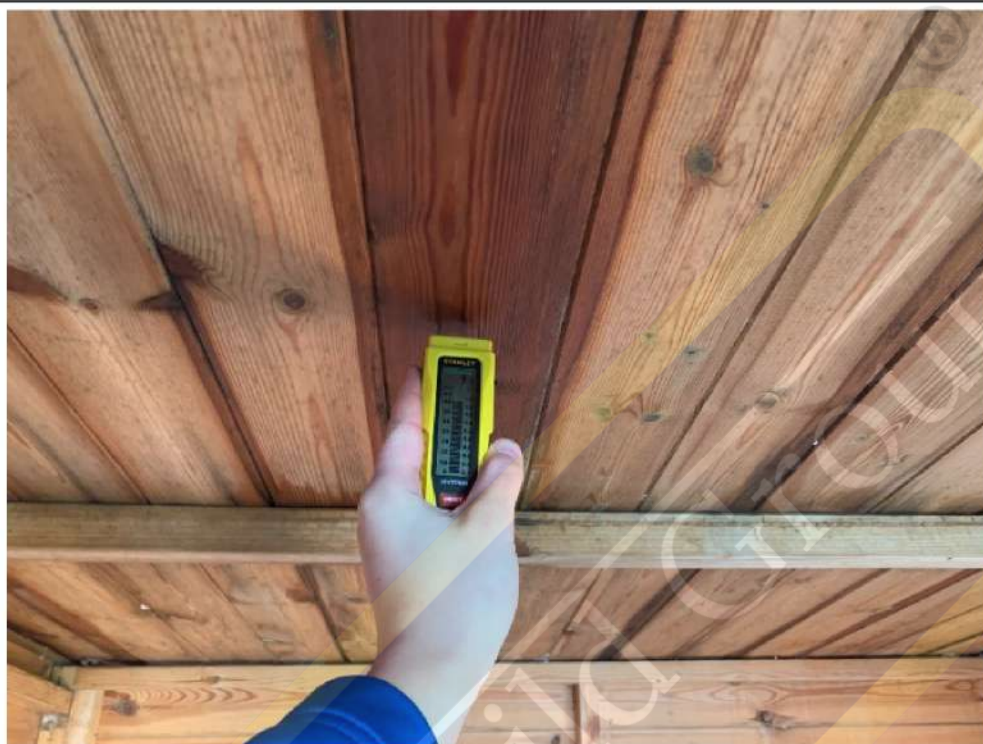
Damp roof

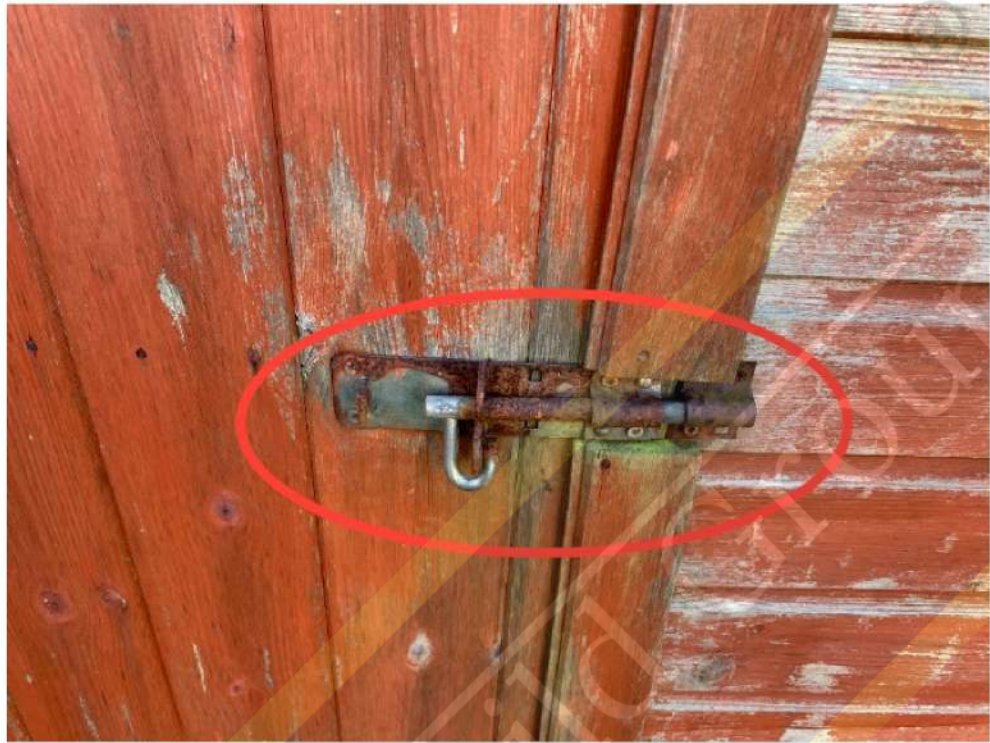
Rusty hardware
