BUILDING SURVEY REPORT

The format of this BUILDING SURVEY REPORT is consistent with the guidance defined by the
RPSA Survey Inspection & Reporting Standards Edition 1v5.2 November 2020

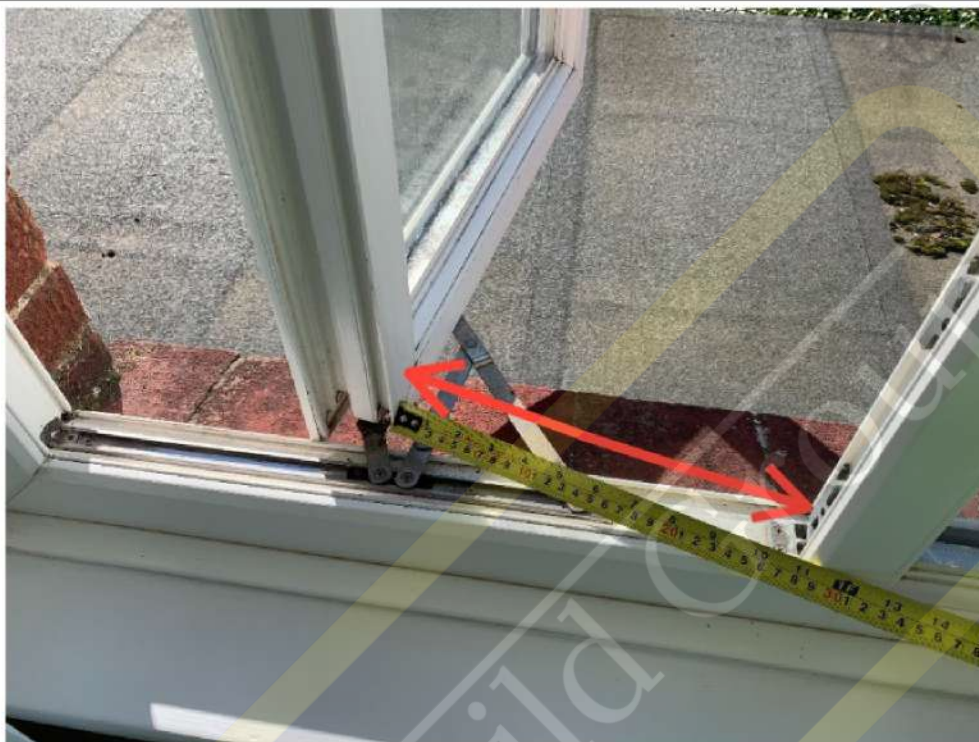
Unobstructed opening is less than required (rear bedroom)

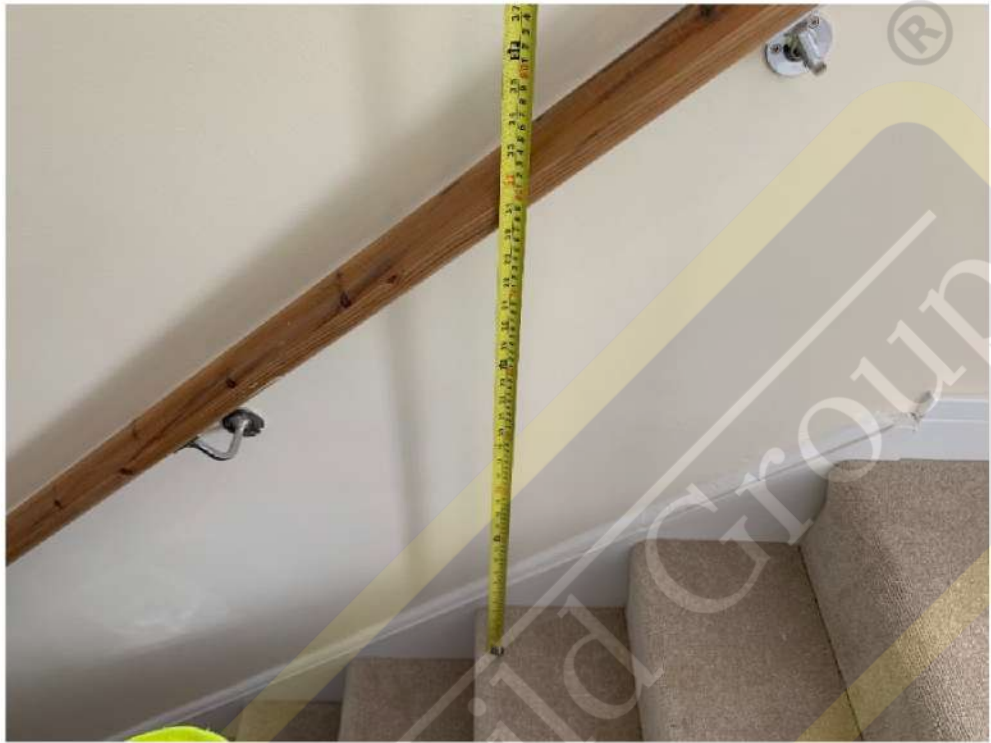
Handrail is lower than required

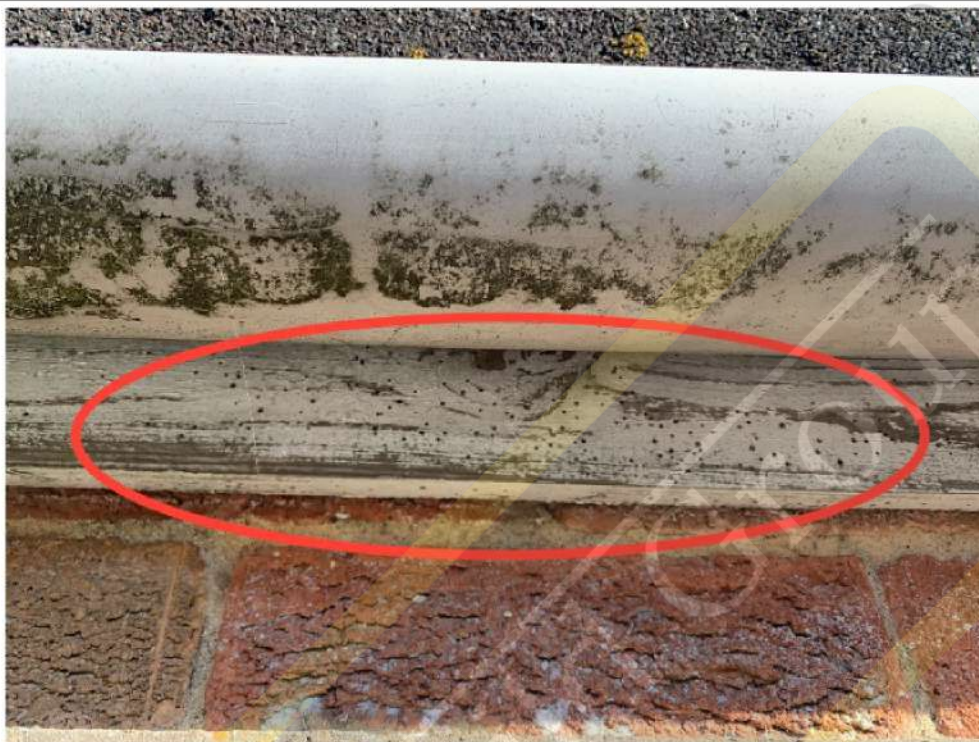
Unsafe Fittings	<p>Fittings within the property, where possible, were checked for normal everyday use, but have not been inspected or tested for safety purposes.</p> <p>Loose wires were noted in the landing cupboard. It is recommended to have a suitably competent person (registered with the Electrical Contractors Association, ECA, or the National Inspection Council for Electrical Installation Contracting, NICEIC), check and improve the wire installation.</p>   <p>Loose wires (landing cupboard)</p>
Insect and Rodent Infestations	<p>Wood borer holes were noted in the garage fascia board. The fascia board should be treated.</p>

Woodborer holes (garage fascia board)

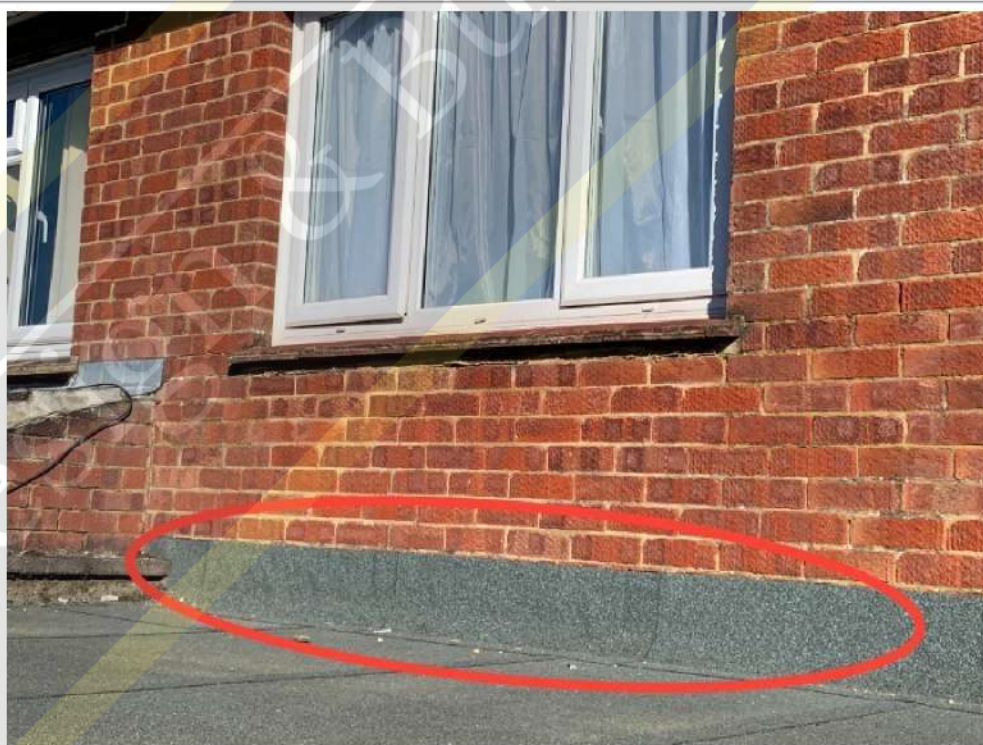
Poorly installed flashing (extension roof)

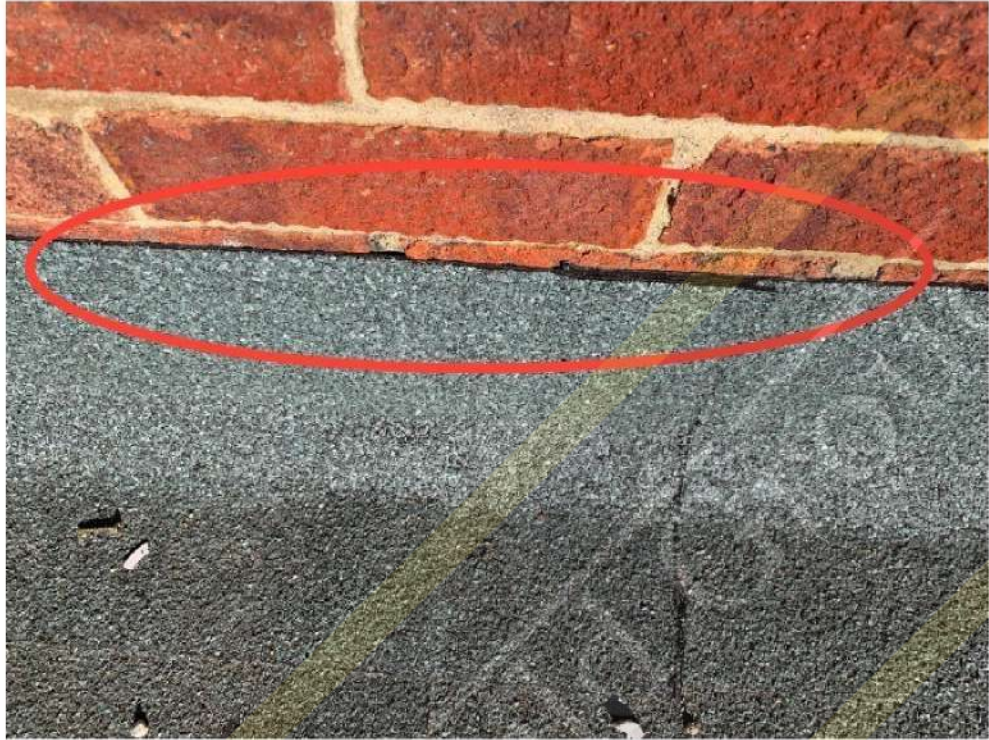
Poorly installed flashing (extension roof)

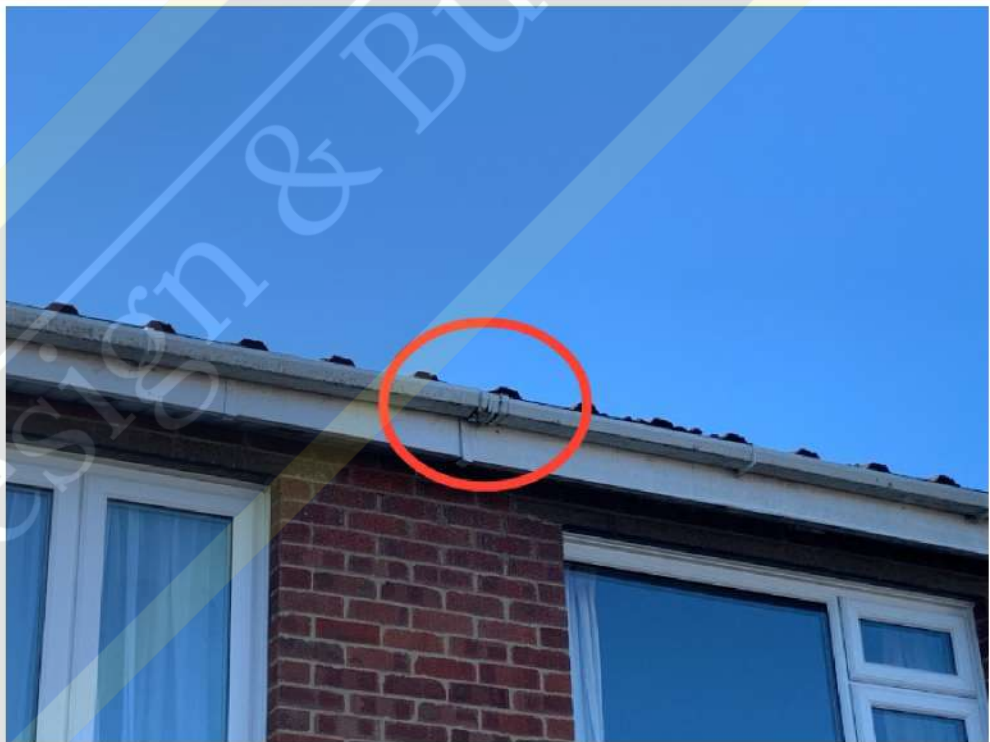
Poorly joint (front gutter)

<p>Action Required</p>	<p>It is recommended to clear out and check all gutters etc., for any leakage following a period of rainfall and carry out any repairs found to be necessary.</p> <p>It would be prudent to consider redirecting the main roof rear downpipe to discharge directly into the underground rainwater drainage system.</p> <p>It is recommended to re-direct the extension downpipe to an underground rainwater system that discharges into a soakaway situated away from the base of the building.</p> <p>The neighbour's gutter should be repaired as soon as possible to prevent damage to the subject property. This work should be done by the neighbour. Your legal advisor should advise you on this aspect.</p> <p>Minor defects are considered to be part of normal maintenance. The property must be maintained in a normal way.</p>

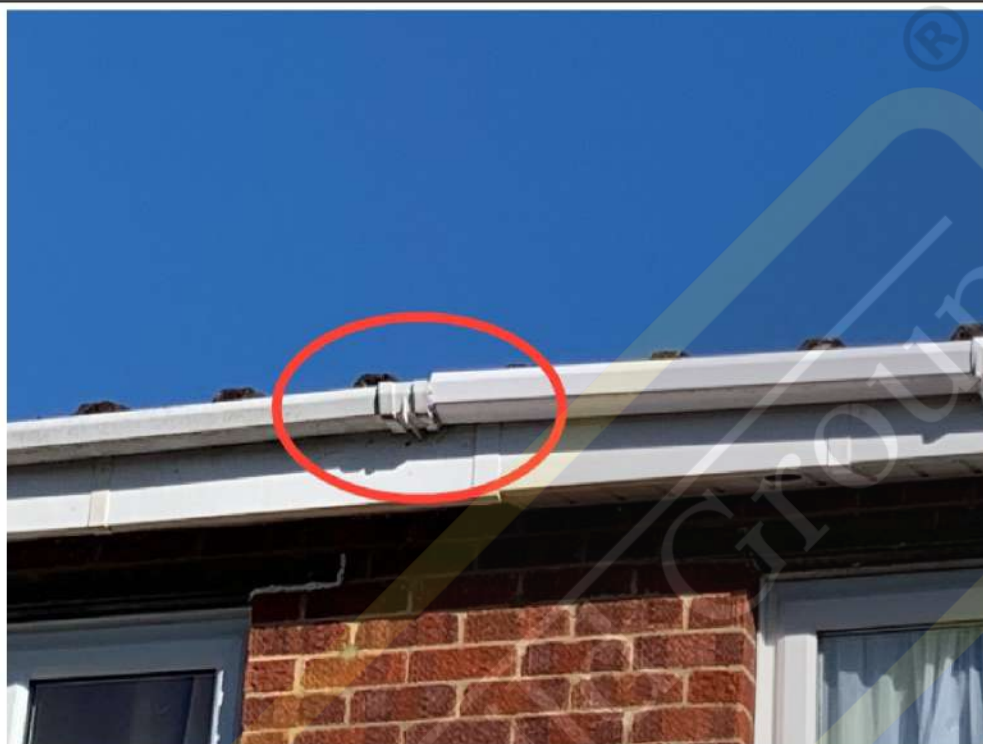
Poorly made joint (rear gutter)

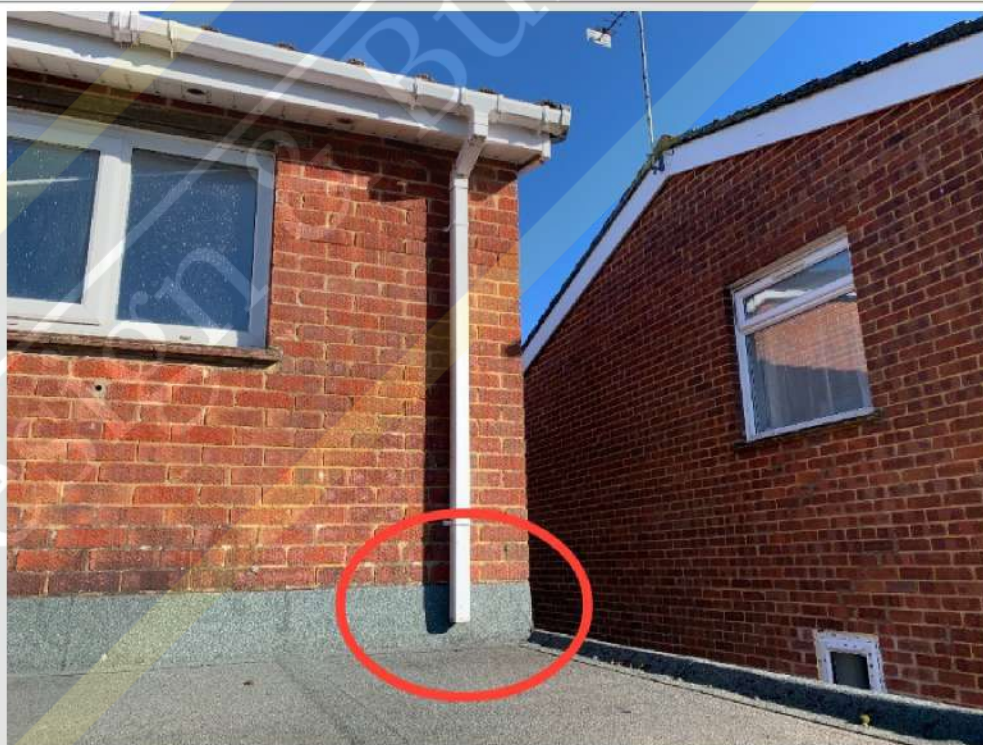
4.3 Rainwater and Above Ground Drainage Fittings	Condition rating	3
Construction & Type	<p>The rainwater fittings are plastic.</p> <p>The gutters are fixed along the perimeter of the roof slopes to collect rainwater outfall, which is then discharged via downpipes.</p>		
Nature of inspection and Limitations	<p>An inspection was carried out from ground level with the aid of binoculars to look for possible areas of leakage, misalignment, overflow and other defects.</p> <p>As it was not raining at the time of the inspection, it is not possible to confirm that the rainwater installation is free from blockage, leakage etc., or that it is coping with long periods of heavy rainfall.</p> <p>No tests have been carried out to either trace or establish the structure or condition of any underground soakaways.</p>		
Condition	<p>The joints where the front and rear gutters join the neighbour's gutters appear to be poorly made, which could lead to leaks. Defective rainwater goods can lead to serious defects in other parts of the property if not repaired.</p> <p>Although plastic rainwater goods are relatively low maintenance, the joints of plastic gutters are sealed with flexible gaskets, and these perish with age, commonly lasting around 20 years.</p> <p>The rear downpipe from the main roof discharges onto the extension roof. There is a risk that the extension gutter may not be sufficient to handle the amount of water discharged from the main roof during heavy rain periods.</p> <p>It was noted that the extension rainwater downpipe discharges rainwater onto the ground. During prolonged or heavy rains, the discharged water can oversaturate the soil near the house, which can lead to a loss of the bearing capacity of the soil under the foundation, which, in turn, can lead to damage to the foundation and, as a result, to structural deformations of the building.</p> <p>It was noted that the neighbour's gutter was missing an end cap. During rain, the water from the gutter would discharge onto the subject property's extension wall which over time could lead to serious defects.</p>

Downpipe from main roof discharges onto extension roof

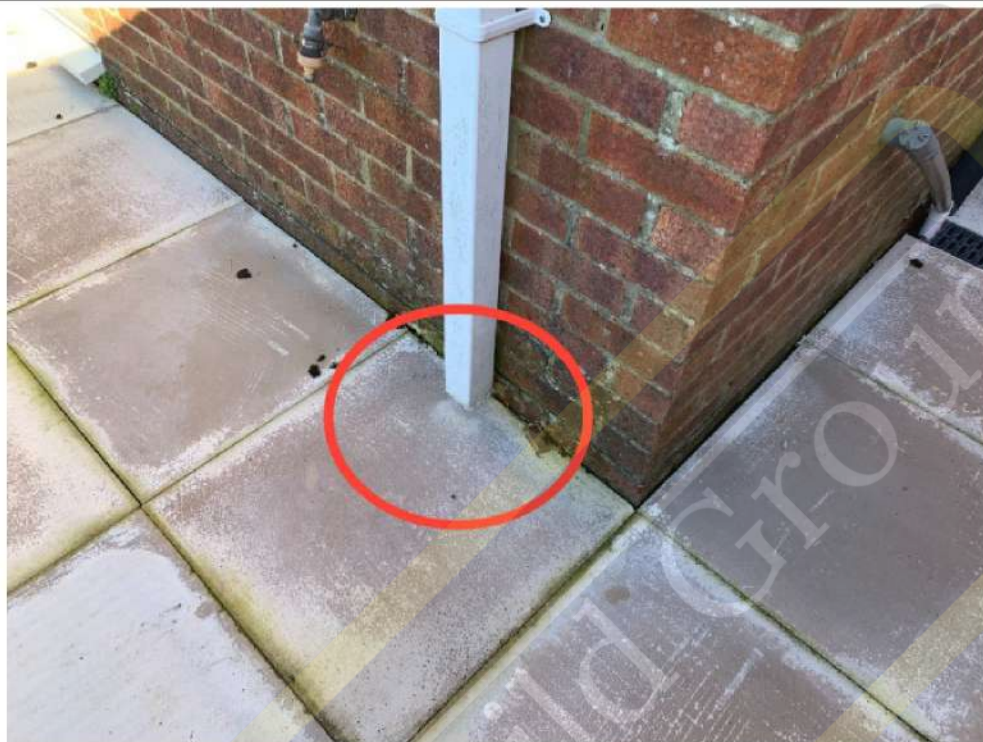
Rear downpipe discharges onto the ground

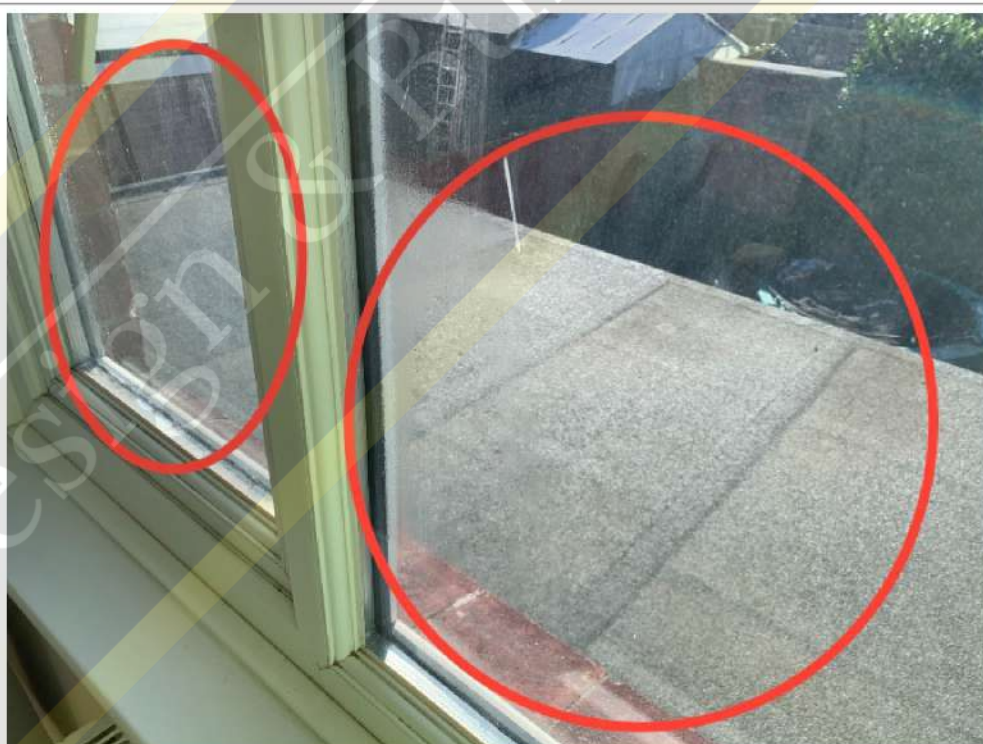
Condensation inside double-glazed units (bedroom 2)

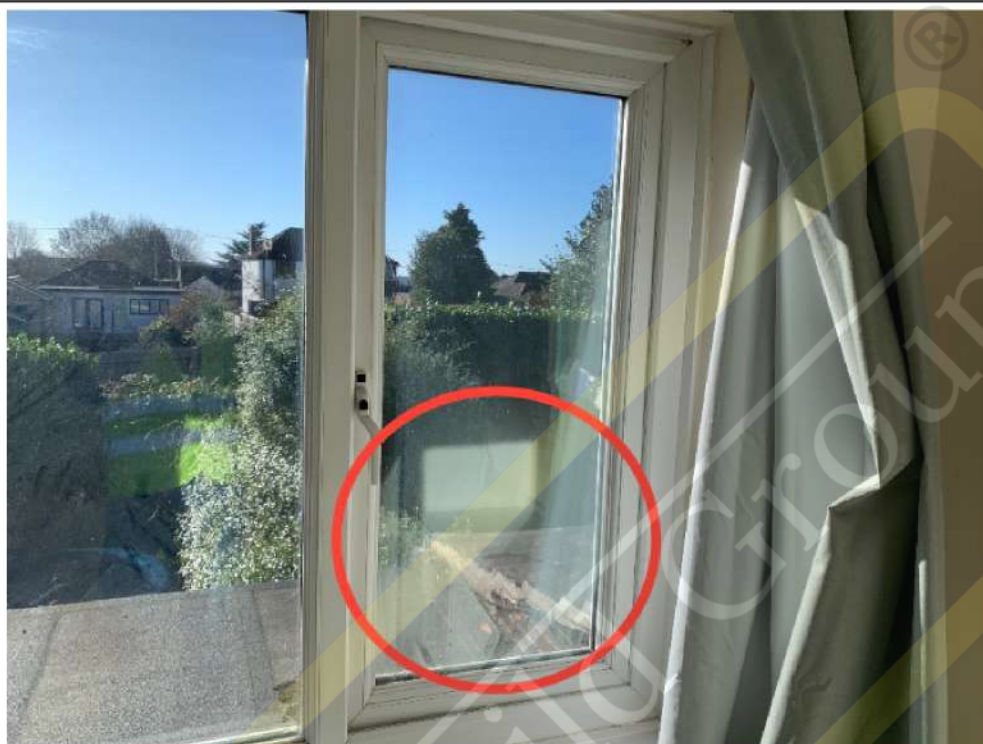
Condensation inside double-glazed unit (bedroom 2)

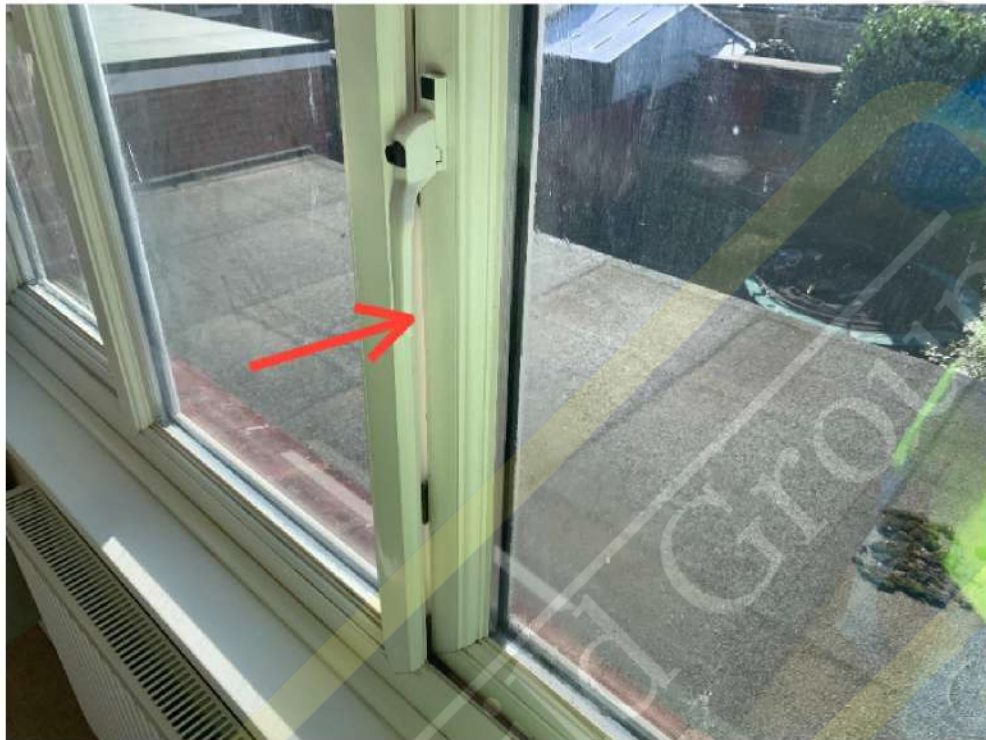
Window was not closed properly (bedroom 2)

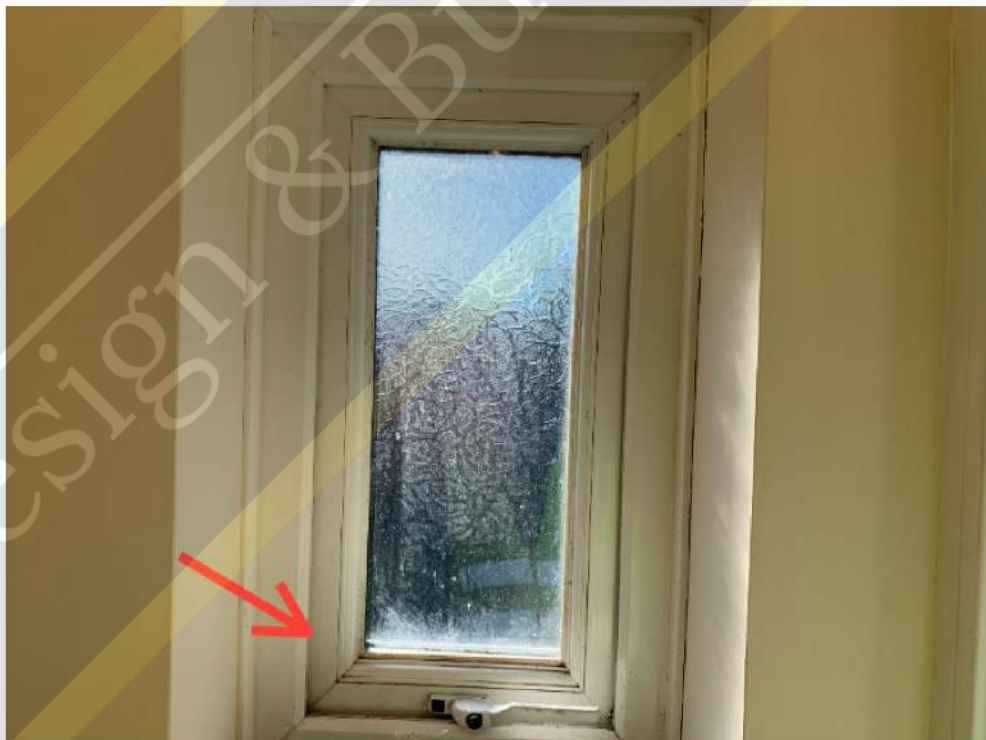
Window was not closed properly (toilet)

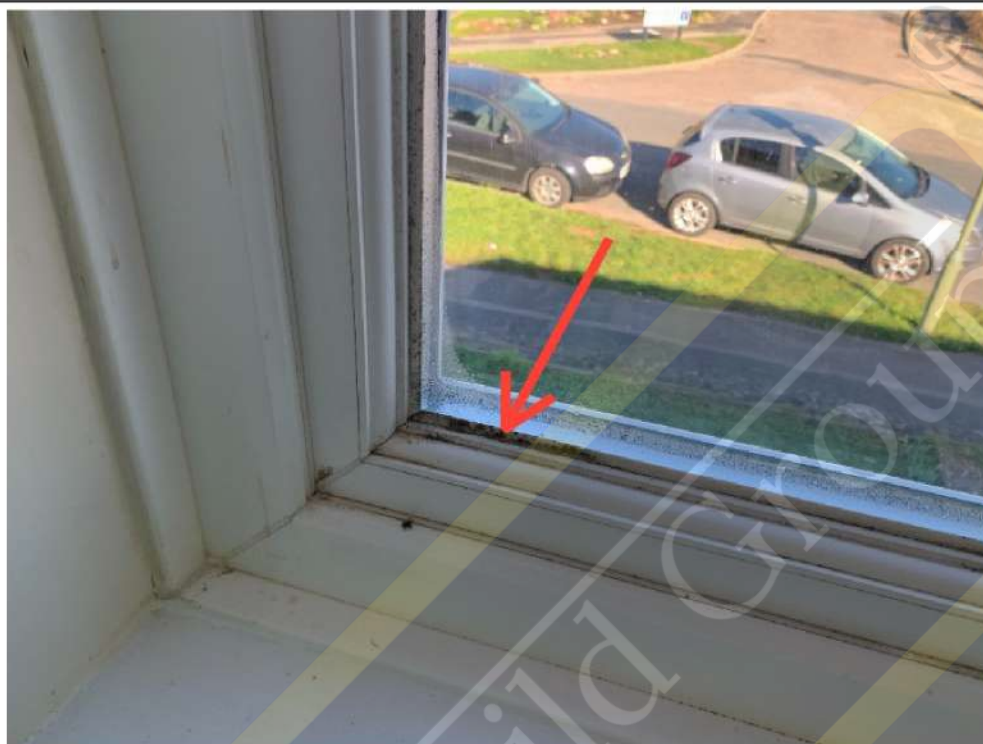
Mouldy gaskets (bedroom 3)

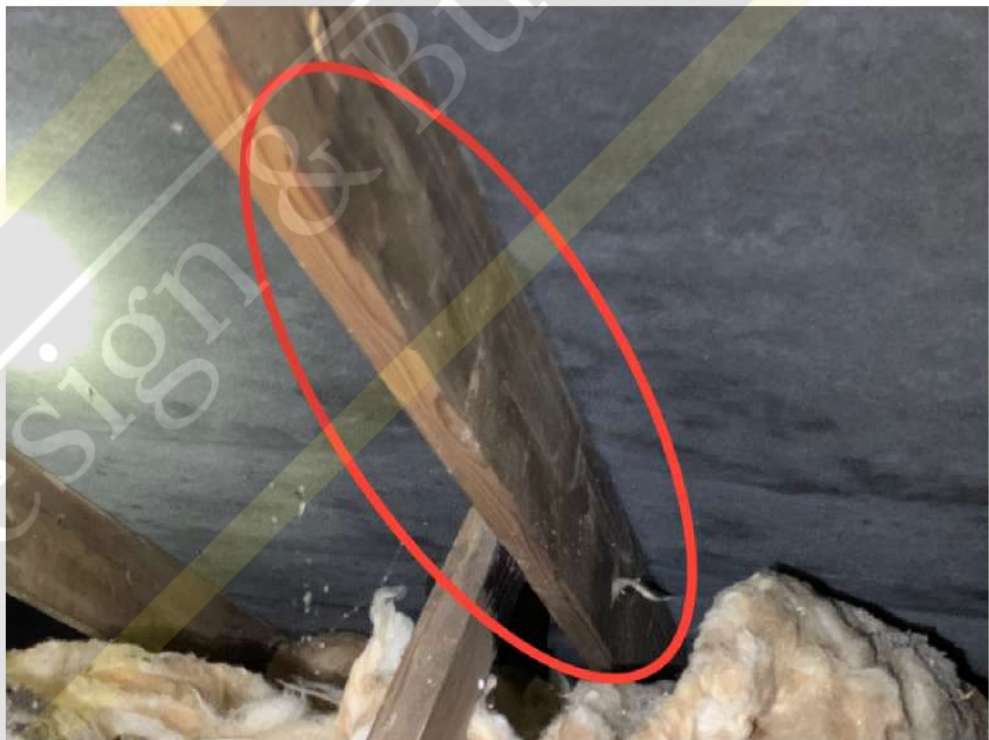
Mouldy rafter

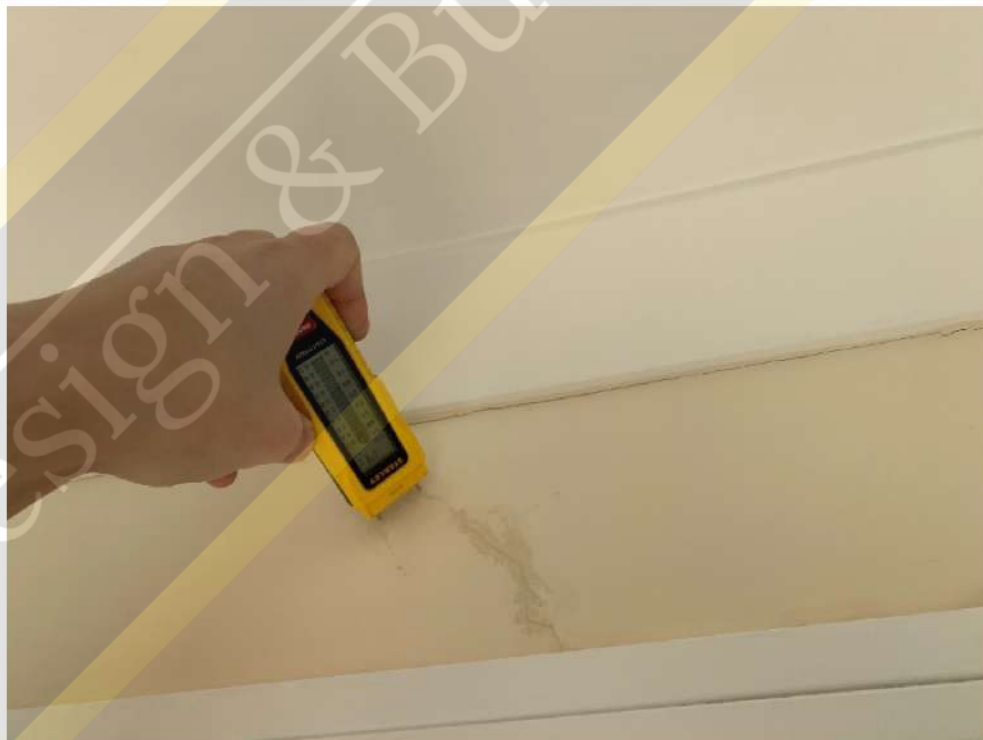
Dampness Summary	There is a hairline crack above a doorway in the wall between the dining room and kitchen. The wall next to the crack had high moisture content which indicates a leak. Please refer to section 5.3 for more details.
Structural Summary	<p>There is a hairline crack above a doorway in the wall between the dining room and kitchen. The wall next to the crack had high moisture content which indicates a leak. Please refer to section 5.3 for more details.</p> <p>The concrete lintel above the garage door has cracked and the rebar is rusty. Please refer to section 7.1 for more details.</p>

Hairline crack with high moisture content (wall between dining room and kitchen)

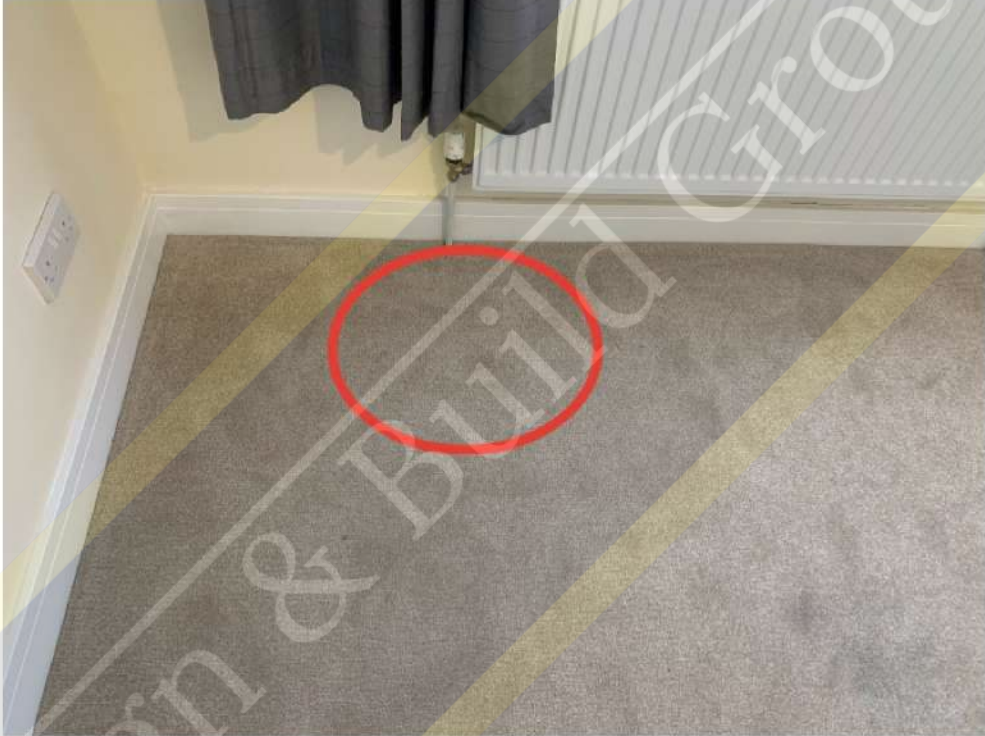
Condition	<p>Part of the floor in the small bedroom sags underfoot. When the floor sags, the underlying floor structure should be inspected. There may be structural issues, such as rotten or damaged joists that need to be repaired/replaced. This is the reason for condition rating 3.</p> <p>The rest of the timber floor is generally satisfactory, without excessive creaking, sagging, slopping, etc.</p> <p>The concrete floor was found to be firm, level and tight to the underside of floor skirtings. No ramping or deflection was evident, and there was no evidence of widespread resonance (hollowness). Therefore, no visual signs were found indicating that the ground floor slab was adversely affected due to problems associated with ground movement.</p> <p>The vinyl tiles most likely contain asbestos (so-called vinyl-asbestos tiles or VAT), and precautions are required when removing and disposing of them.</p> <p>The carpets in the hallway and landing were dirty.</p> <p>Although the rest of the floor finishes are generally in good condition allowing for their age and normal wear, some minor repairs may be required on closer inspection.</p> <p>There is always a risk of hidden defects that will only be discovered when the floor coverings are lifted. Future repairs may be needed.</p>

<p>Sagging floor (bedroom 3)</p>

Action Required	<p>It is recommended to have a reputable contractor check the sagging floor in the small bedroom and estimate the costs of necessary repairs prior to the exchange of contracts.</p> <p>It would be prudent to consider the replacement of all VAT with safer floor coverings after purchase. Therefore, it is recommended to have a licensed contractor estimate the costs of replacement prior to the exchange of contracts.</p> <p>The landing and hallway carpets require professional cleaning.</p> <p>Any minor or cosmetic defects are considered to be part of normal maintenance. The property's floors must be maintained in a normal way.</p>

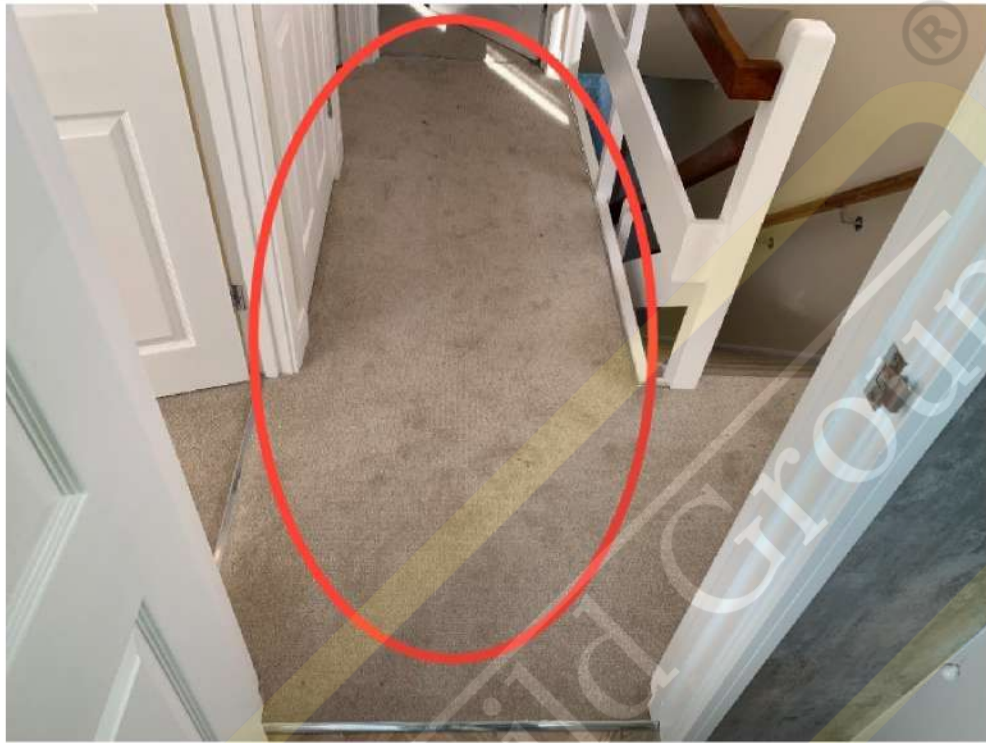
Dirty carpet (landing)

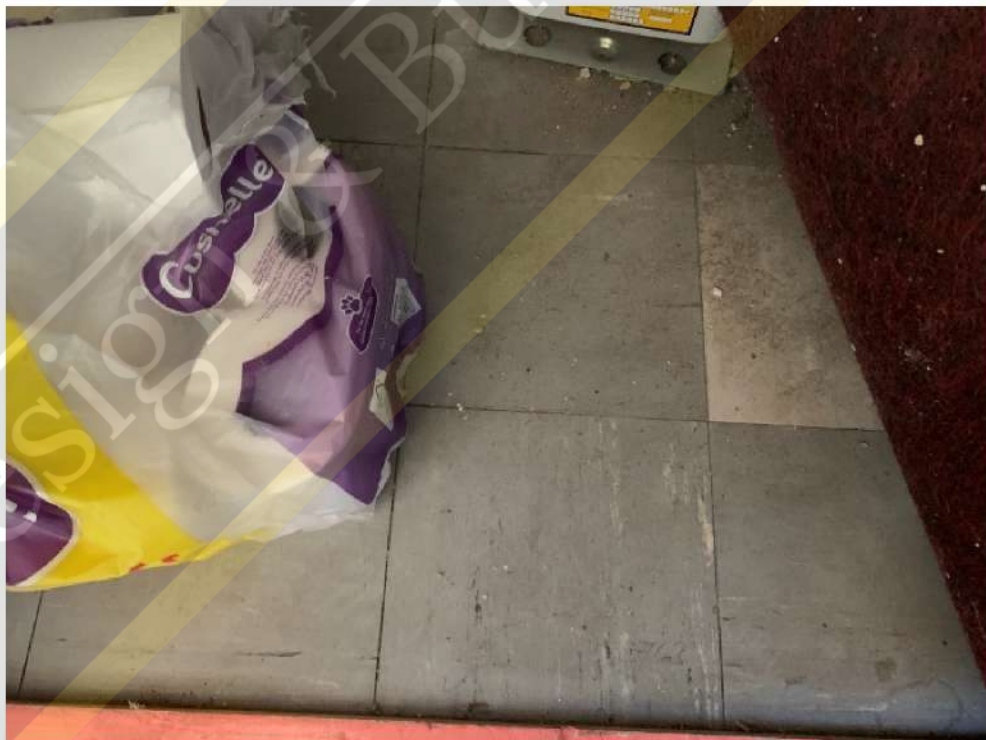
VAT tiles (cupboard under the stairs)

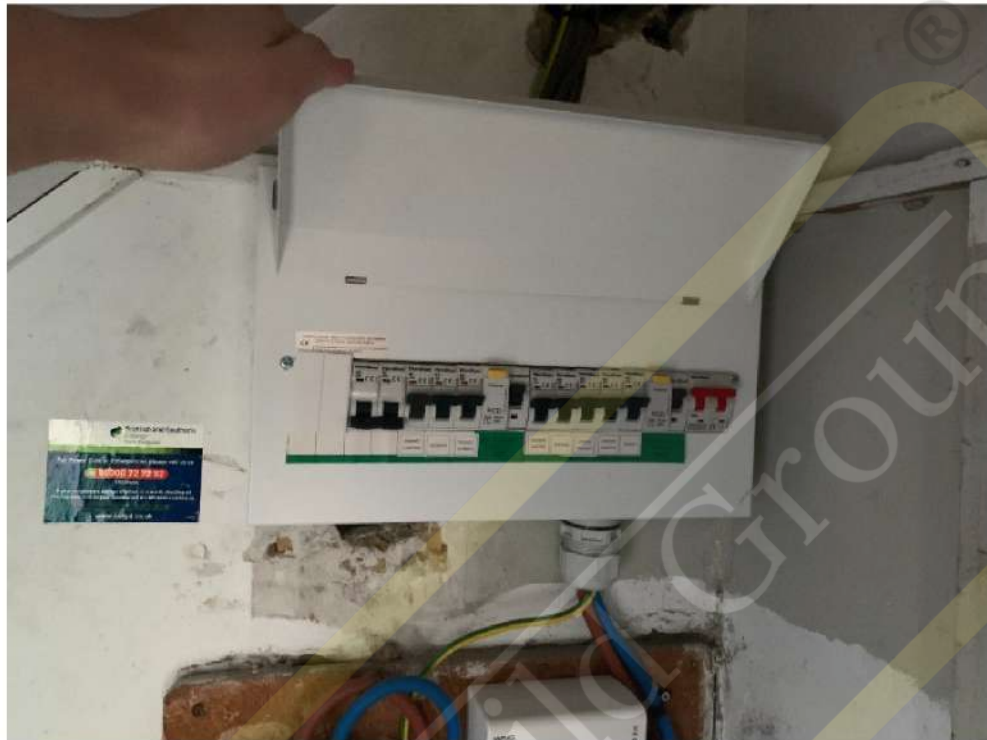
Consumer unit (understairs cupboard)

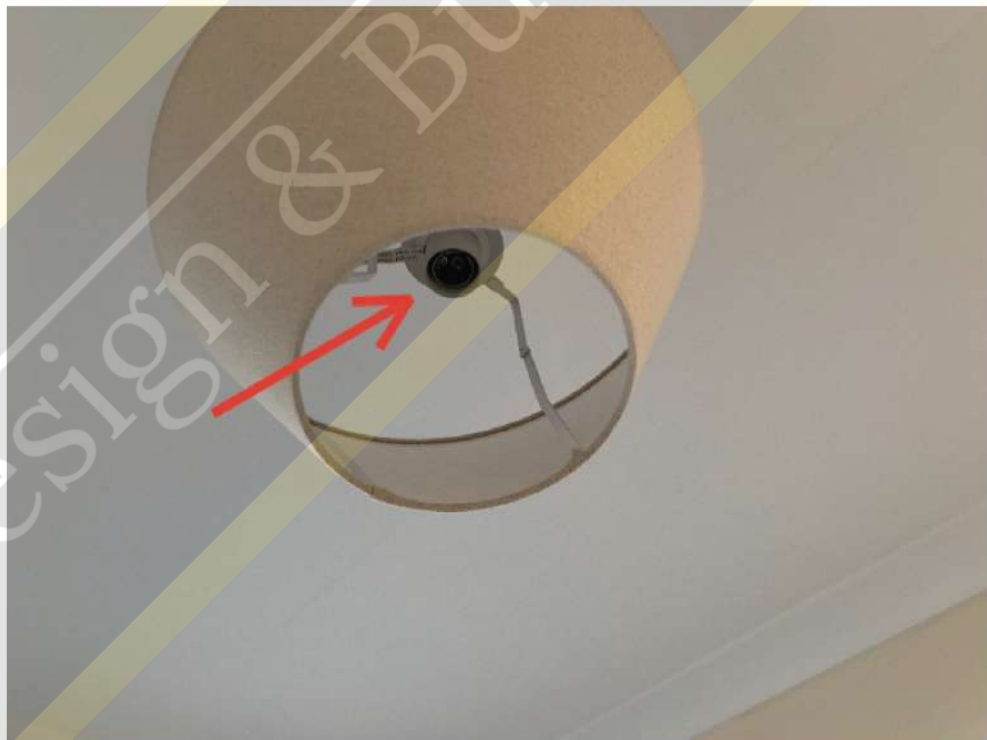
No lightbulb fitted (hallway)

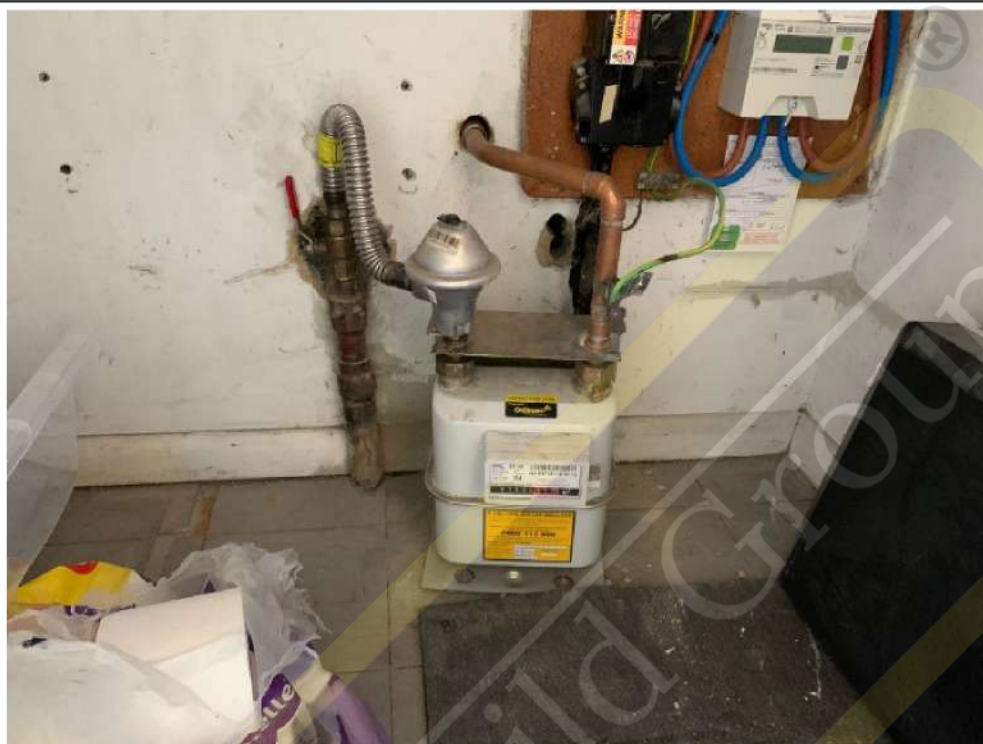
6.2 Gas / Oil	Condition rating	HS
Construction & Type	Gas is supplied from the mains and the gas meter is located in the understairs cupboard.		
Nature of inspection and Limitations	<p>We are not specialised in this field and therefore recommend that you seek specialist advice on all service matters. The items below should be regarded as helpful comments and suggestions. They are not a full and complete assessment of any problems that may exist.</p> <p>The main service installations within this property have been subjected to a visual inspection only and no intrusive checks have been carried out. The information provided in this part of the report is purely for your consideration only.</p>		
Condition	<p>For the most part, the gas installation appeared to be generally acceptable, with no obvious defects. However, considering the potential risks of an unsafe gas supply, a suitably competent person, such as a Gas Safe registered contractor, should inspect the gas installation before exchanging contracts. This is considered to be a potential health and safety risk and should be treated as requiring urgent attention. In the absence of certification, surveyors must give rating HS to the item.</p>

Gas meter (cupboard under the stairs)

Action Required	<p>A suitably competent person, such as a Gas Safe registered contractor, should inspect the gas installation before exchanging contracts.</p> <p>For safety precautions, it would be prudent to consider relocation of the gas meter outside. The ideal location for a gas meter is on an external wall that is no more than 2 meters from the corner of the property on either side of a door or sealed window.</p>

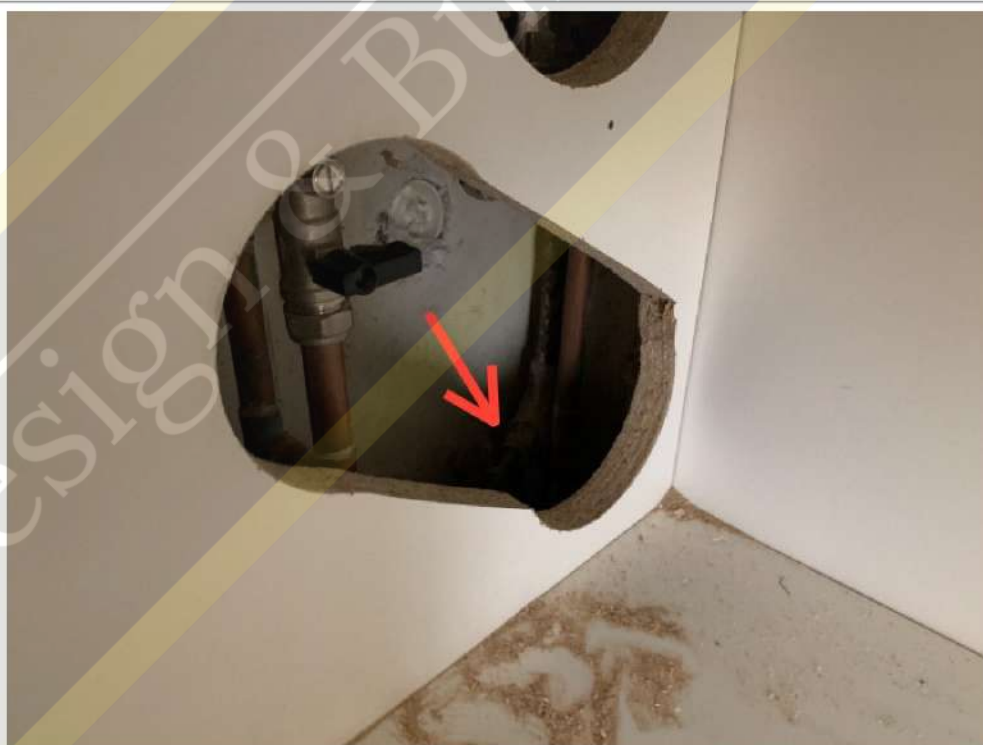
Internal stop tap (kitchen corner unit)

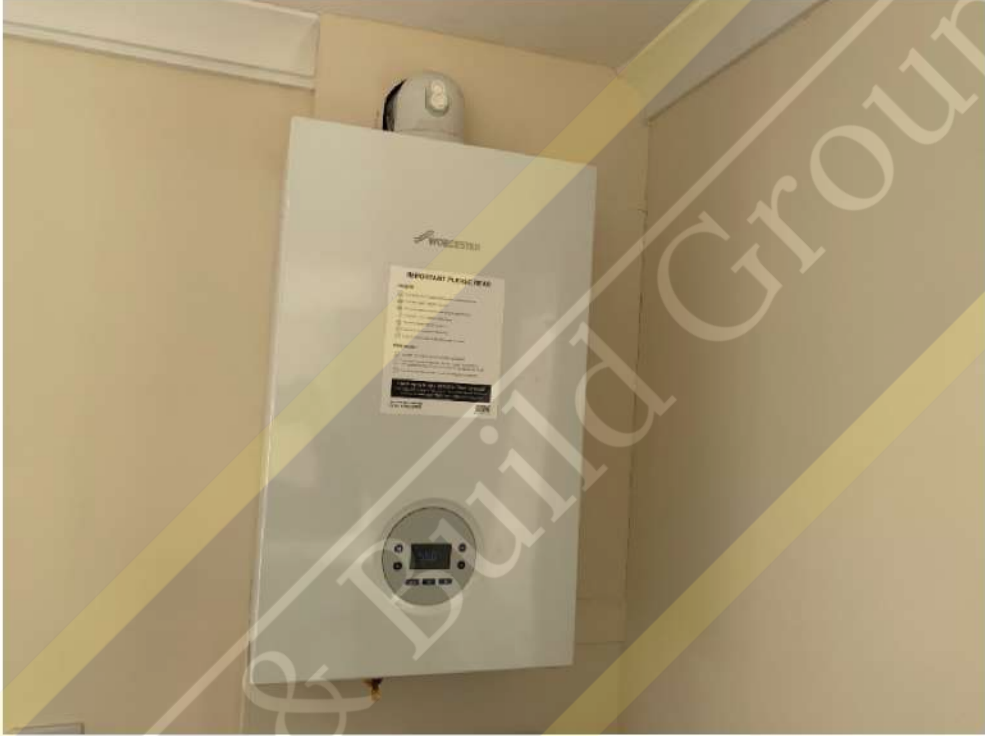
Condition	<p>The heating system appeared satisfactory but was not running at the time of the inspection and therefore no assessment could be made on its performance or serviceability.</p> <p>We were not informed that there was a gas service agreement. Copies of records and certificates should be obtained prior to the exchange of contracts.</p> <p>The heating systems tend to collect sludge, which can reduce the installation efficiency and, consequently, the cost of heating bills etc. Eventually, some flushing out or replacement may be necessary, but this is part of normal maintenance for a heating system.</p> <p>TRVs allow separate control of each radiator. If used correctly, they can improve the efficiency of a system, but in practice, they are challenging to operate effectively. As mechanical devices, they can sometimes jam and become ineffective.</p> <p>Minor and cosmetic defects are considered to be part of normal maintenance.</p>

<p>Greenstar GR1000W 30 C NG combi gas boiler (kitchen)</p>

Action Required	<p>Your legal adviser should check whether there is any documentary evidence that the heating installation has been tested or serviced recently. In the absence of documentary evidence to show that the heating system has been tested, surveyors must give designation HS to the item and the heating system should be checked by a suitably qualified person before exchanging contracts. If legal enquiries reveal that the system has been tested recently, then a test may not be required. This is considered to be a health and safety risk and should be treated as requiring urgent attention.</p>

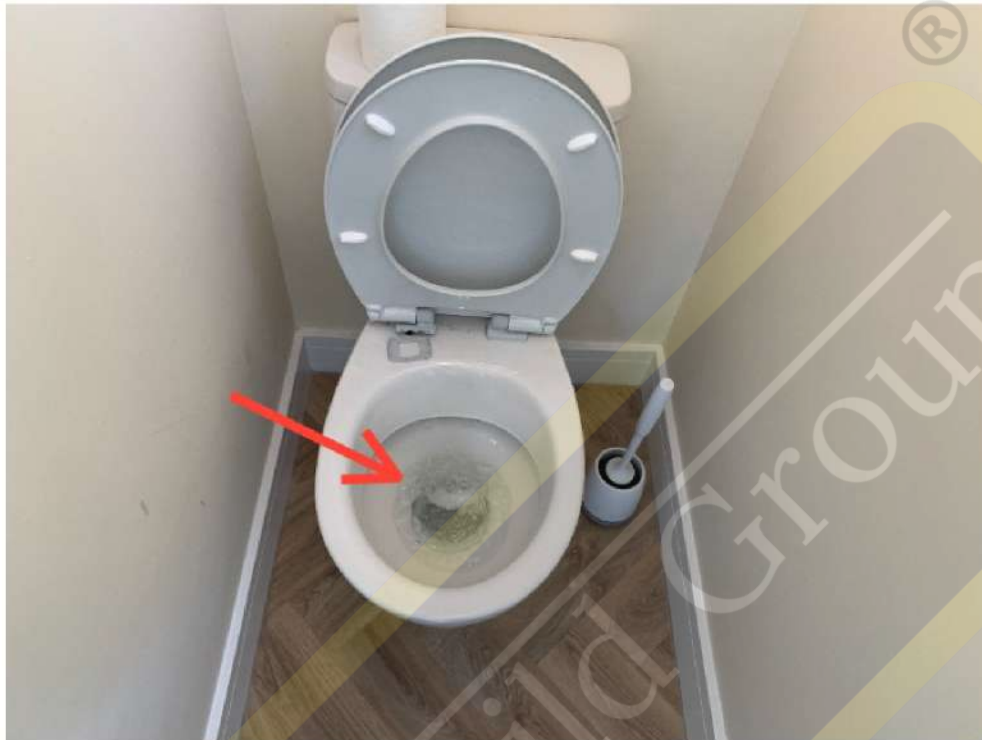
Condition	<p>Water was not draining properly from the ground floor toilet which indicates that the drains could be clogged or defective.</p> <p>Apart from the issue above and where visible, the internal drainage system appeared satisfactory, with normal water drainage and no disrepair evident.</p> <p>The above ground wastes generally appeared in serviceable conditions where visible with no evidence of leakage or major disrepair.</p> <p>Without extensive exposure work, we cannot confirm the type or layout of the underground rainwater drainage system.</p>		
Action Required	<p>Given the age of the property and the potential risks that underground drains may be defective or clogged, it is recommended to arrange a home buyer drainage survey before exchanging contracts. The survey should include an assessment of the property's drainage system, including a drainage map showing where and what drainage a property has, a compliance assessment to check whether the property's drainage is compliant with the necessary environmental and building regulations, functionality assessment including sizing checks, defects and maintenance checks, a full CCTV condition survey of the drains, appropriate repair methods, and full written report with recommendations and budget figures for repair or replacement.</p> <p>Minor defects are considered to be part of normal maintenance.</p>

Water does not drain properly

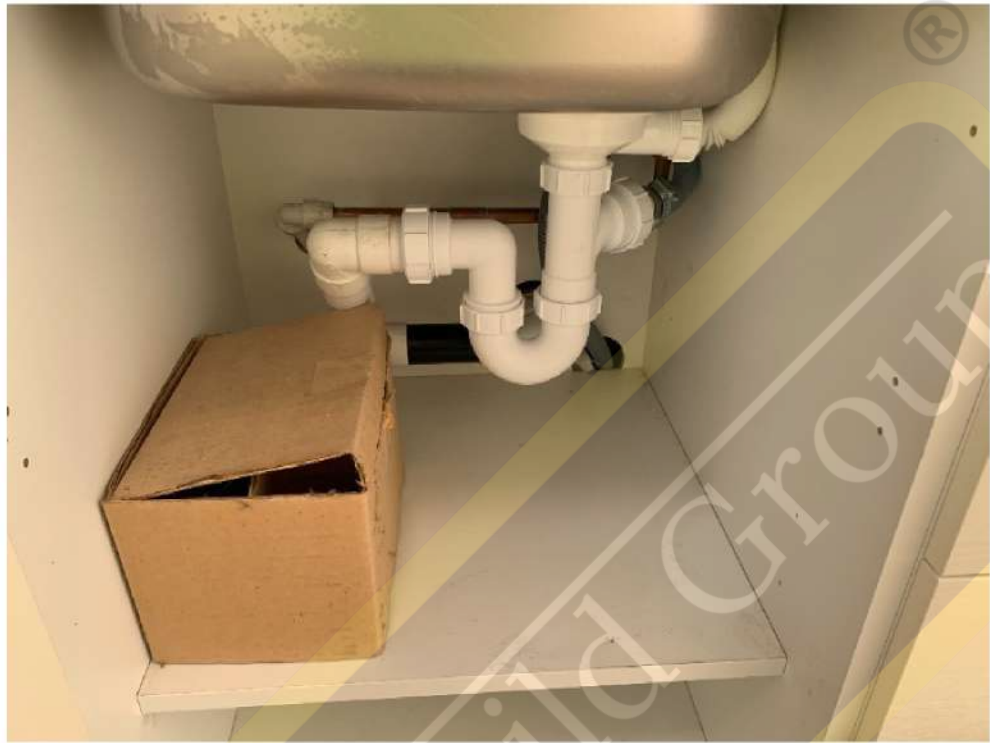
Kitchen sink drainage

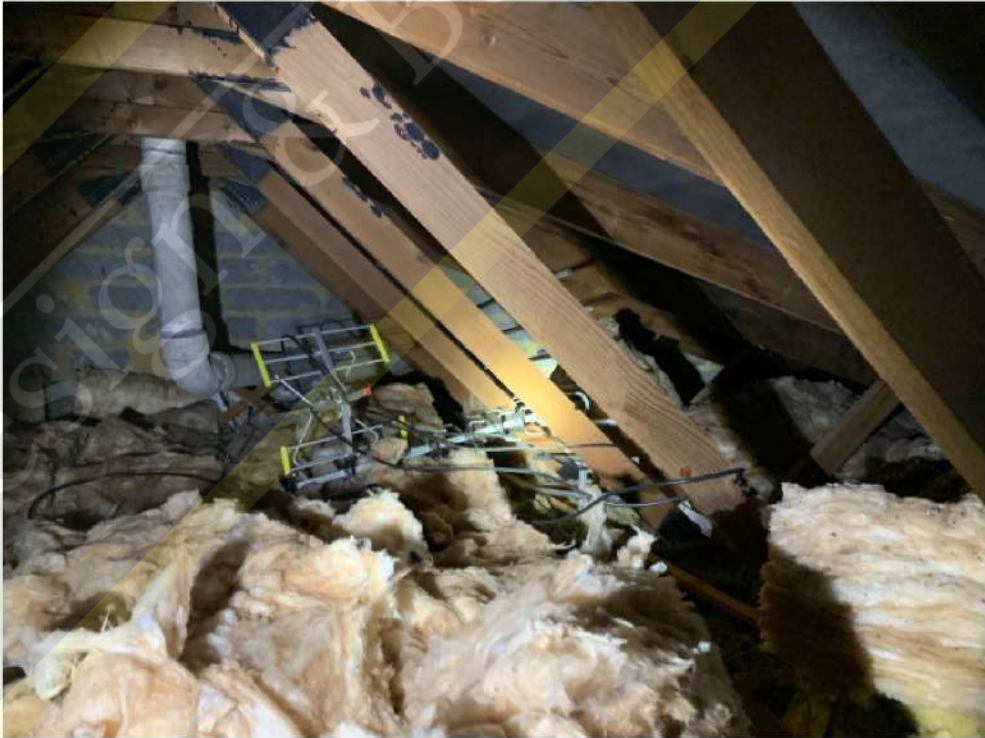
Television aerials (loft)
