BUILDING SURVEY REPORT

The format of this BUILDING SURVEY REPORT is consistent with the guidance defined by the
RPSA Survey Inspection & Reporting Standards Edition 1v5.2 November 2020

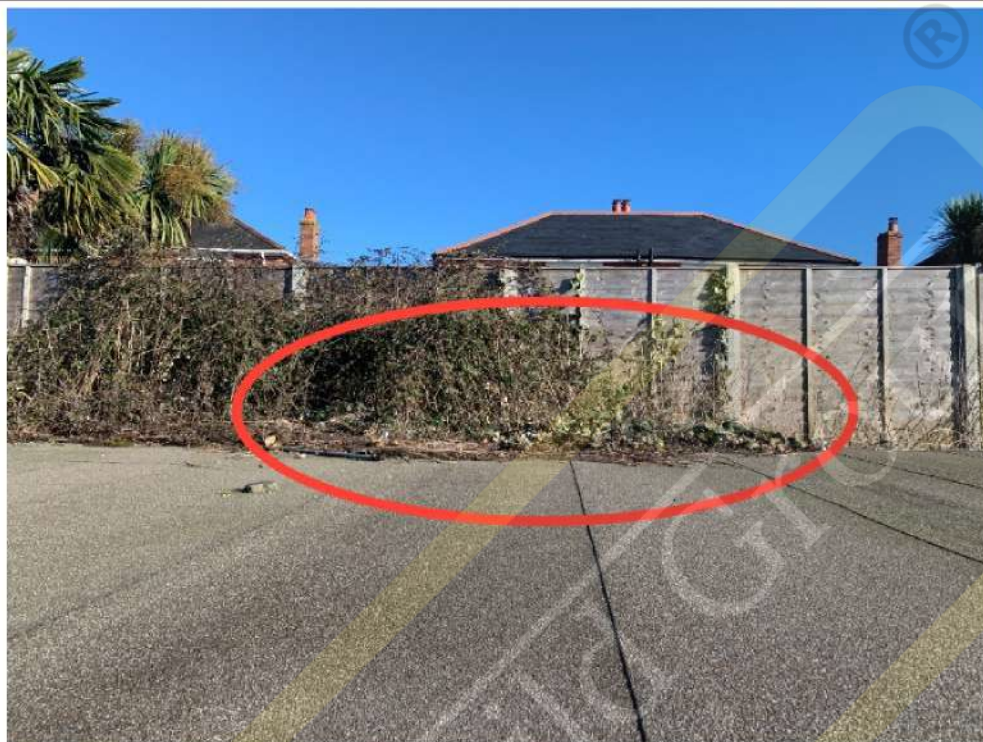
Roof partly covered with vegetation and debris

<p>Action Required</p>	<p>It is recommended to treat the rusty rebar and repair the lintel soon after taking over the property.</p> <p>It is recommended to remove vegetation growing on and near the garage. Once vegetation is removed the felt covering should be checked and repaired if necessary.</p> <p>The gutter should be replaced. It is also important to clean the gutter regularly.</p> <p>The fascia board should be treated.</p> <p>It would be prudent to ask the vendors about the purpose of the metal posts.</p> <p>The damp-proof course should be improved which could be done by injecting a silicone-based damp-proof cream into the brickwork above the low DPC</p> <p>Rectification of any minor or cosmetic defects is considered to be part of normal maintenance.</p>
	  <p style="text-align: center;">Garage</p>

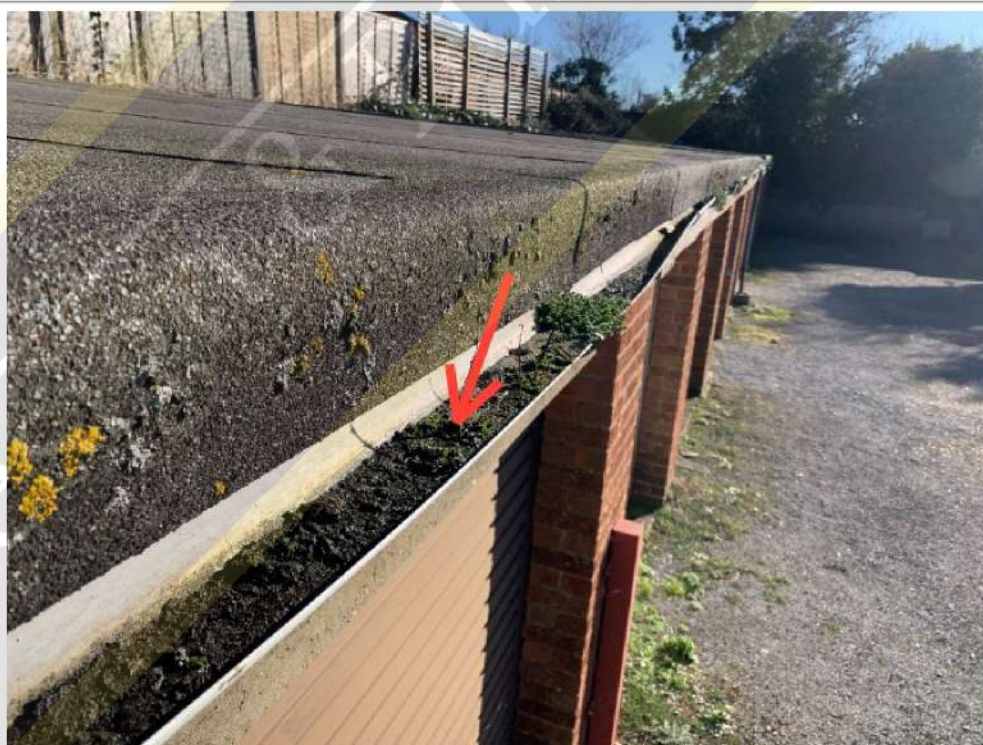
Clogged gutter

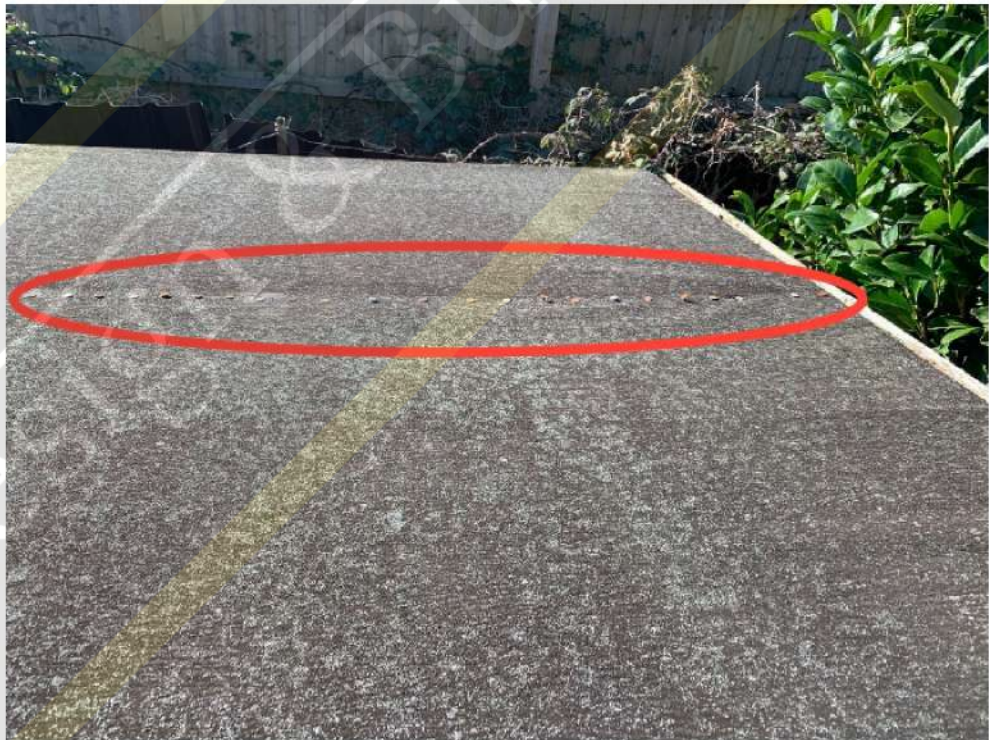
Poorly fixed roof covering

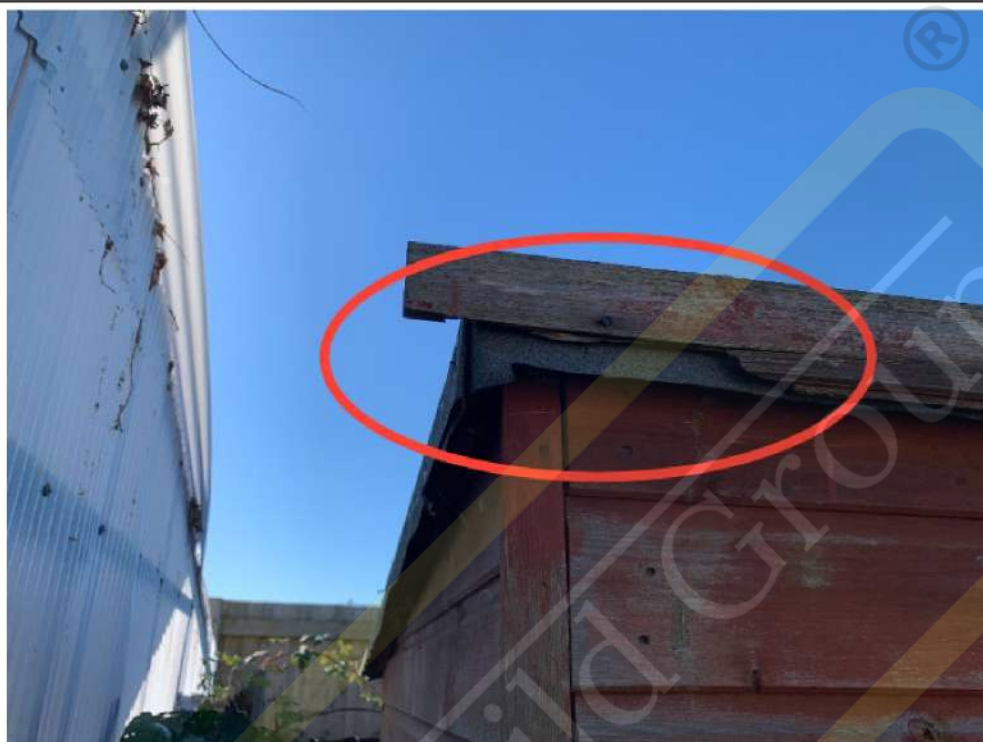
Rotten fascia

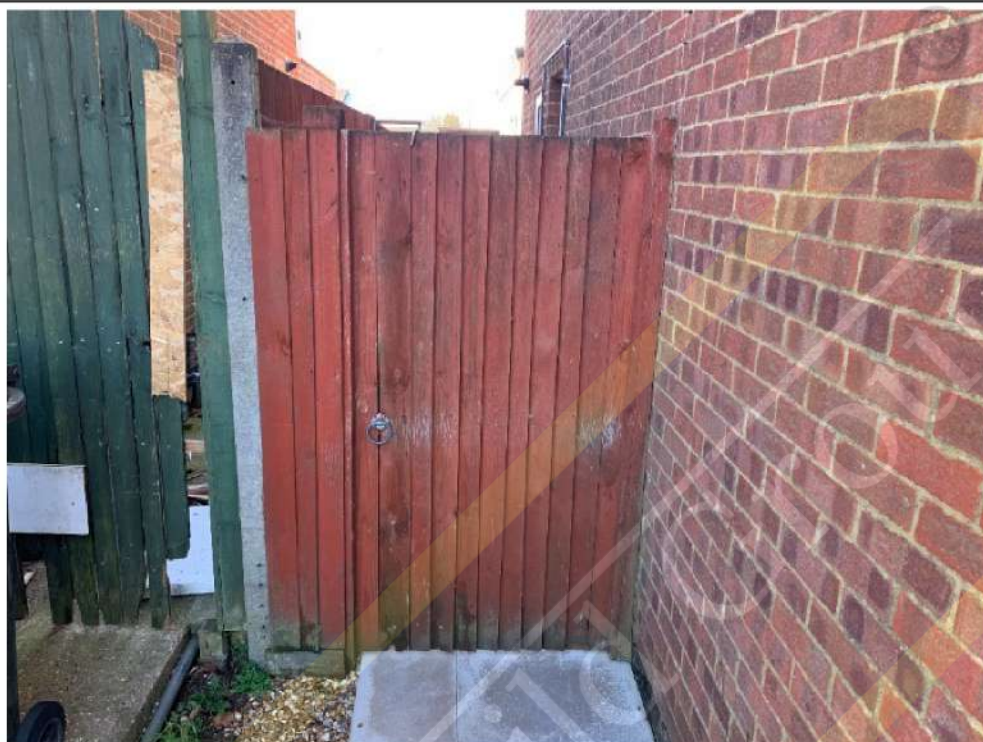
Condition	<p>The mortar pointing between the paving and concrete slabs has deteriorated in places.</p> <p>The side gate and timber fencing decoration has weathered.</p> <p>The natural stone slabs at the back of the rear garden are loose.</p> <p>The masonry wall has cracked in places.</p> <p>Apart from the issues above no significant defects were noted. There is no evidence of any damage from flooding.</p>

Gate - weathered decoration

<p>Action Required</p>	<p>The mortar pointing between the paving and concrete slabs has deteriorated and needs to be improved soon after taking over the property. The paved areas enhance the quality of the property curtilage. However, they must be kept in satisfactory condition otherwise this could present a safety hazard to users.</p> <p>It is recommended to treat the timber fencing and gate on an annual basis to ensure their longevity and maintain their appearance. Regular treatment helps protect the wood from moisture, UV rays, and other elements that can cause deterioration. By treating timber fencing and the side gate annually, you can extend their lifespan, enhance their aesthetic appeal, and provide added resistance against rot, decay, and damage.</p> <p>The natural stone slabs should be re-bedded.</p> <p>Cracks in the boundary wall should be sealed.</p> <p>Minor defects are considered to be part of normal maintenance. The property must be maintained in a normal way. Your legal adviser should verify the responsibility of the property owners for maintaining boundary timber fencing, masonry walls, metal mesh fencing and hedges.</p>

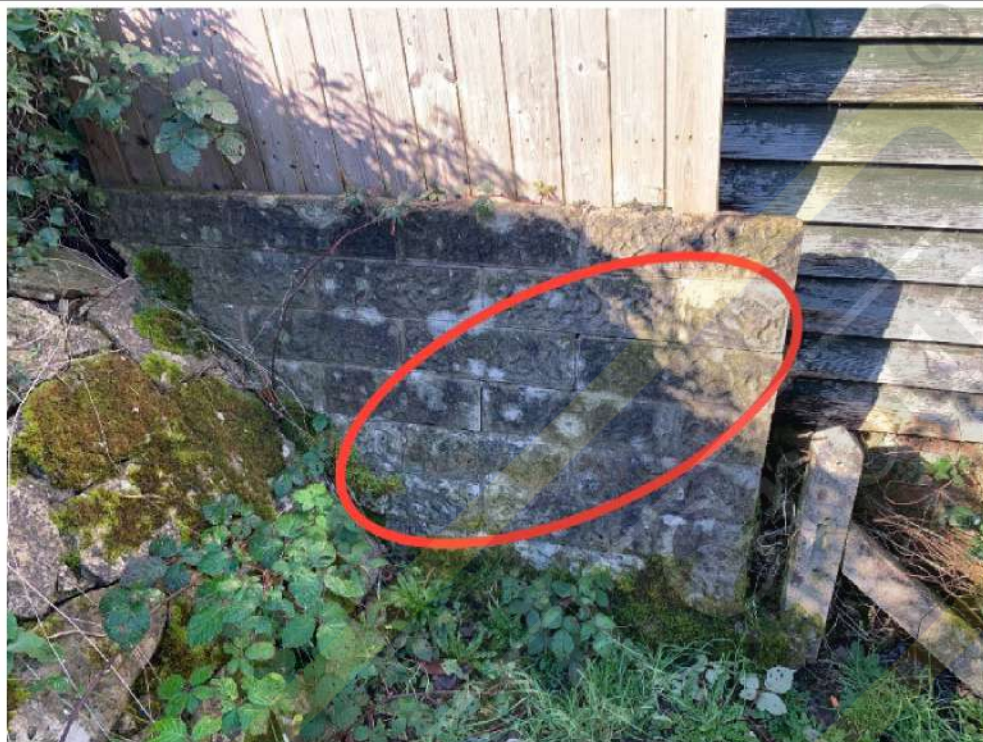
Cracks in the boundary wall
